# Building / Site Assessment Report

AFP3 Buildings 001, 002, 118 and 119  
Spirit Aerosystems and Navistar Tenant Space  
3330 N Mingo Rd  
Tulsa, OK 74116

Engineering Services Department  
Project No. 170045.2, Amendment No.1

09 / 30 / 2019

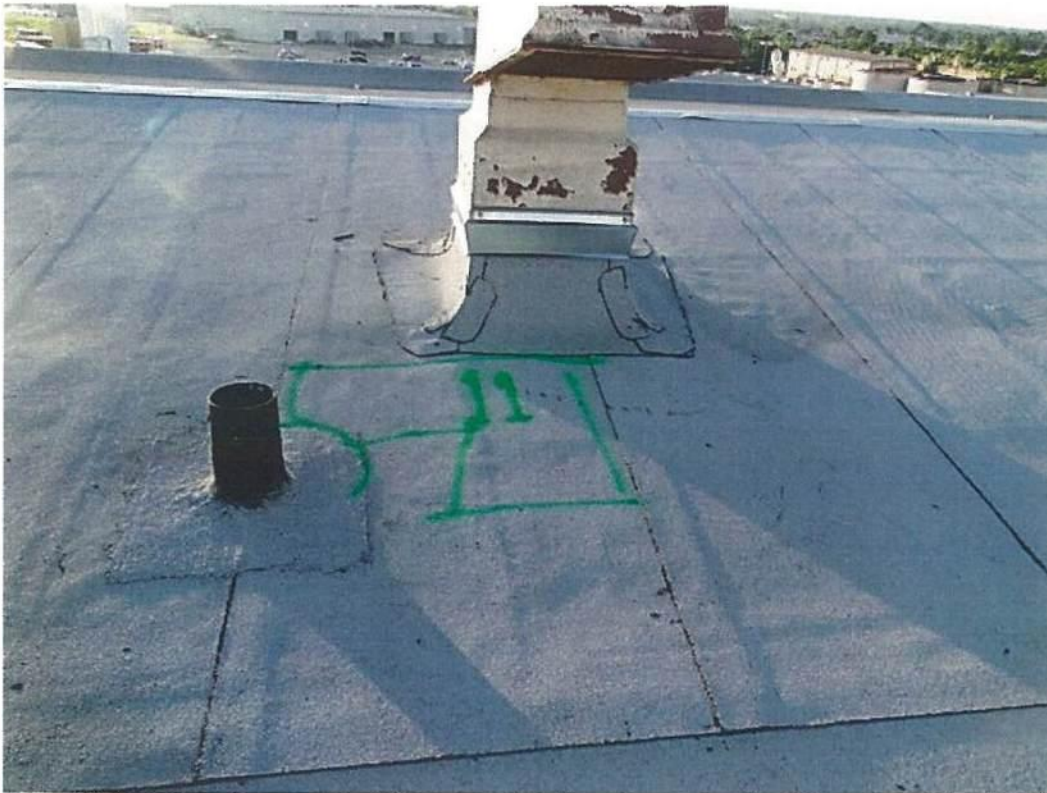
Photo #9702 View of entrapped moisture location #11 at between a plumbing vent and the rim of an exhaust fan curb at the Upper Roof near the east eave north of expansion joint #4.

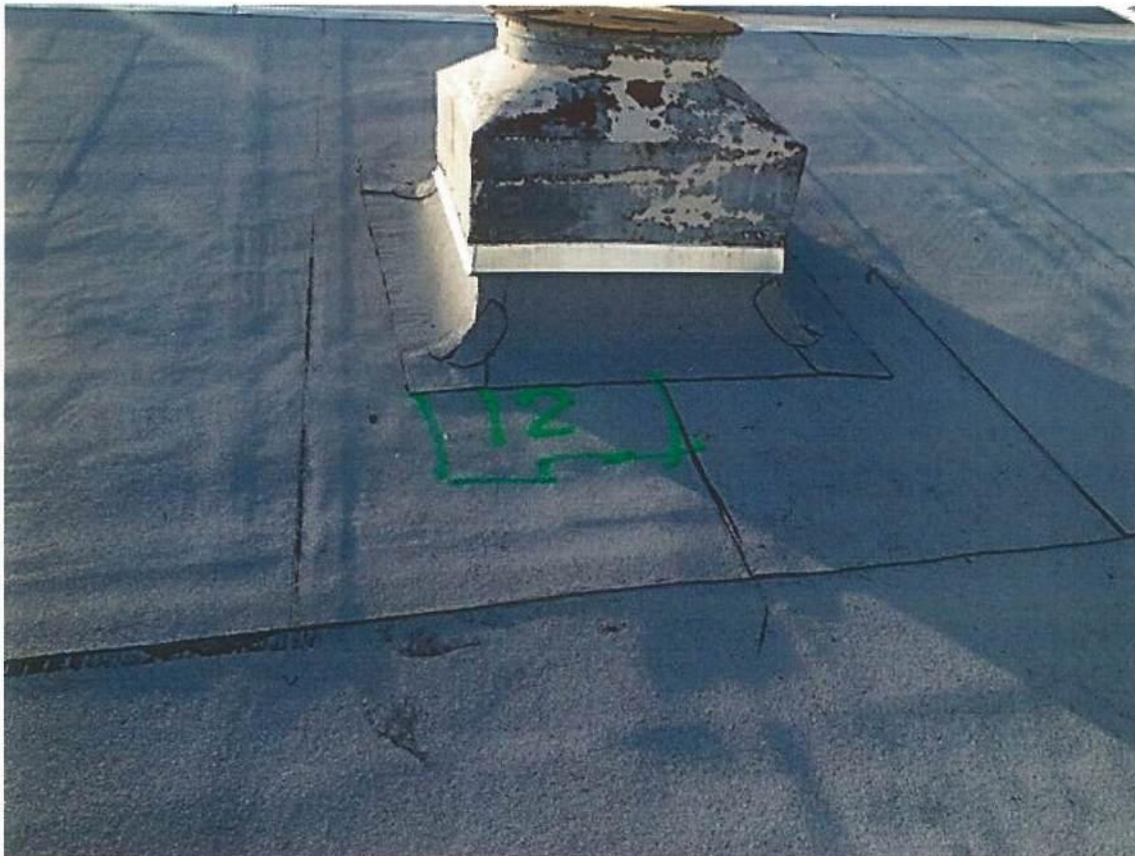
Photo #9701 View of entrapped moisture #12 at the base of an abandoned exhaust fan curb near the east eave of the Upper Roof north of Expansion joint #4.

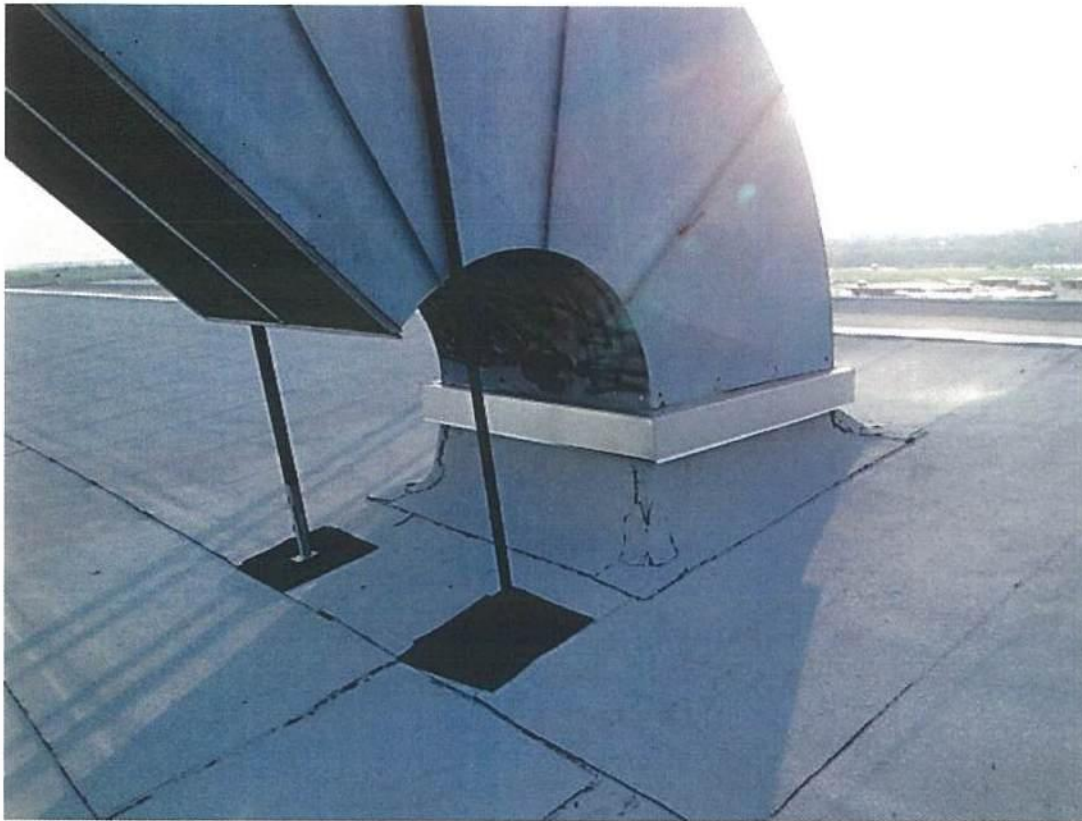
Photo #9732 View of reported leak location at south face of exhaust fan hood. Location is near the east eave of the Upper Roof between expansion joint #4 & 5.

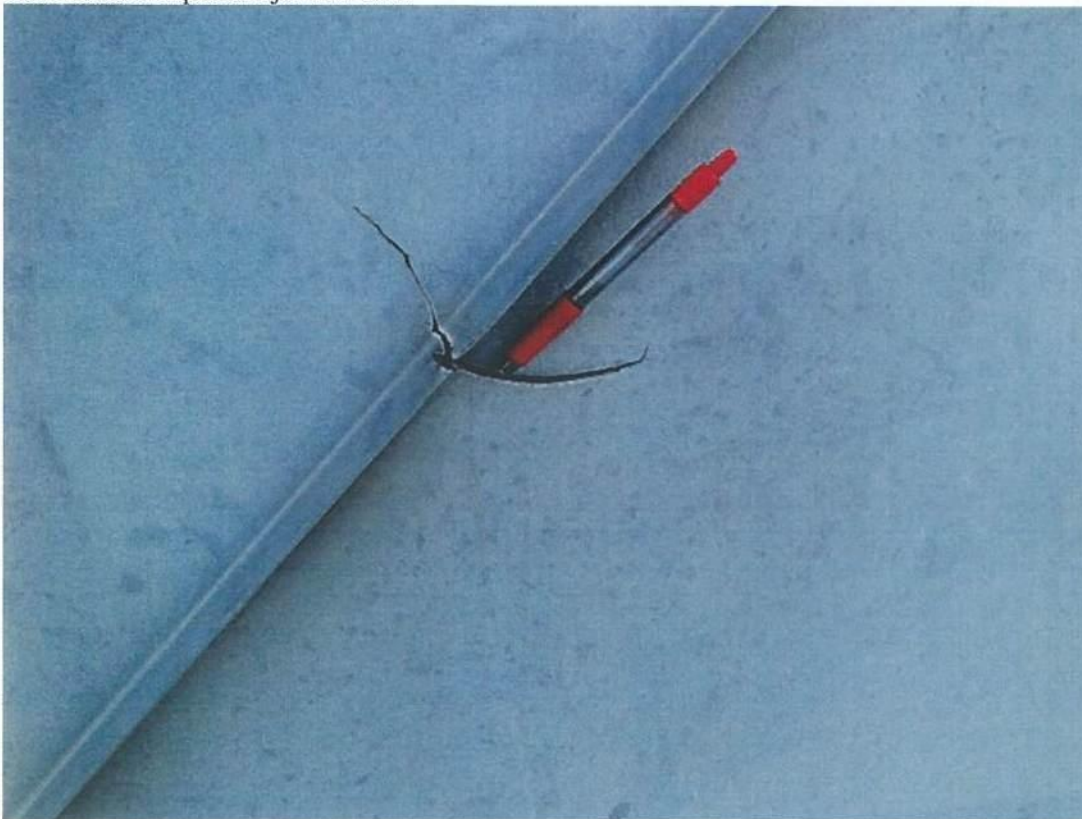
Photo #9733 Close-up view of split in metal weather hood shown above.

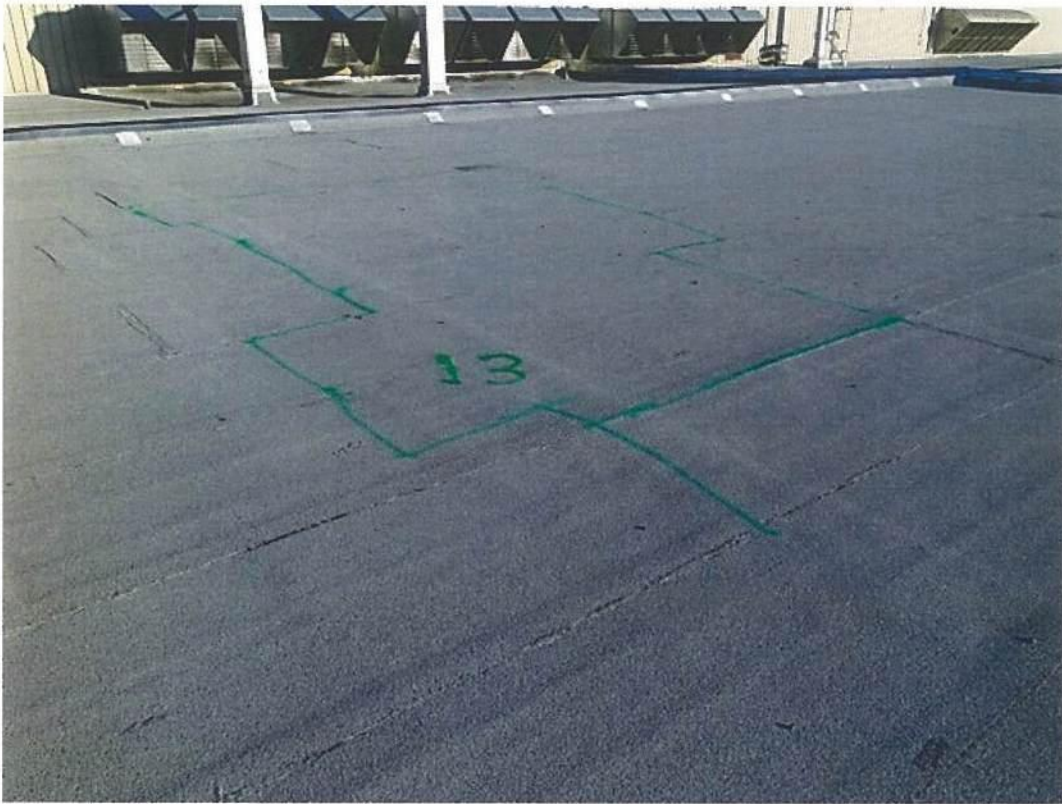
Photo #9710 View of entrapped moisture location #13 at the east 1/2 of the Lower Roof south of Expansion joint #6.

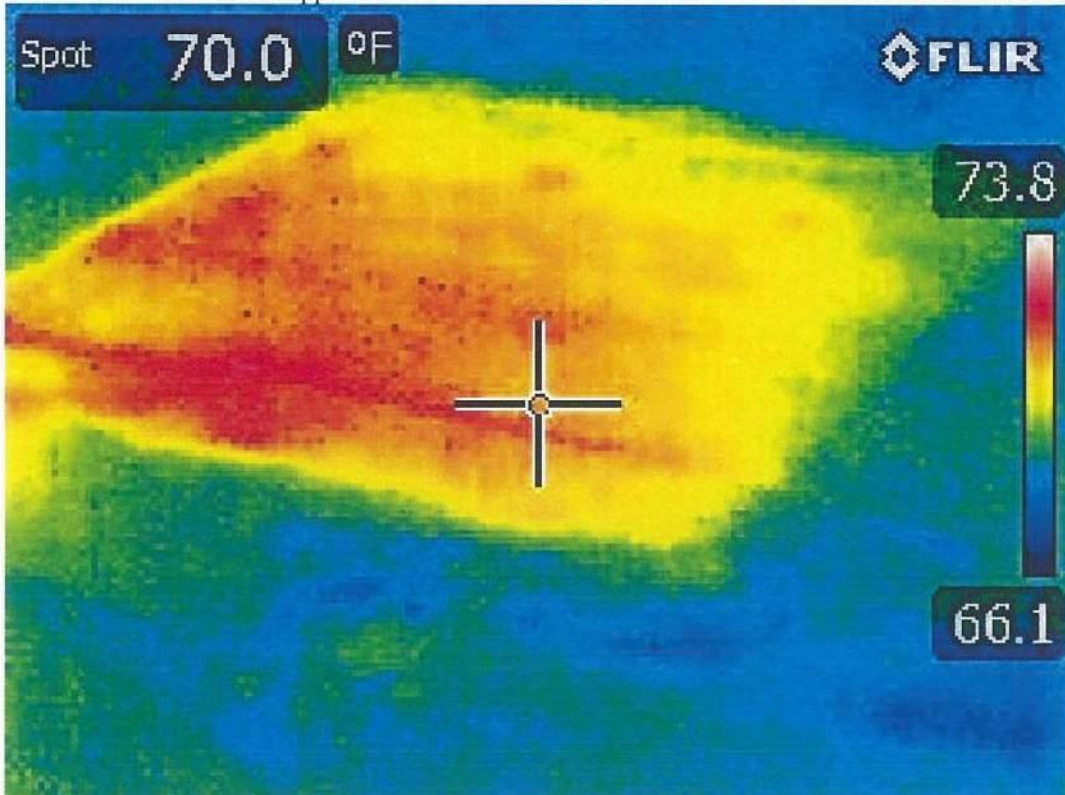
Photo #0466 View of area of entrapped moisture location #13 represented by red and yellow shaded areas at the east 1/2 of the Lower Roof area south of expansion joint #6.

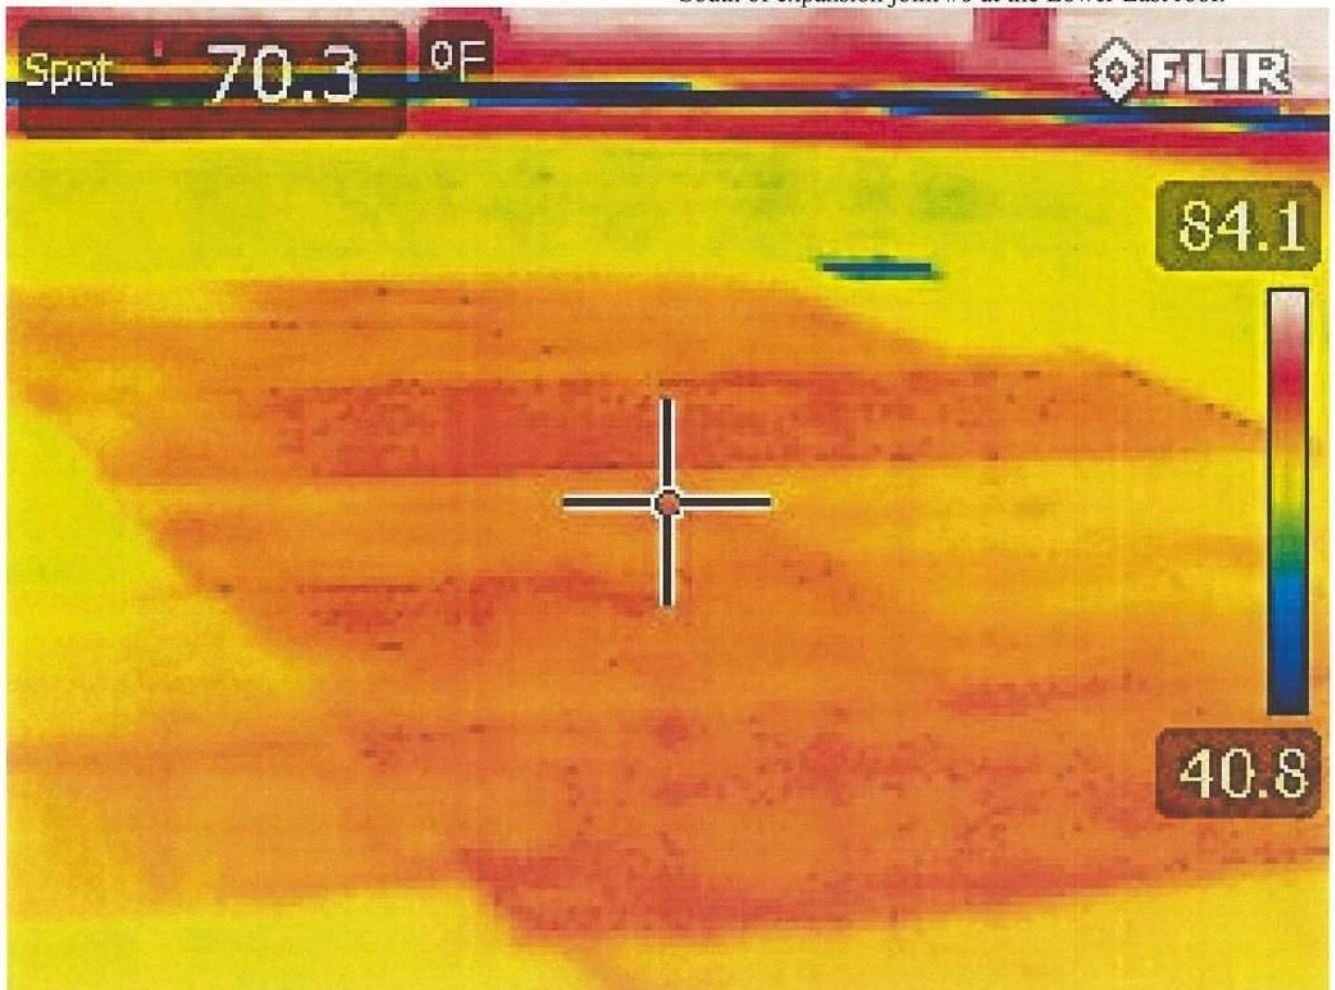
Photo #0468 View of large area of entrapped moisture #14 represented by red and orange shaded areas at the east ½ of the Lower Roof area south of expansion joint #6.

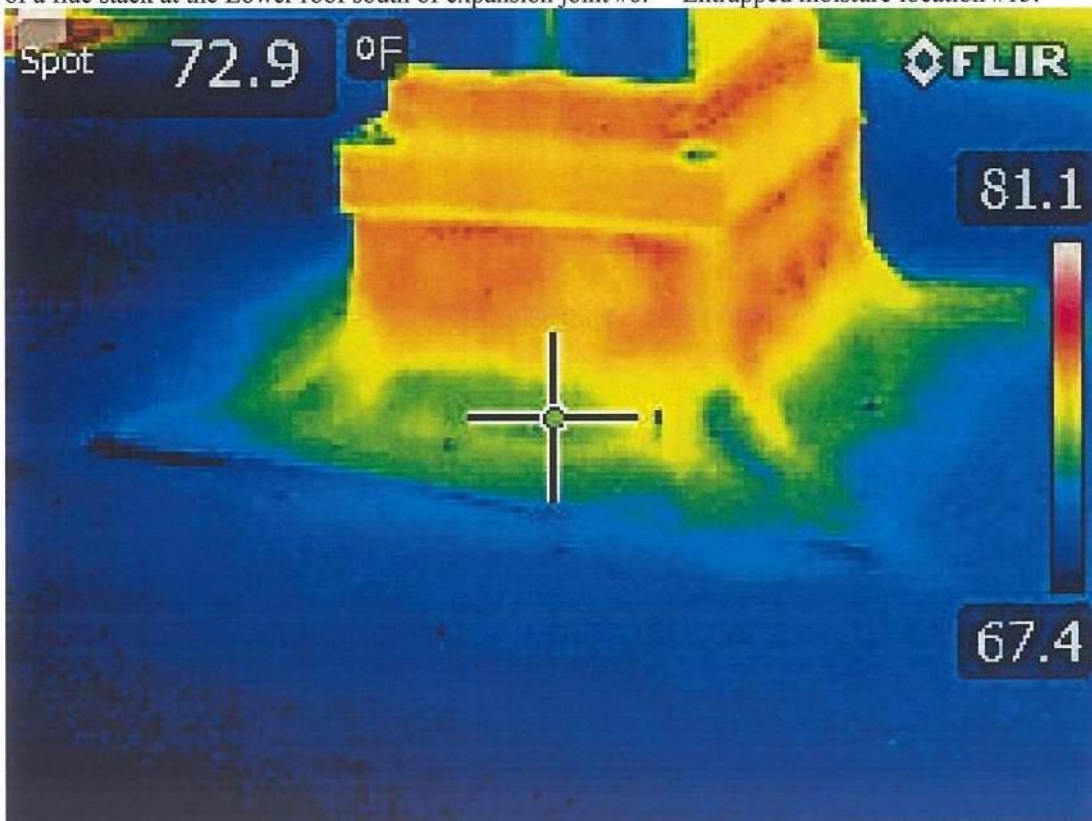
Photo #0470 View of entrapped moisture location #15 represented by red, yellow and green shaded areas at the base of a flue curb at the west 1/2 of the Lower Roof area south of expansion joint #6.

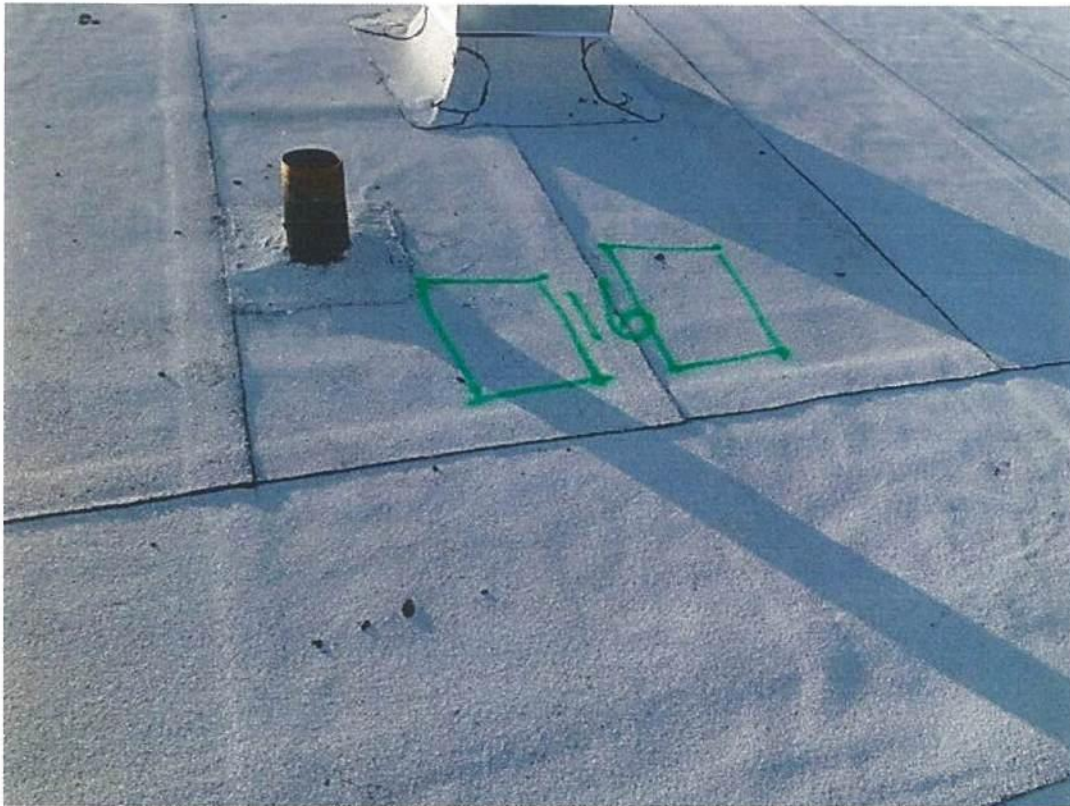
Photo #9708 View of entrapped moisture location #16 near base of an exhaust fan curb and a plumbing vent at the east side of the Upper Roof south of expansion joint #6.

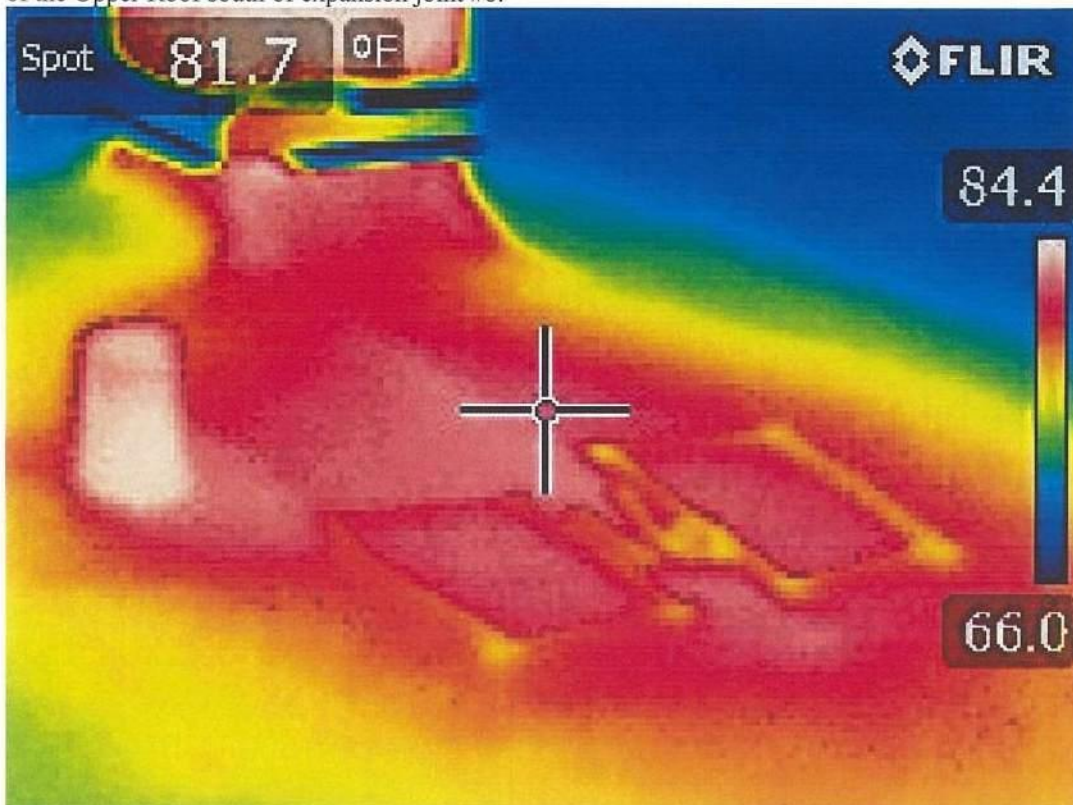
Photo #0472 View of entrapped moisture location #16 represented by red shaded area at the base of a plumbing vent and exhaust fan curb at the east side of the Upper Roof area south of expansion joint #6.

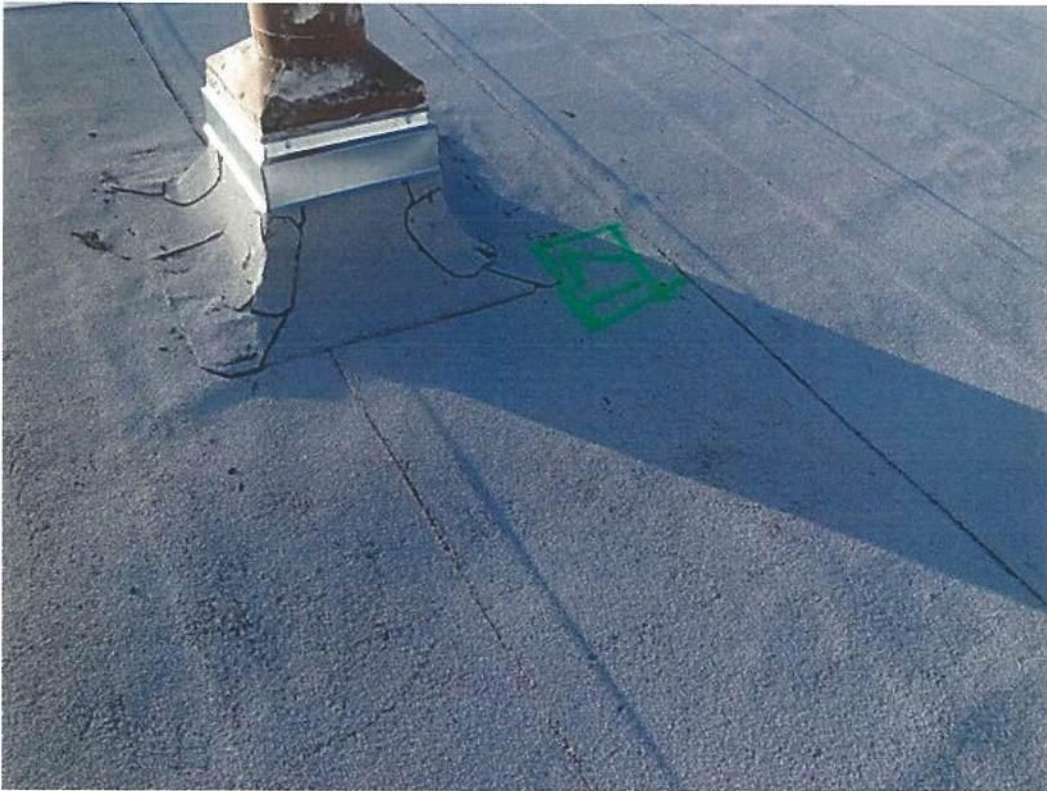
Photo #9709 View of entrapped moisture location 17 near base of an exhaust fan curb at the east side of the Upper Roof south of expansion joint #6.

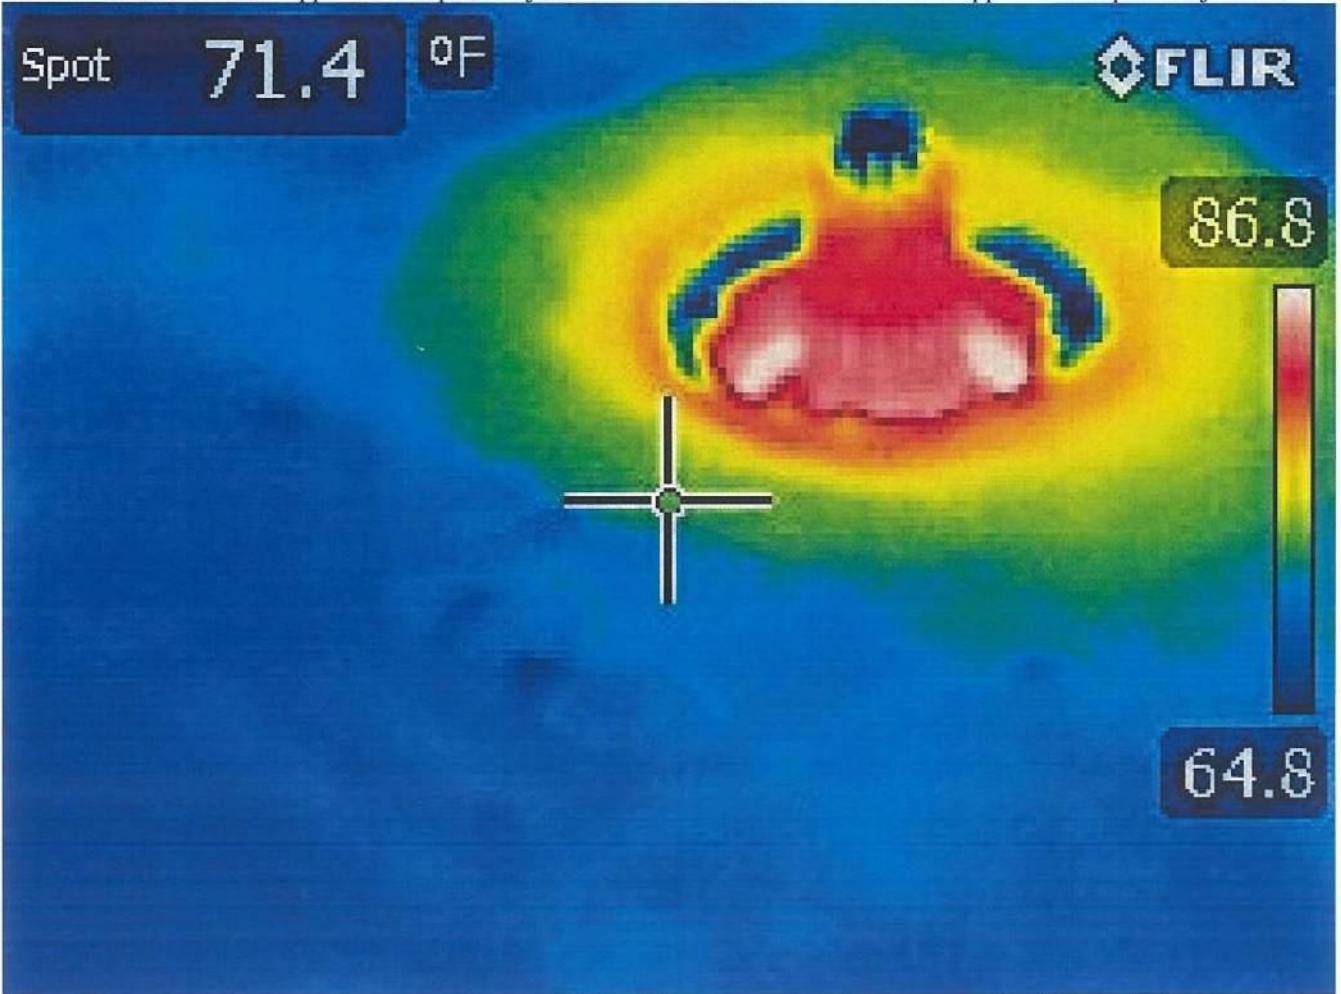
Photo #0476 View of entrapped moisture locations #18 & 19 represented by red, orange and yellow shaded area at the rim of a roof drain at the east 1/2 of the Upper Roof area north of expansion joint #5.

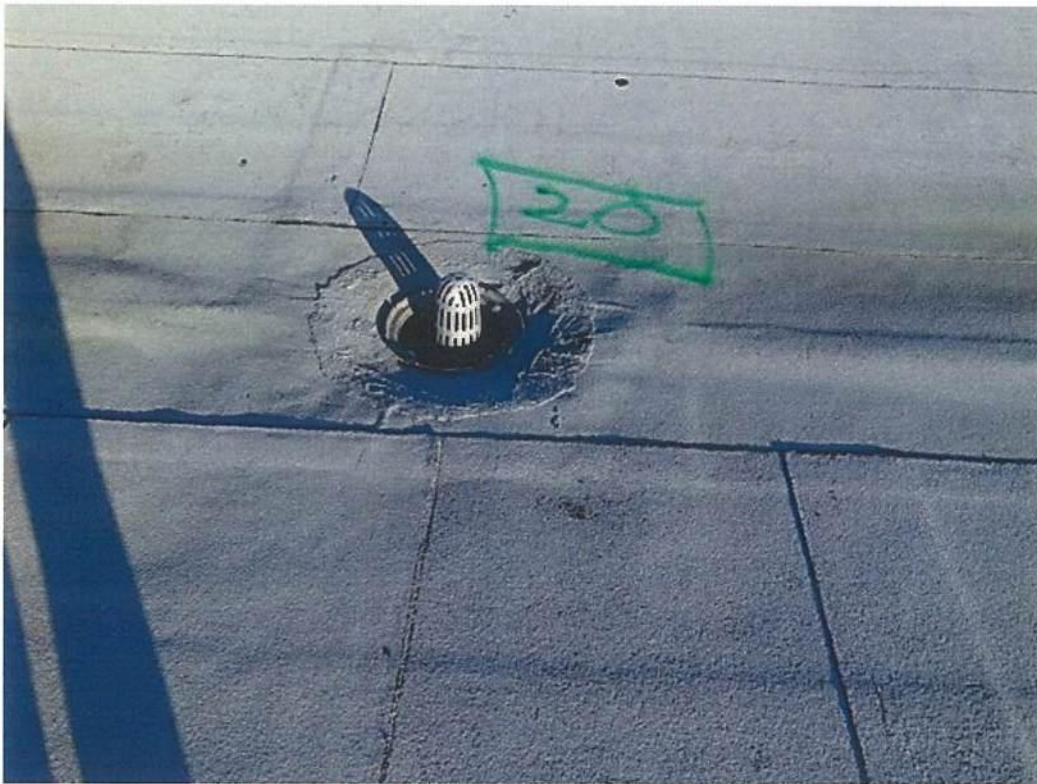
Photo #9706 View of entrapped moisture location #20 near a roof drain at the west side of the Upper roof north of expansion joint #5.

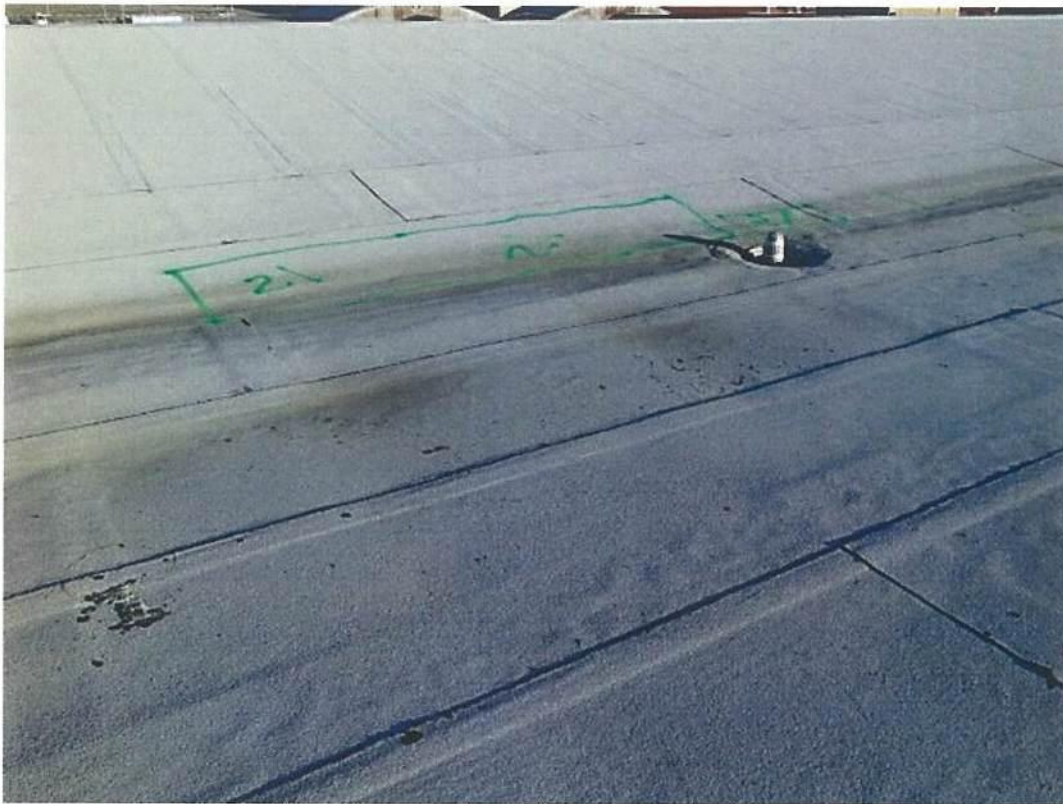
Photo #9707 View of entrapped moisture #21 near a roof drain at the west side of the Upper roof south of expansion joint #6.

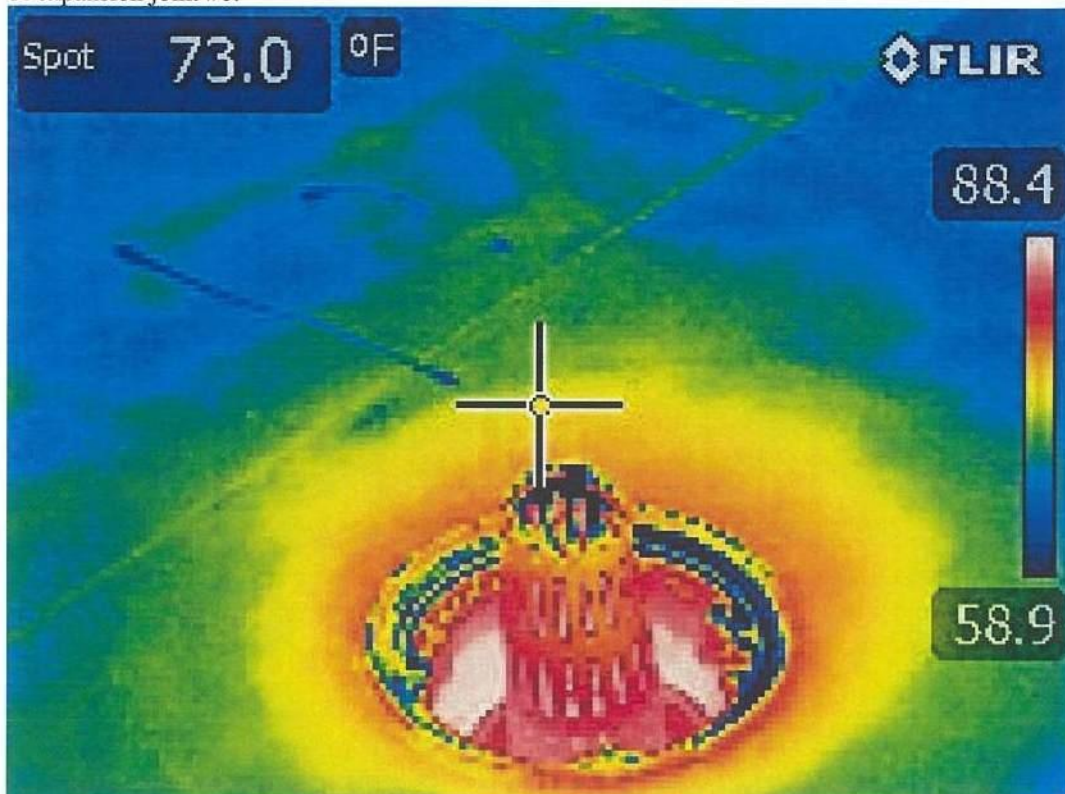
Photo #0480 View of entrapped moisture location #21 represented by yellow and green shaded areas near the rim of a roof drain at the west valley of the Upper Roof area south of expansion joint #6.

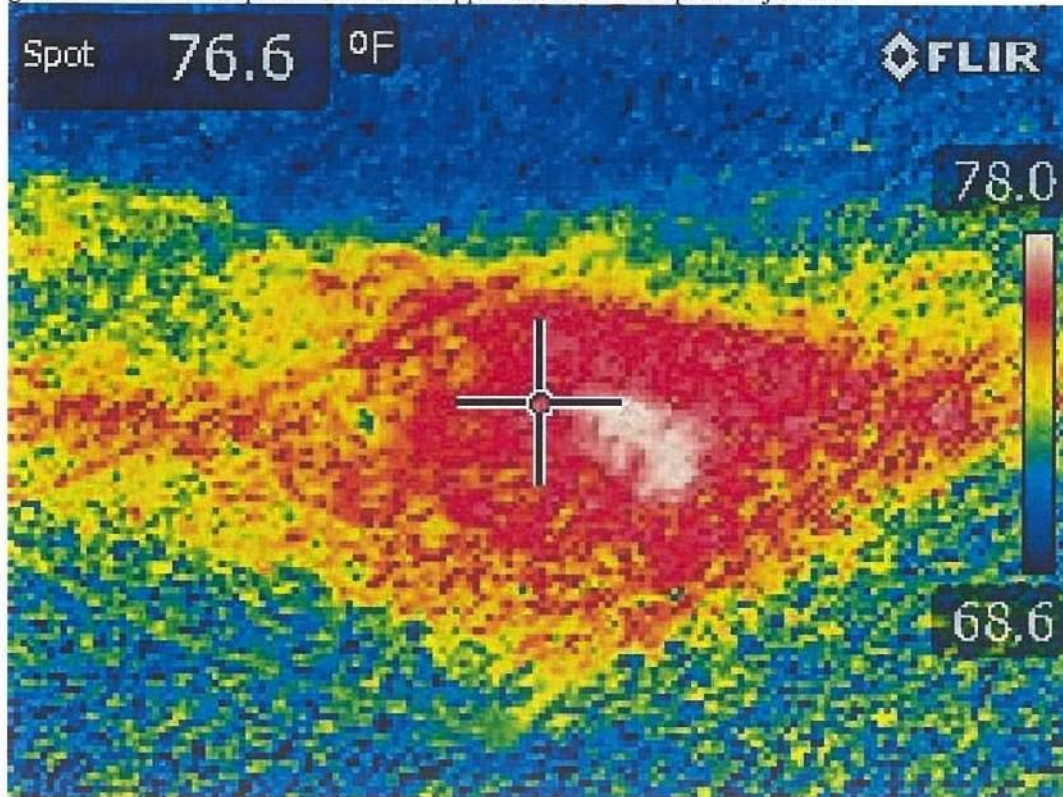
Photo #0490 View of entrapped moisture location #22 represented by red and yellow shaded areas at the gravel surfaced roof at the north side of expansion joint #6.

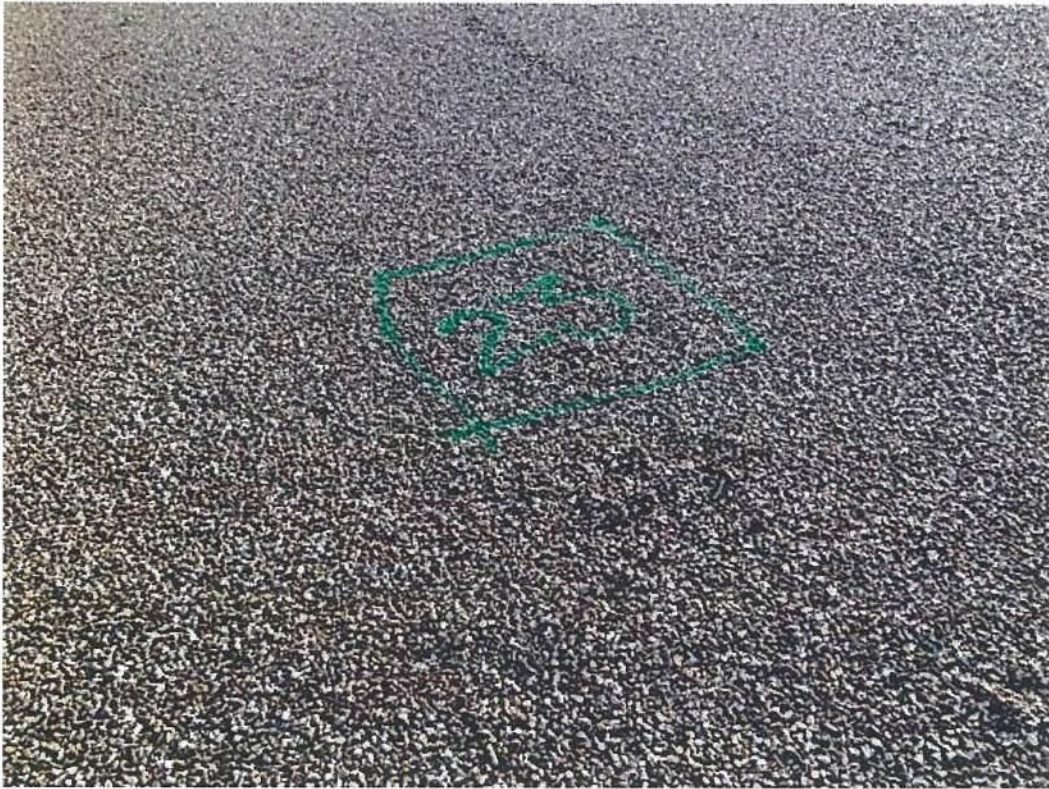
Photo #9716 View of entrapped moisture location #23 at the gravel surfaced built up roof area at the Upper roof north of expansion joint #6.

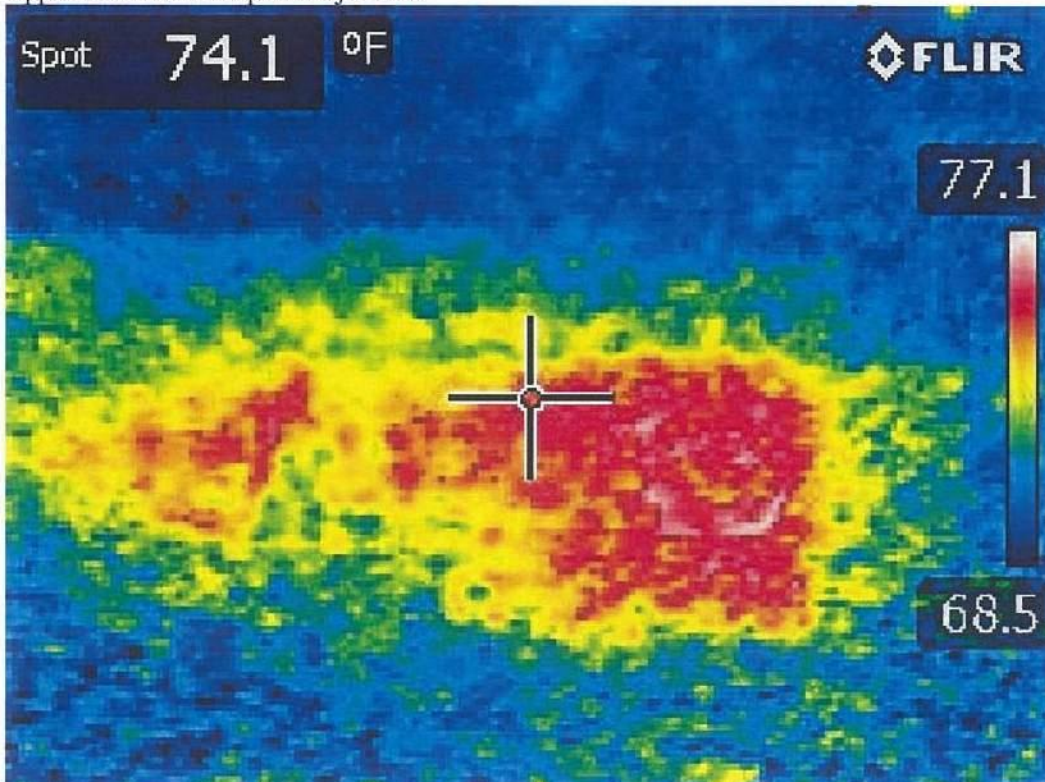
Photo #0486 View of entrapped moisture location #23 represented by red and yellow shaded areas at the gravel surfaced Upper Roof at the north side of expansion joint #6.

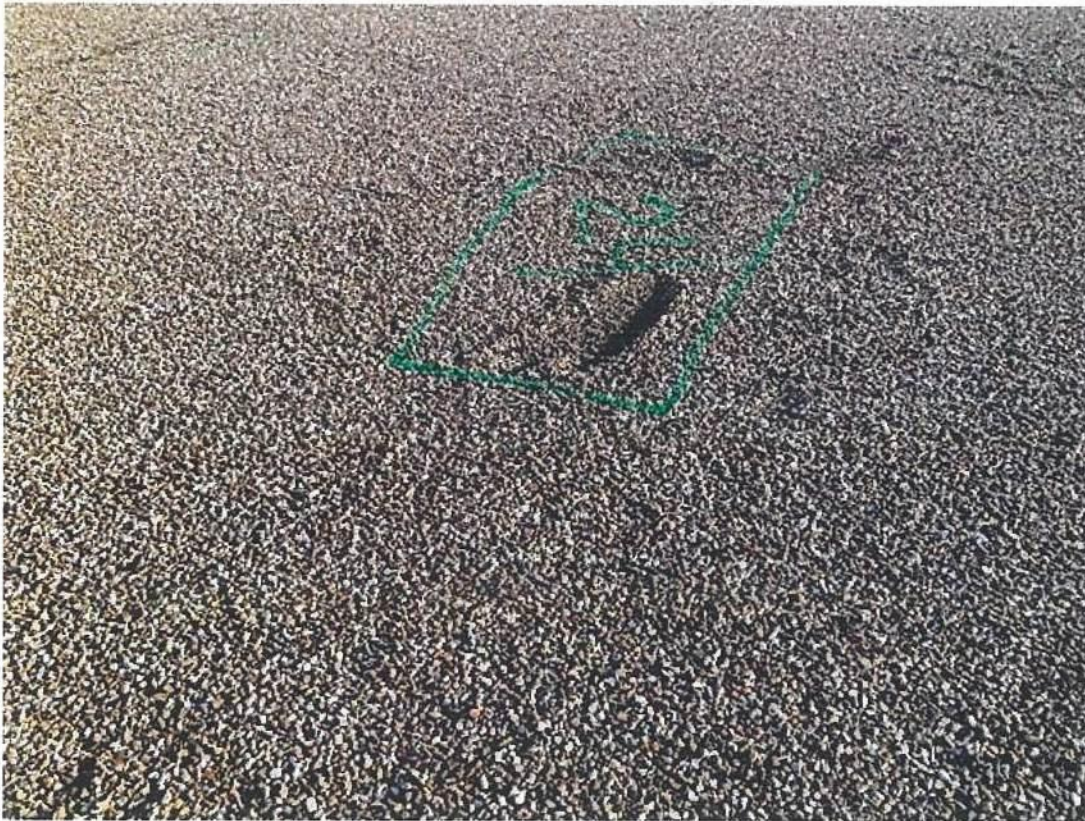
Photo #9713 View of entrapped moisture location #24 at the gravel surfaced Upper Roof north of expansion joint #6.

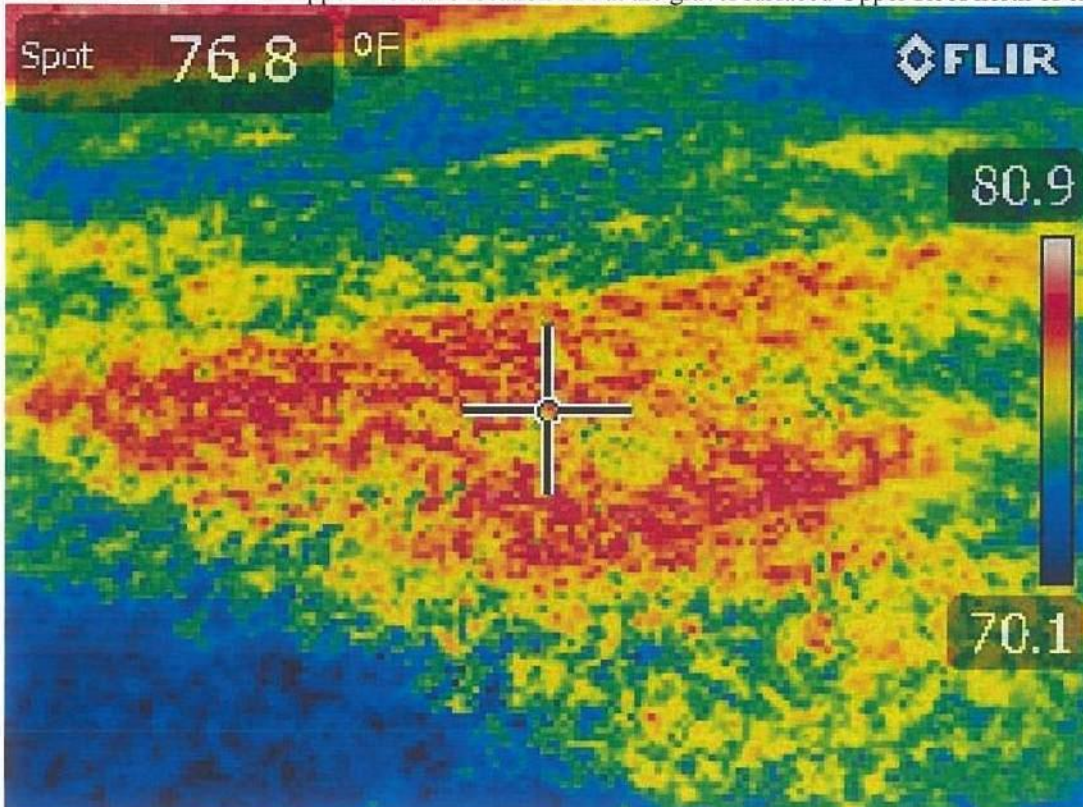
Photo #0484 View of entrapped moisture location #24 represented by red and yellow shaded areas at the gravel surfaced built up roof at the north side of expansion joint #6 at the Upper roof.

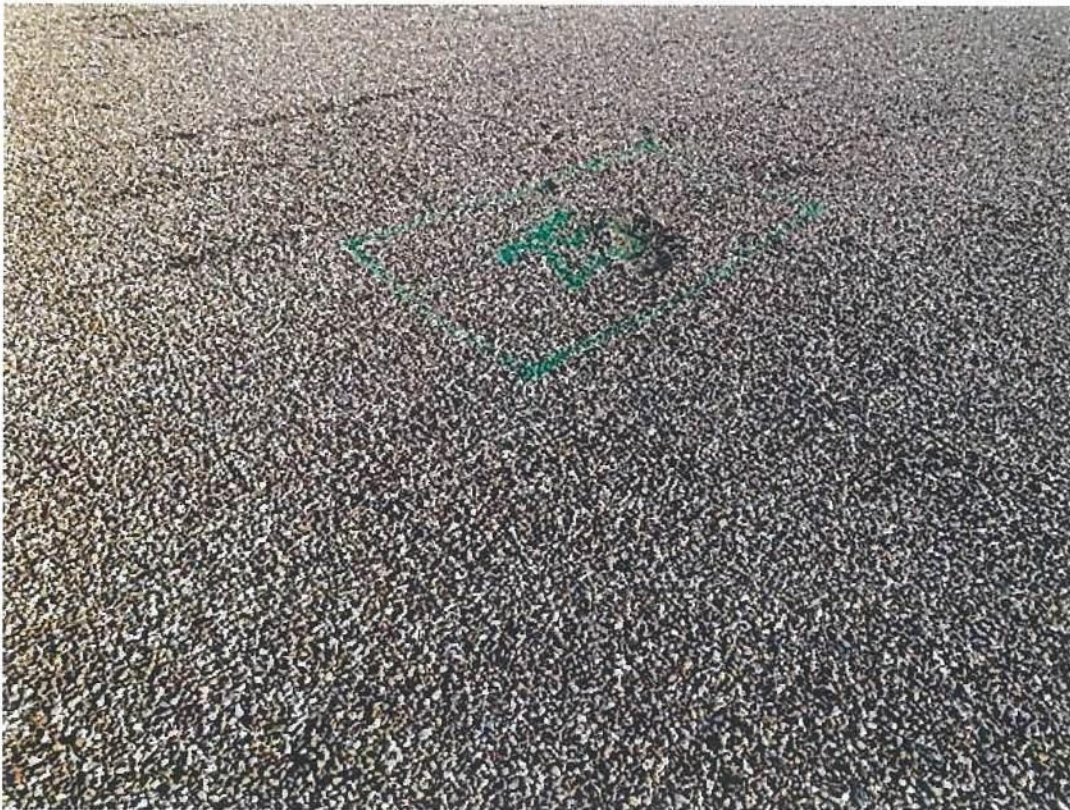
Photo #9714 View of entrapped moisture location #25 at the gravel surfaced built up roof area at the east side of the Upper roof north of expansion joint #6.

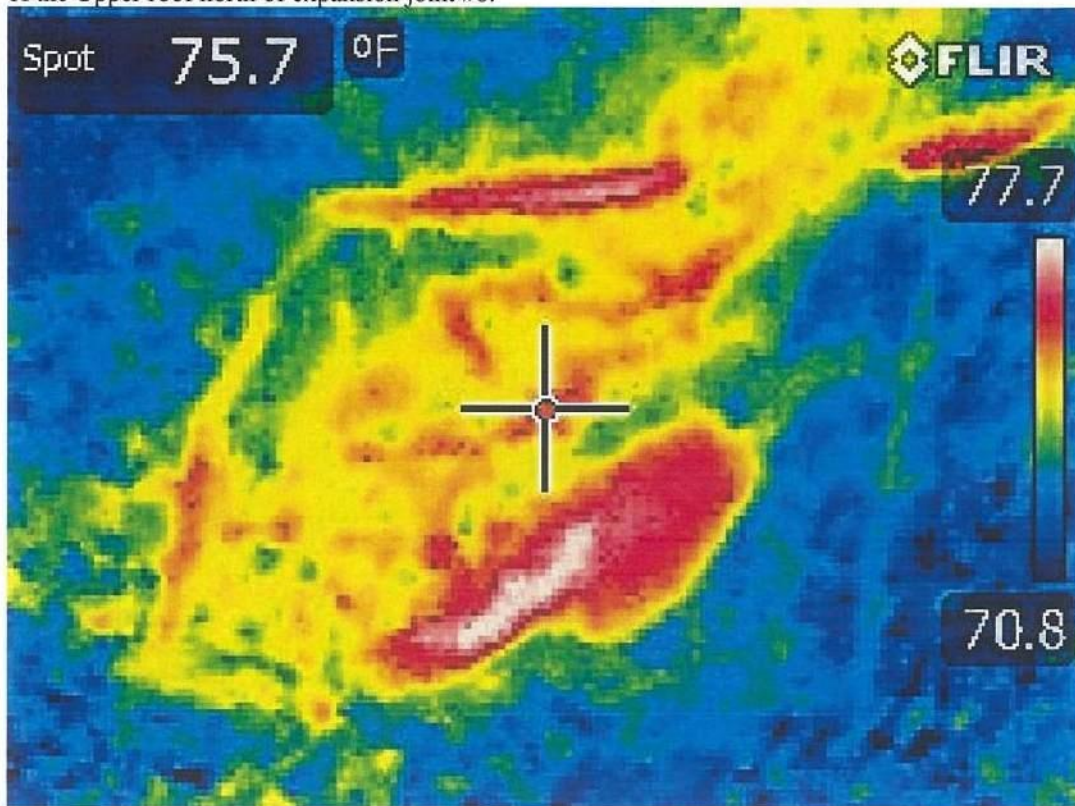
Photo #0488 View of entrapped moisture location #25 represented by red and yellow shaded areas at the gravel surfaced built-up roof at the north side of expansion joint #6.

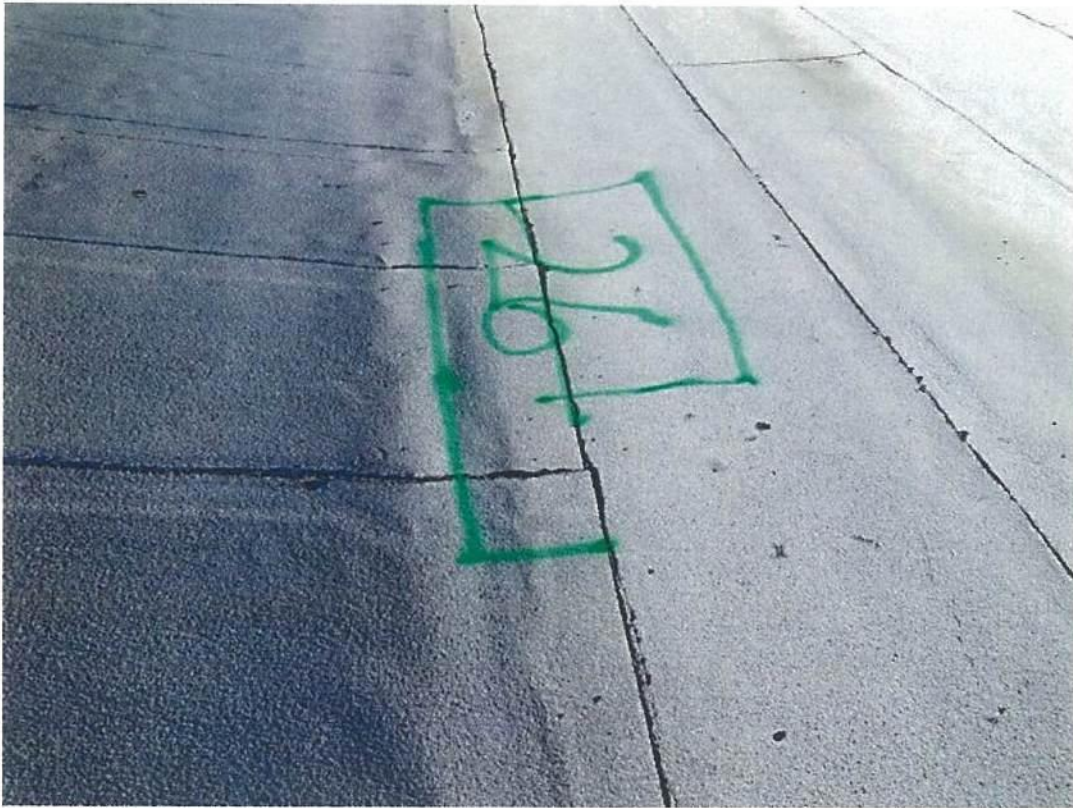
Photo #9718 View of entrapped moisture location #26 at the mineral surfaced modified bitumen roof at the east valley line of the Lower Roof north of expansion joint #7.

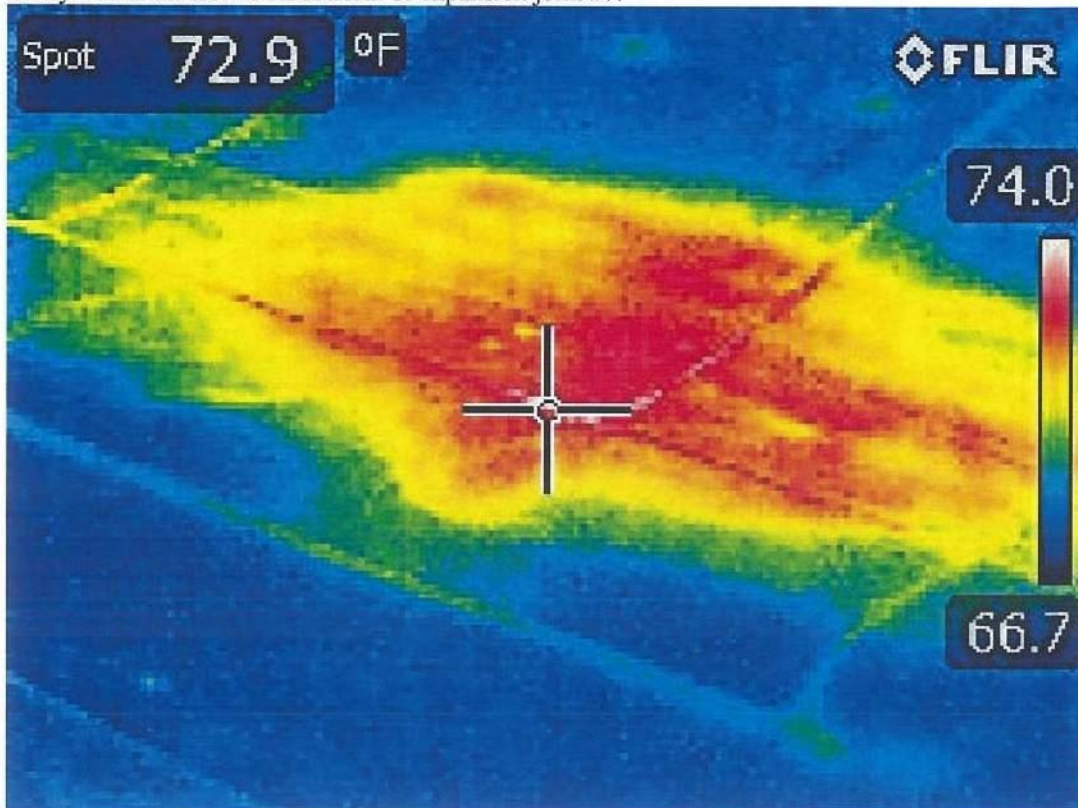
Photo #0492 View of entrapped moisture location #26 represented by red and yellow shaded areas at the mineral surfaced modified bitumen roof at the east valley north of expansion joint #7 at the Lower roof.
