# Building / Site Assessment Report

AFP3 Buildings 001, 002, 118 and 119  
Spirit Aerosystems and Navistar Tenant Space  
3330 N Mingo Rd  
Tulsa, OK 74116

Engineering Services Department  
Project No. 170045.2, Amendment No.1

09 / 30 / 2019

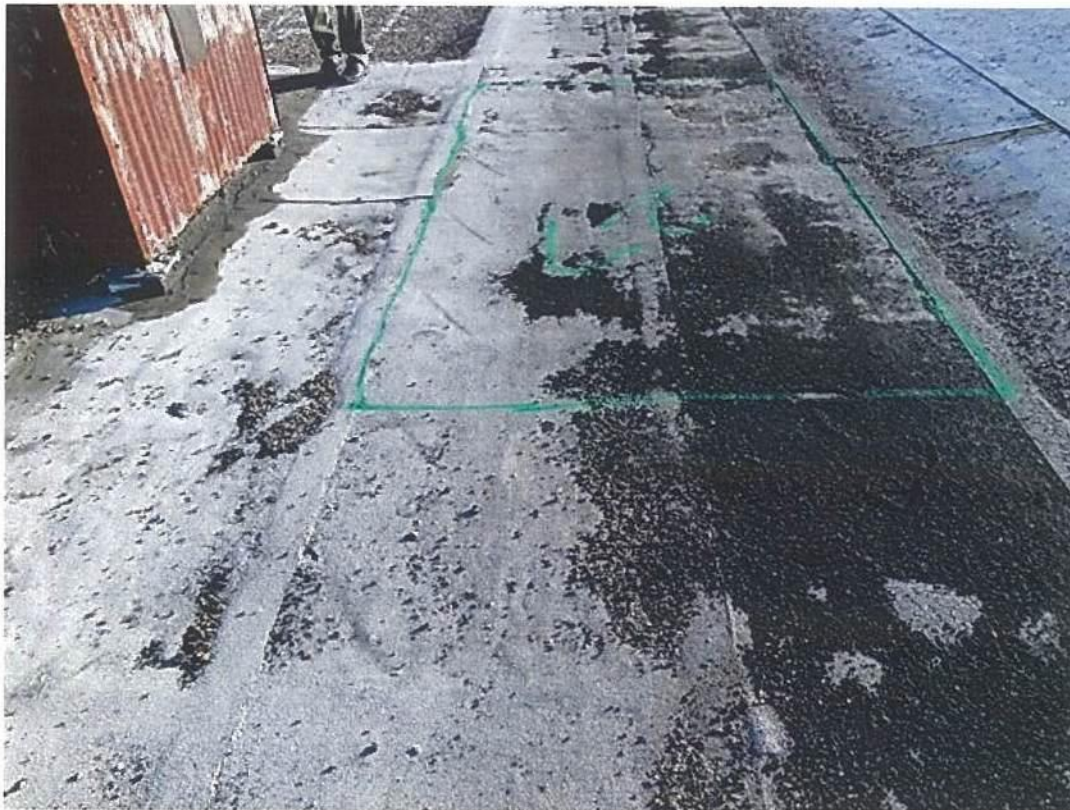
Photo #9717 View of entrapped moisture location #27 at the mineral surfaced modified bitumen patched roof area at the Upper roof east valley north of expansion joint #7.

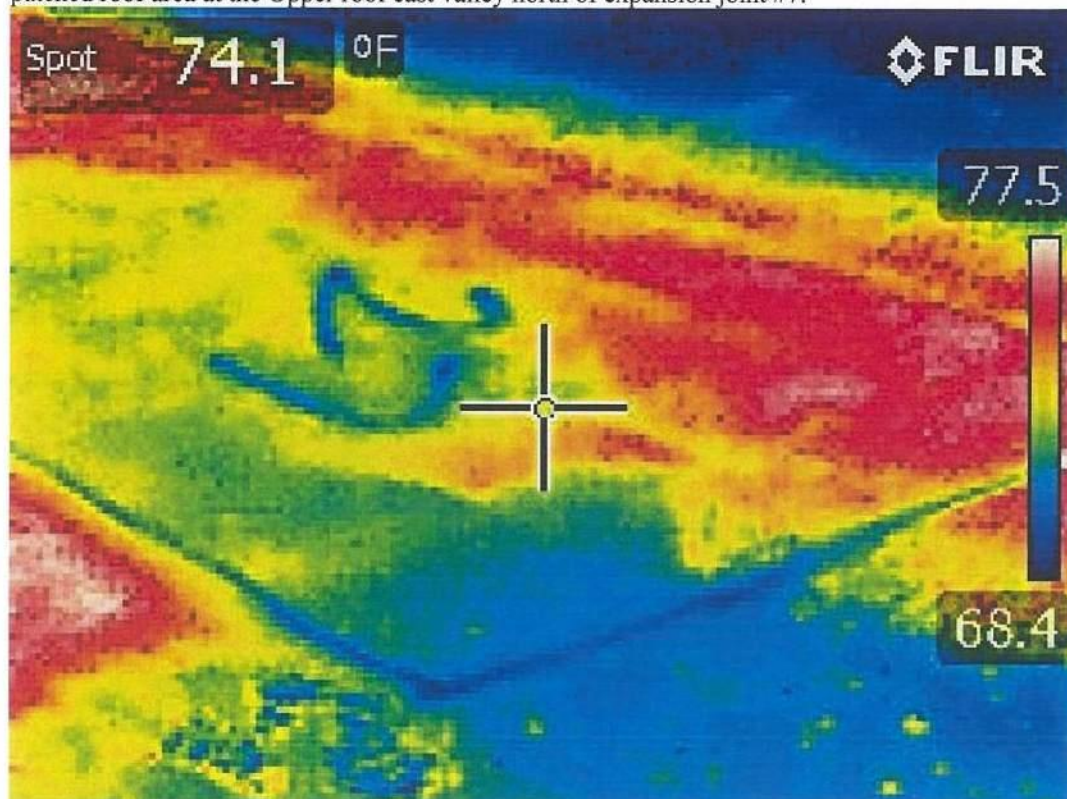
Photo #0494 View of entrapped moisture location #27 represented by red, yellow and green shaded areas at the mineral surfaced modified bitumen patched roof area at the north side of expansion joint #7 at the Upper Roof east valley.

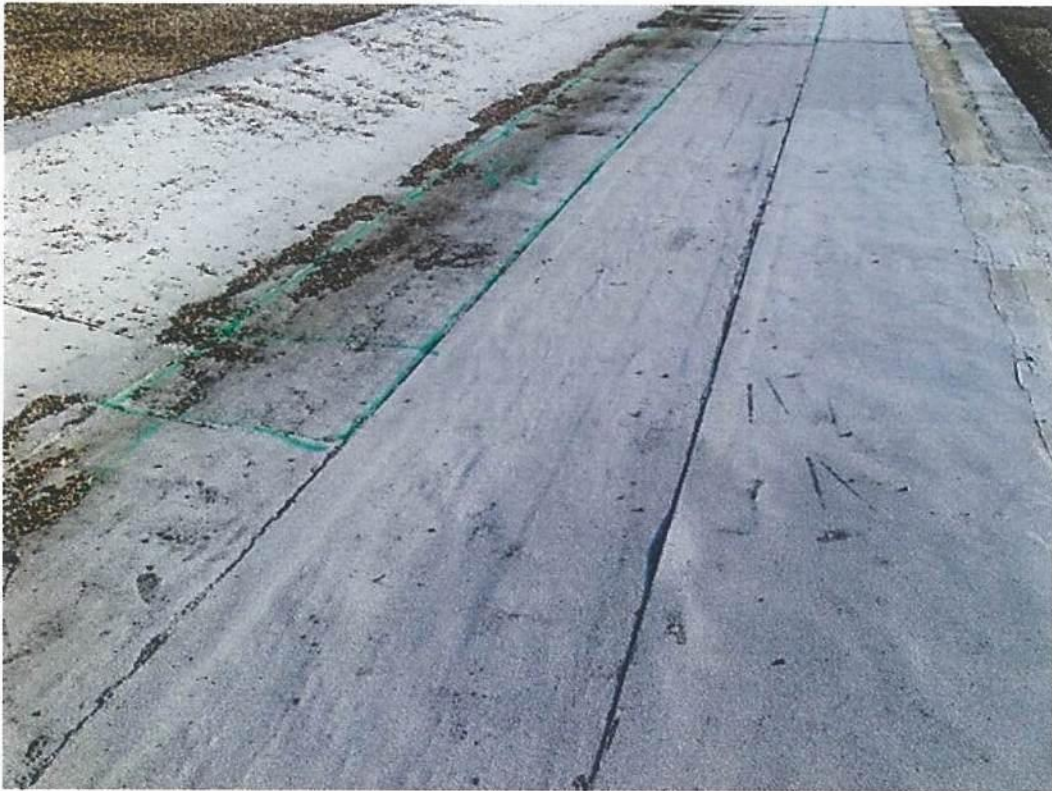
Photo #9742 View of entrapped moisture location #29 at the mineral surfaced modified bitumen roof patch at the west valley line of the Upper Roof north of expansion joint #7.

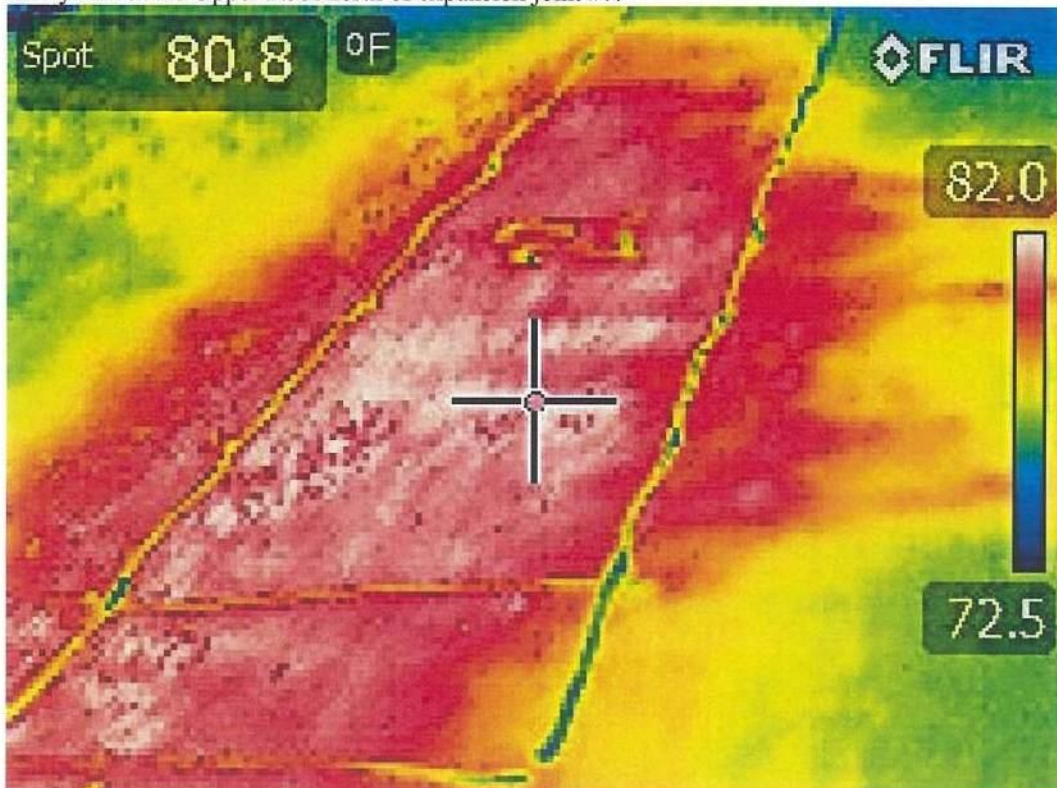
Photo #0498 View of entrapped moisture location #29 represented by red and yellow shaded areas at the mineral surfaced modified bitumen roof patch at the west valley north of expansion joint #7 at the Upper Roof.

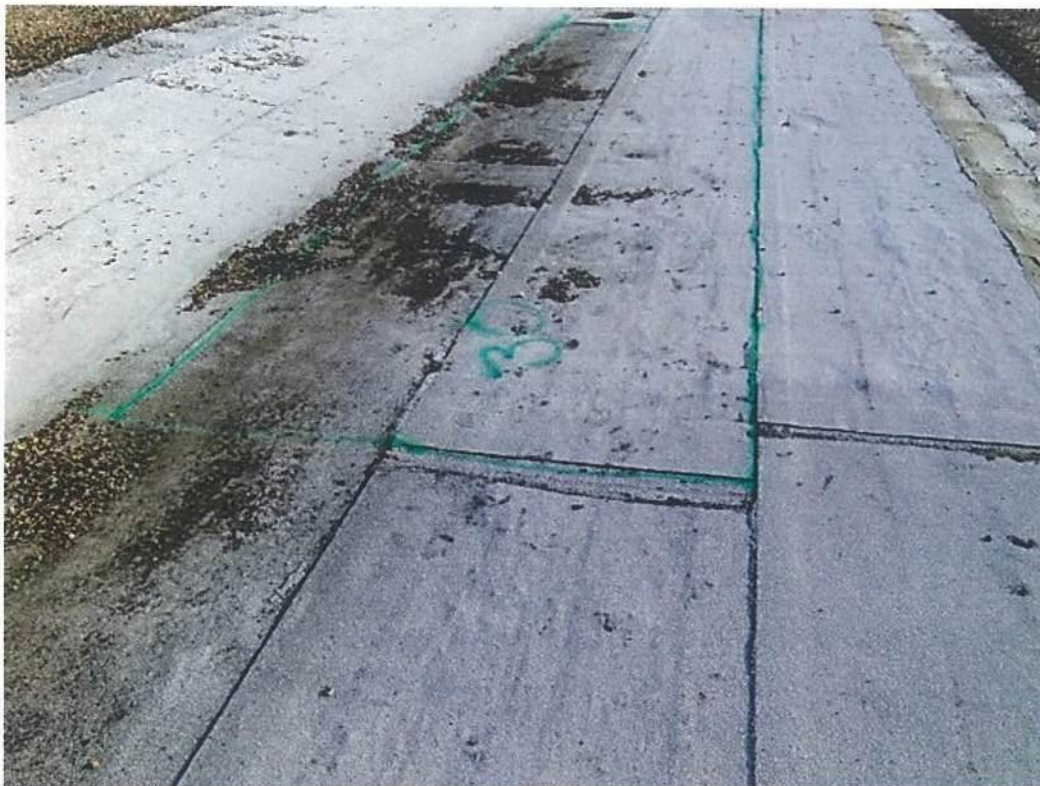
Photo #9743 View of entrapped moisture location #30 at the mineral surfaced modified bitumen roof patch at the west valley line of the Upper Roof south of expansion joint #8.

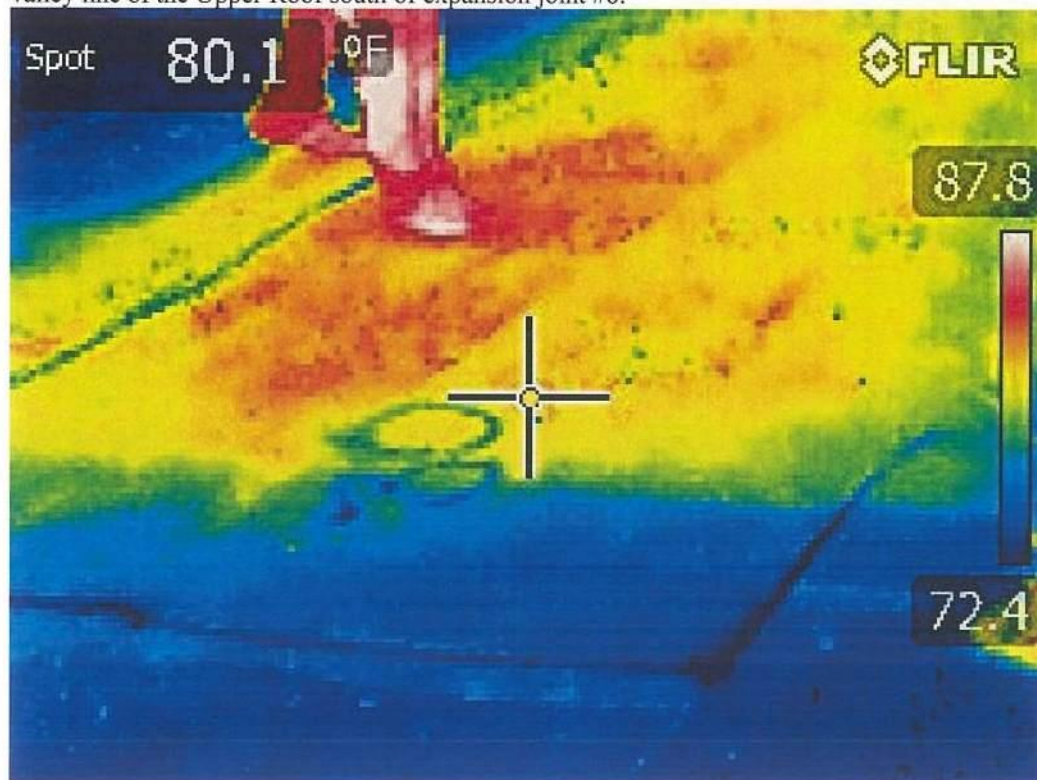
Photo #0500 View of entrapped moisture location #30 represented by red and yellow shaded areas at the mineral surfaced modified bitumen roof patch at the west valley south of expansion joint #8 at the Upper Roof.

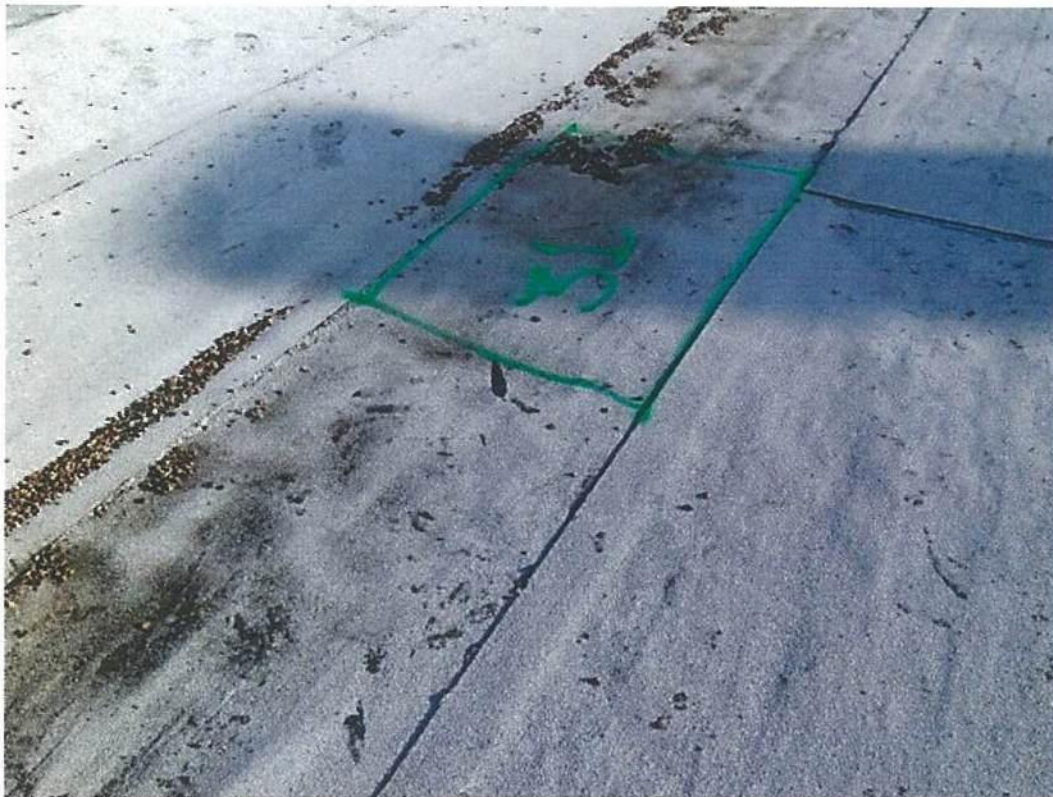
Photo #9744 View of entrapped moisture location #31 at the mineral surfaced modified bitumen roof patch at the west valley line of the Upper Roof south of expansion joint #8.

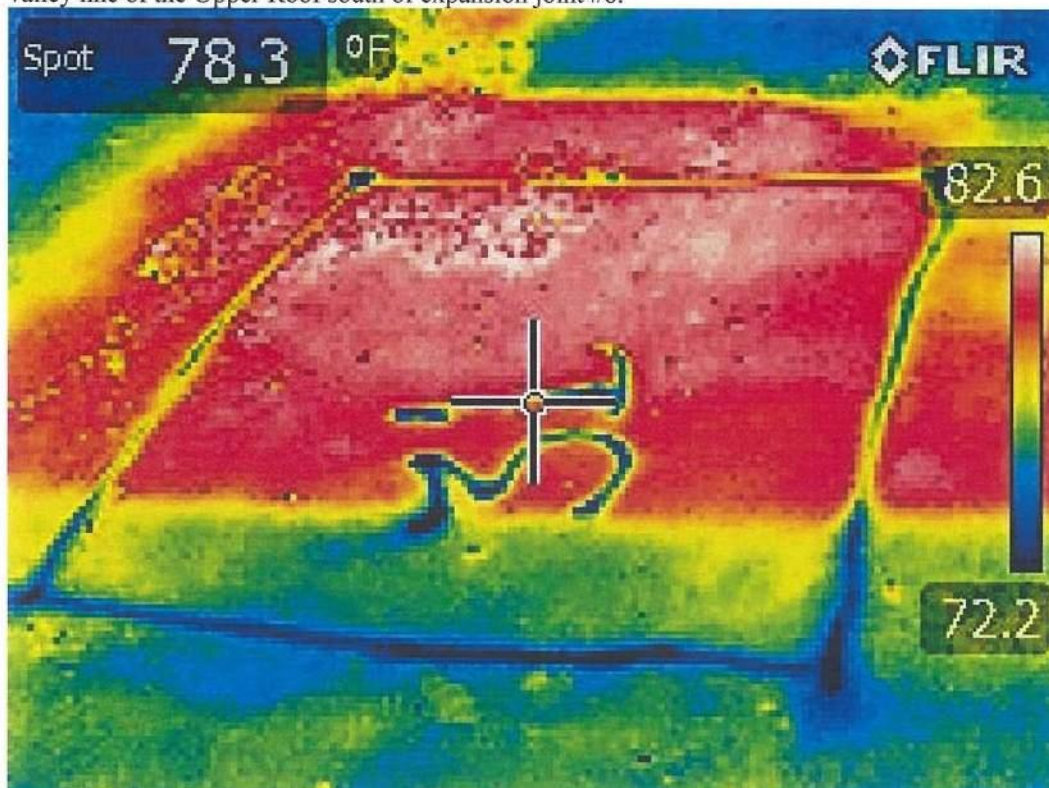
Photo #0502 View of entrapped moisture location #31 represented by red and yellow shaded areas at the mineral surfaced modified bitumen roof patch at the west valley south of expansion joint #8 at the Upper Roof.

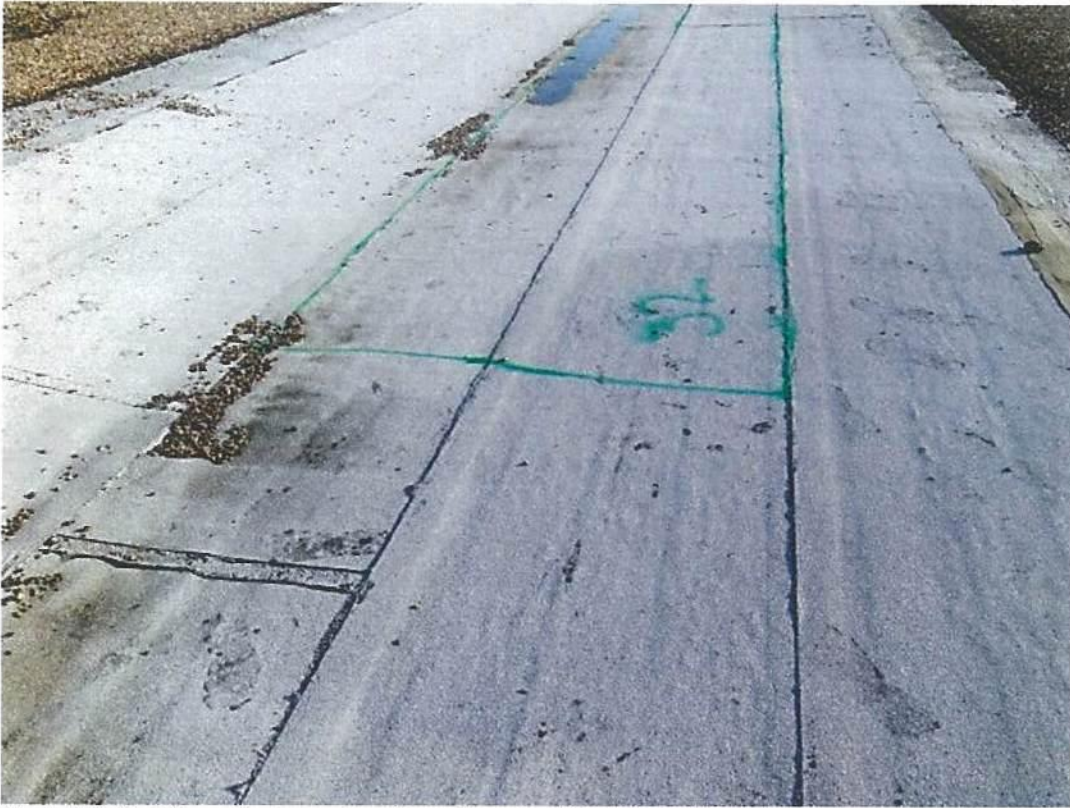
Photo #9745 View of entrapped moisture location #32 at the mineral surfaced modified bitumen roof patch at the east valley line of the Upper Roof south of expansion joint #8.

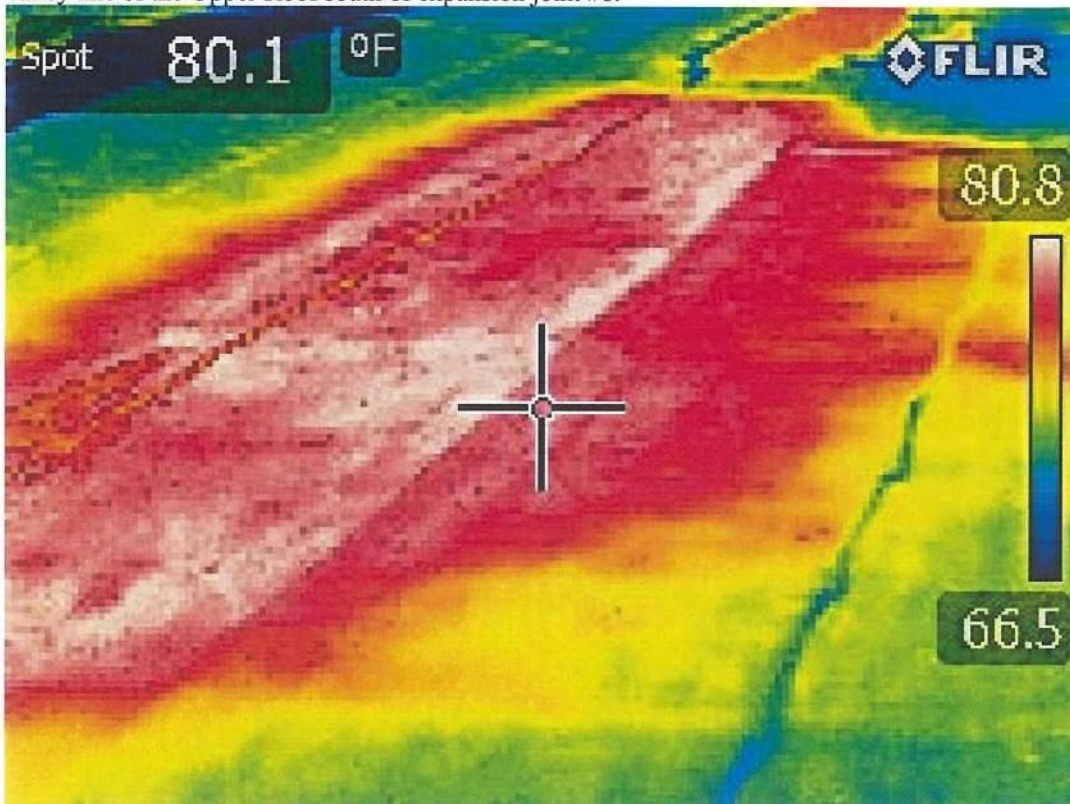
Photo #0504 View of entrapped moisture location #32 represented by red, white and yellow shaded areas at the mineral surfaced modified bitumen roof patch at the west valley south of expansion joint #8 at the Upper Roof.

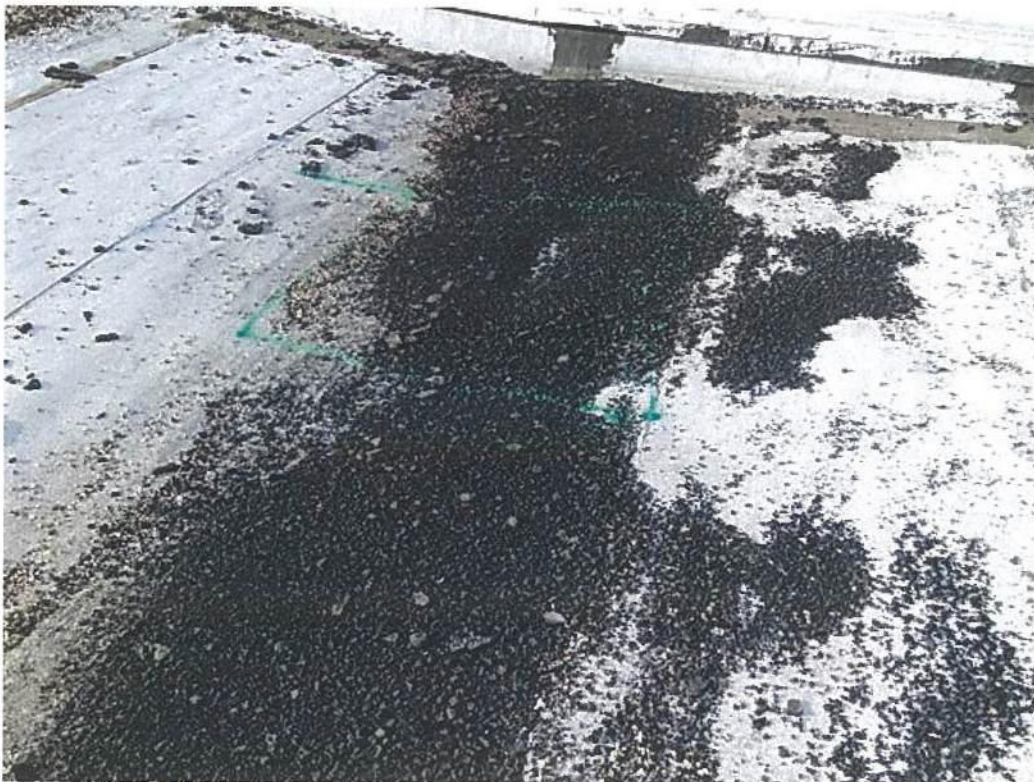
Photo #9750 View of entrapped moisture location #34 at the mineral surfaced modified bitumen roof patch at the east valley line of the Upper Roof north of expansion joint #8.

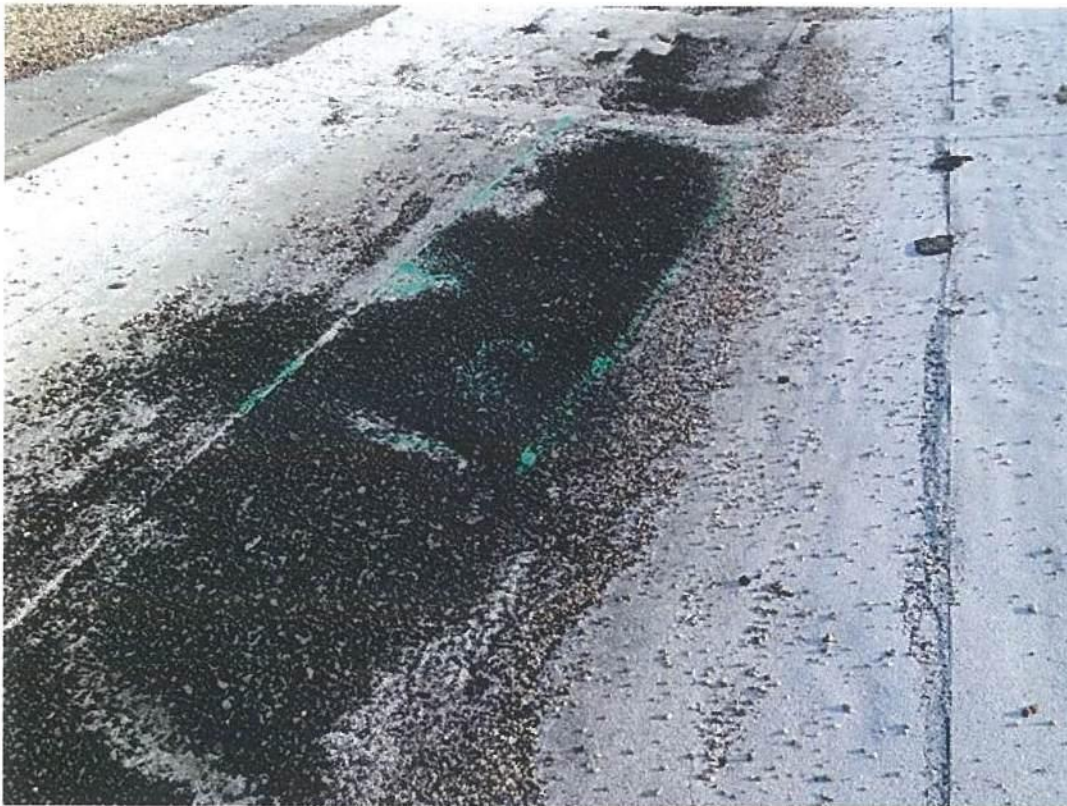
Photo #9752 View of entrapped moisture location #36 at the mineral surfaced modified bitumen roof patch at the east valley line of the Upper Roof north of expansion joint #8.

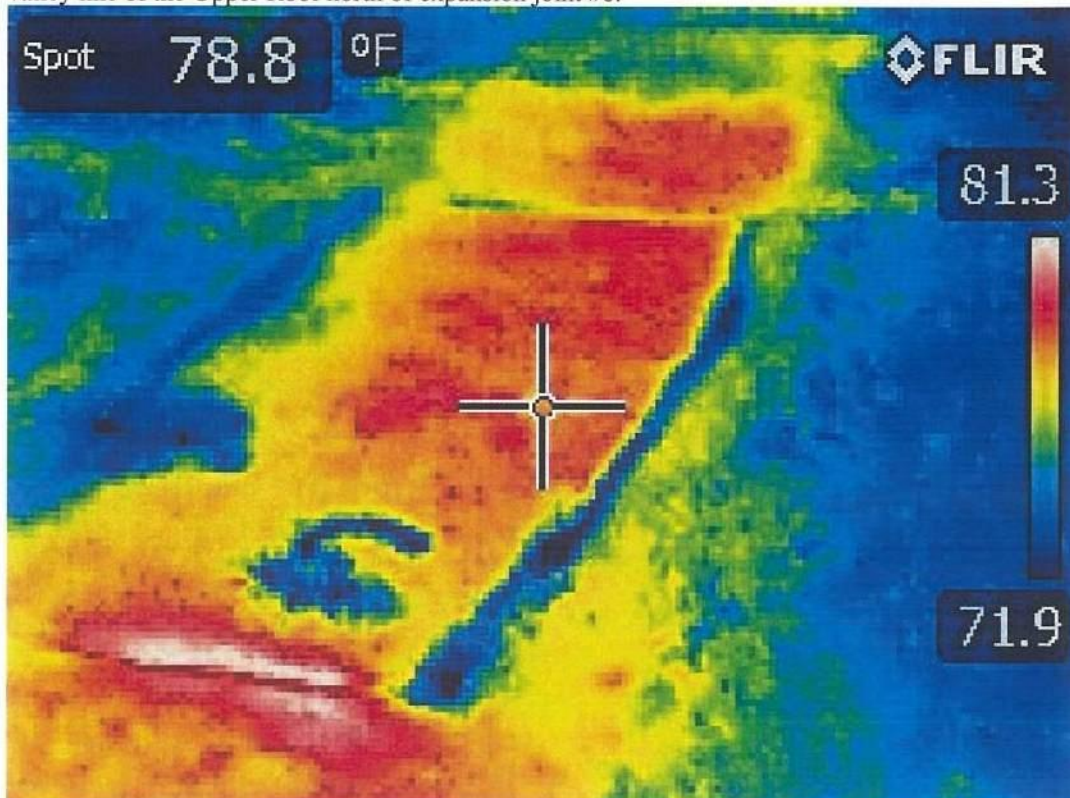
Photo #0514 View of entrapped moisture location #36 represented by red and yellow shaded areas at the mineral surfaced modified bitumen roof patch at the east valley north of expansion joint #8 at the Upper Roof.

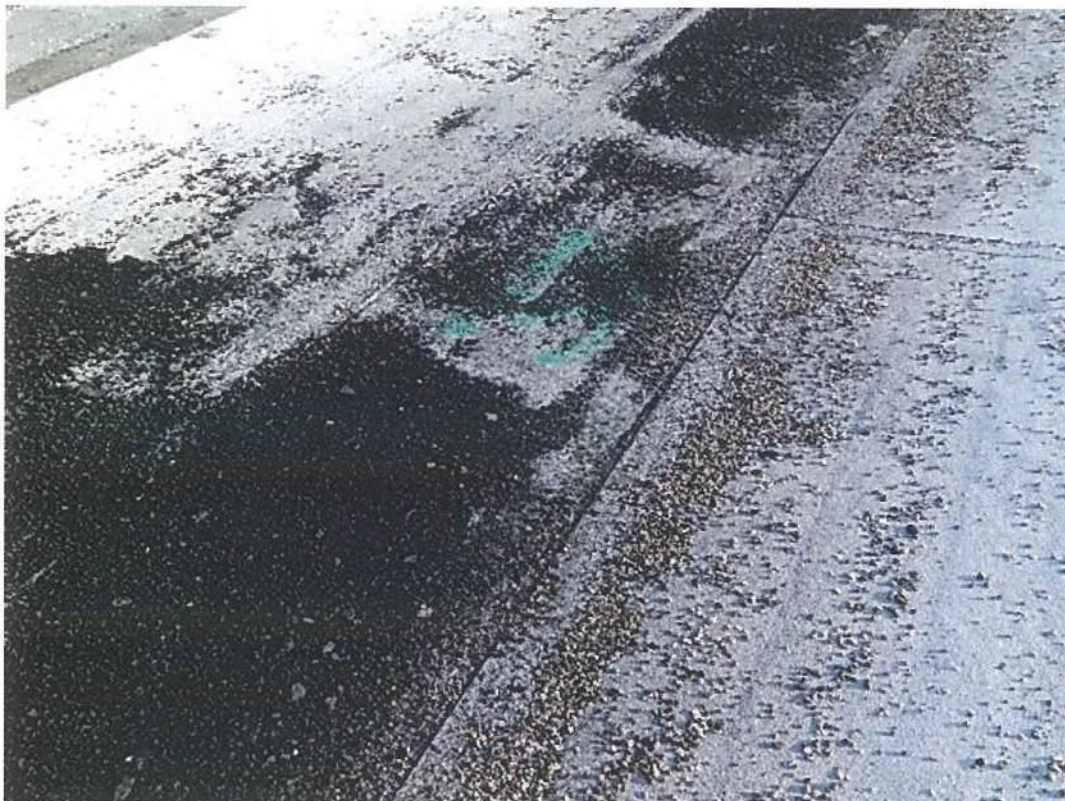
Photo #9753 View of entrapped moisture location #37 at the mineral surfaced modified bitumen roof patch at the east valley line of the Upper Roof north of expansion joint #8.

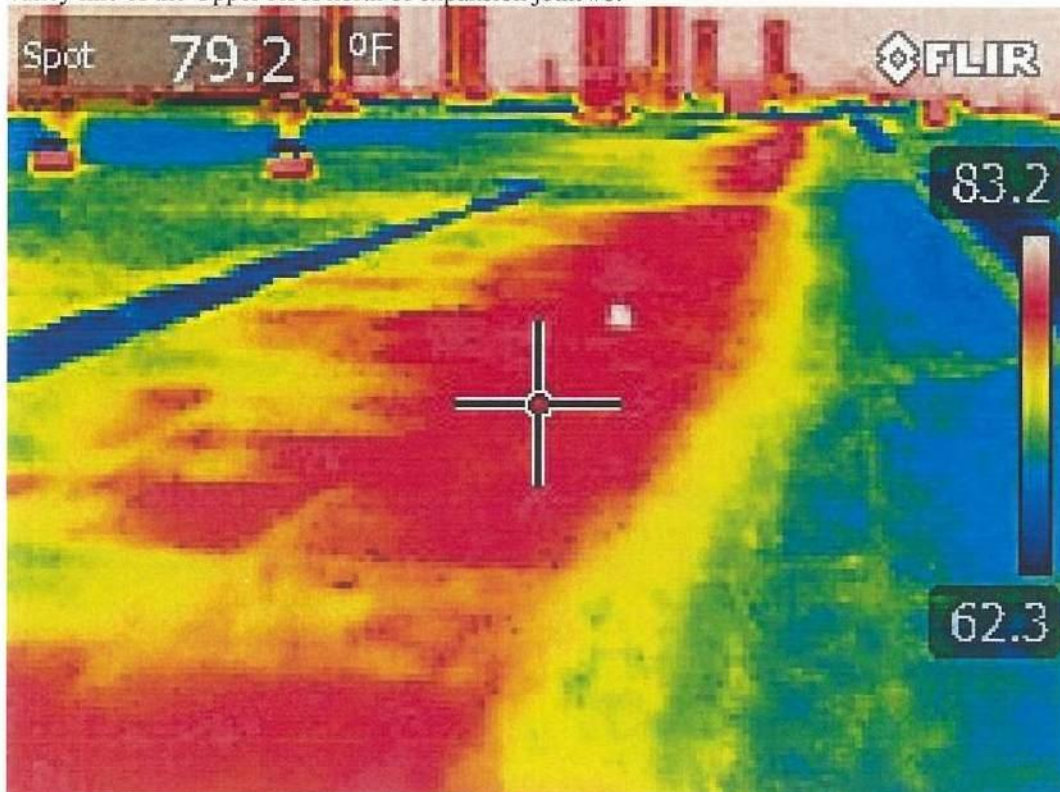
Photo #0514 View of entrapped moisture location #37 represented by red and yellow shaded areas at the mineral surfaced modified bitumen roof patch at the east valley north of expansion joint #8 at the Upper Roof.

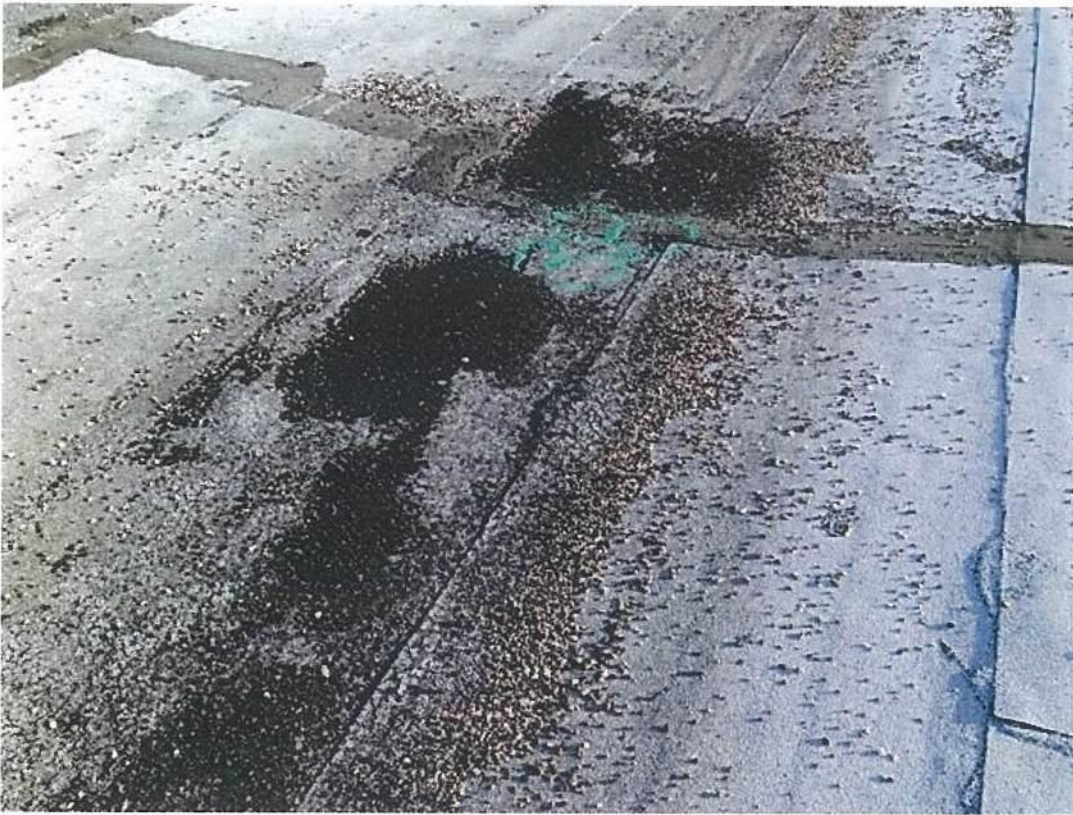
Photo #9754 View of entrapped moisture location #38 at the mineral surfaced modified bitumen roof patch at the east valley line of the Upper Roof north of expansion joint #8.

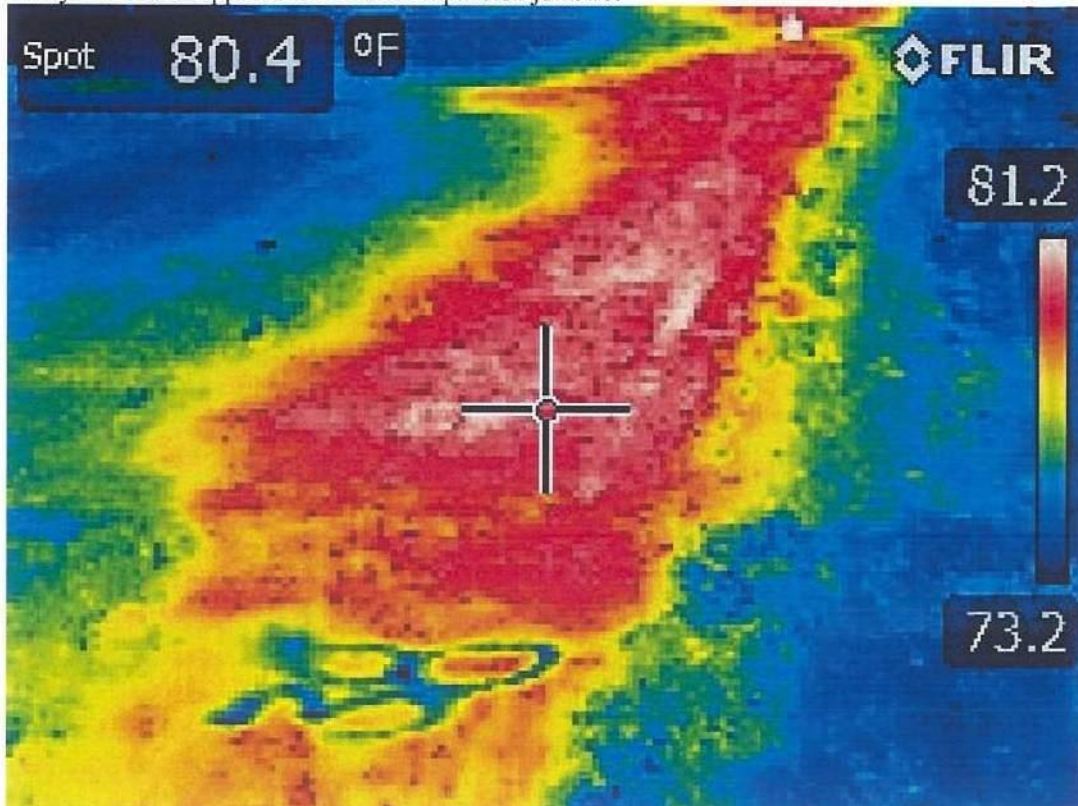
Photo #0518 View of entrapped moisture location #38 represented by red and yellow shaded areas at the mineral surfaced modified bitumen roof patch at the east valley north of expansion joint #8 at the Upper Roof.

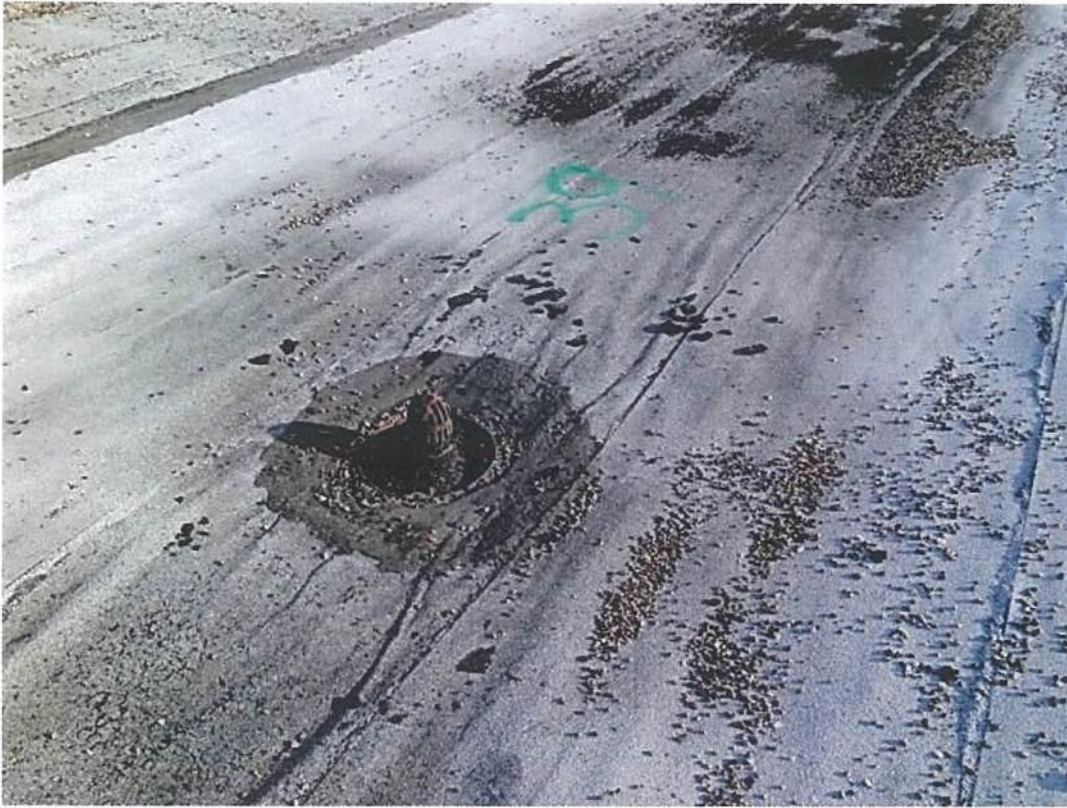
Photo #9755 View of entrapped moisture location #39 at the mineral surfaced modified bitumen roof patch at the east valley line of the Upper Roof north of expansion joint #8.

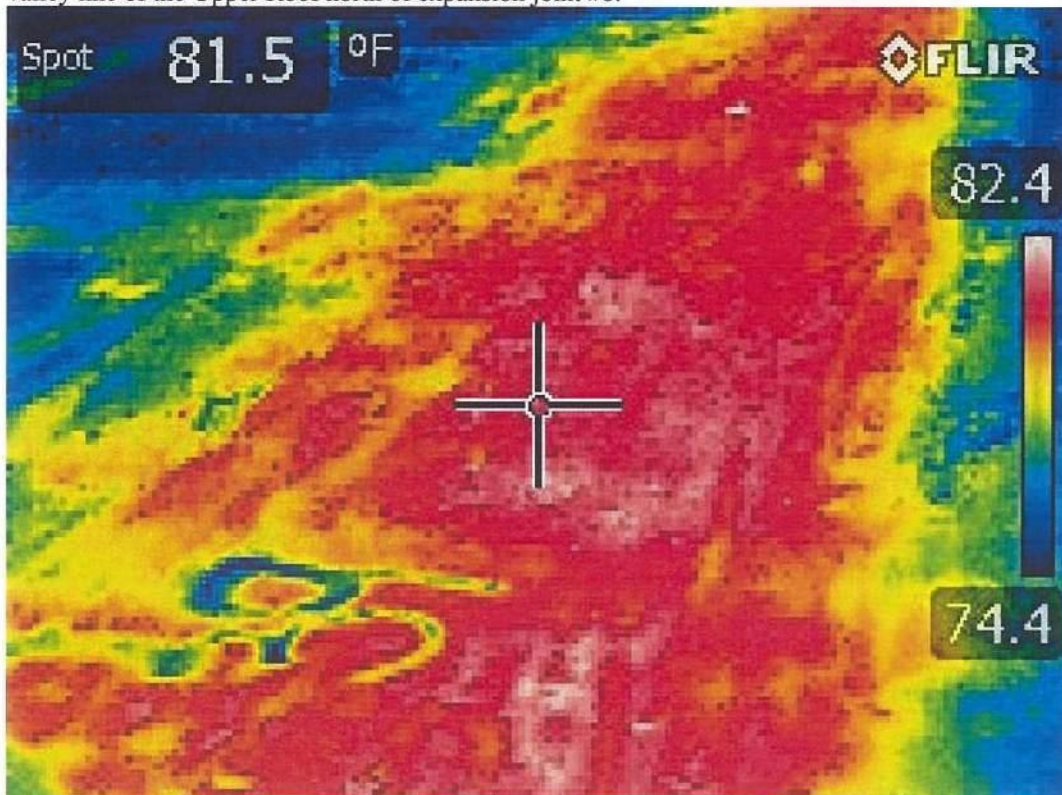
Photo #050 View of entrapped moisture location #39 represented by red and yellow shaded areas at the mineral surfaced modified bitumen roof patch at the east valley north of expansion joint #8 at the Upper Roof.

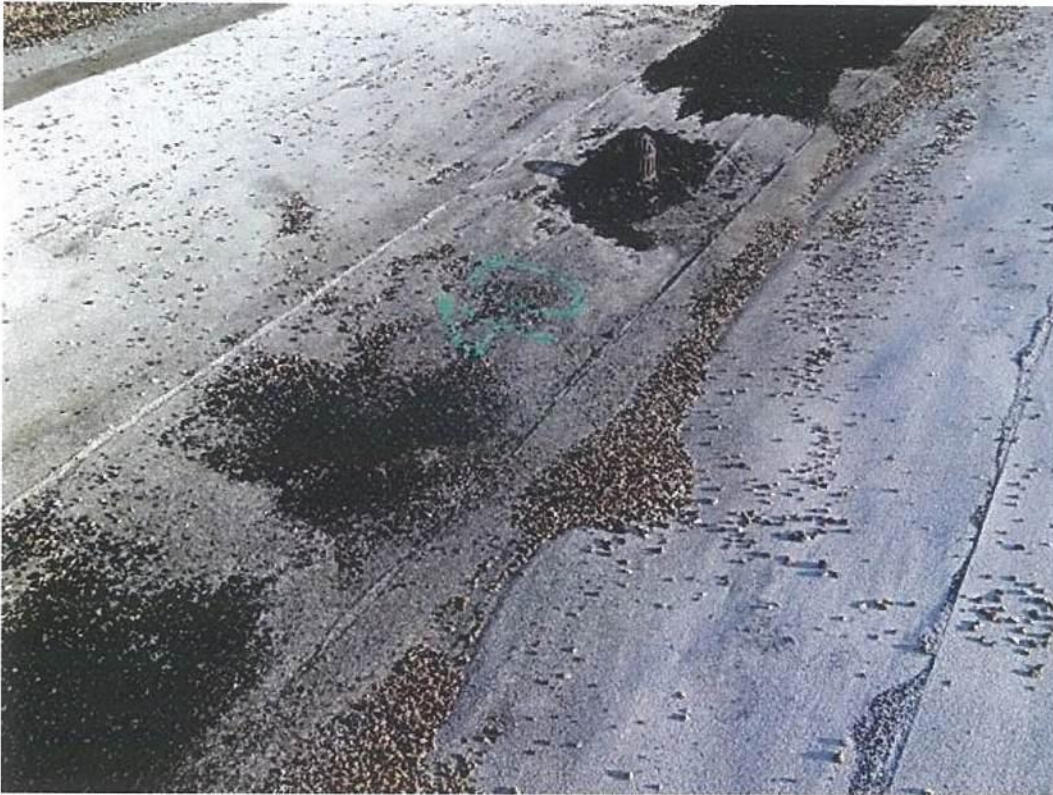
Photo #9756 View of entrapped moisture location #40 at the mineral surfaced modified bitumen roof patch at the east valley line of the Upper Roof south of expansion joint #9.

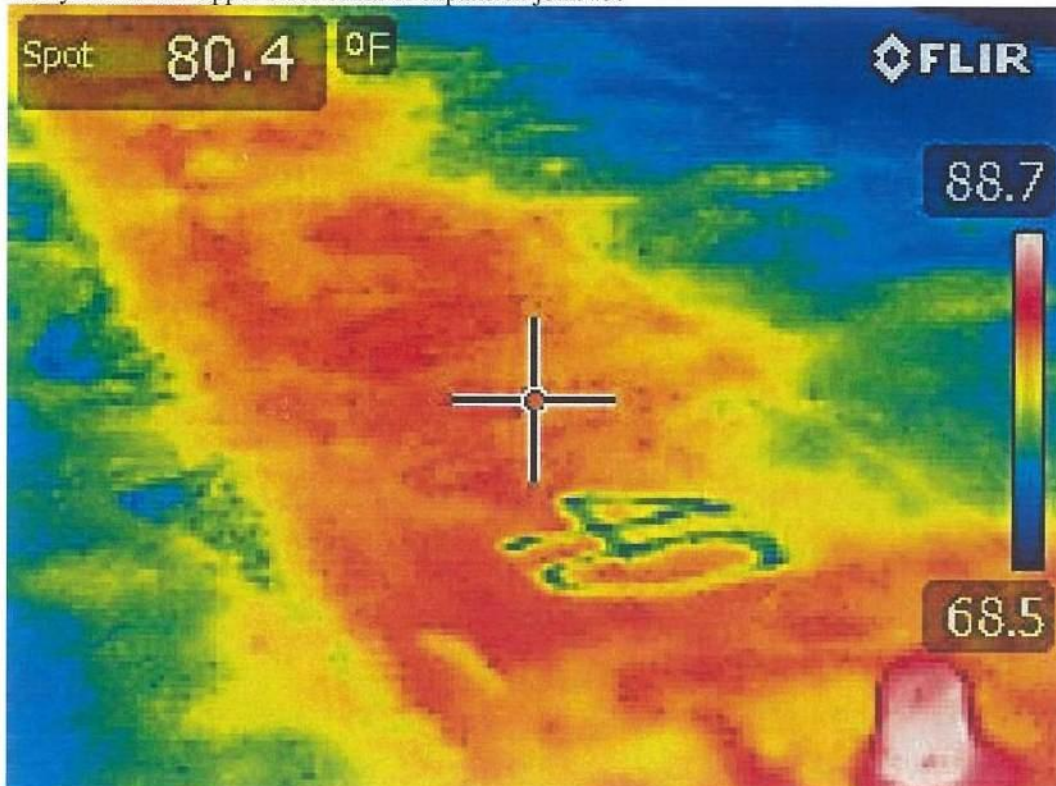
Photo #0522 View of entrapped moisture location #39 represented by red and yellow shaded areas at the mineral surfaced modified bitumen roof patch at the east valley south of expansion joint #9 at the Upper Roof.

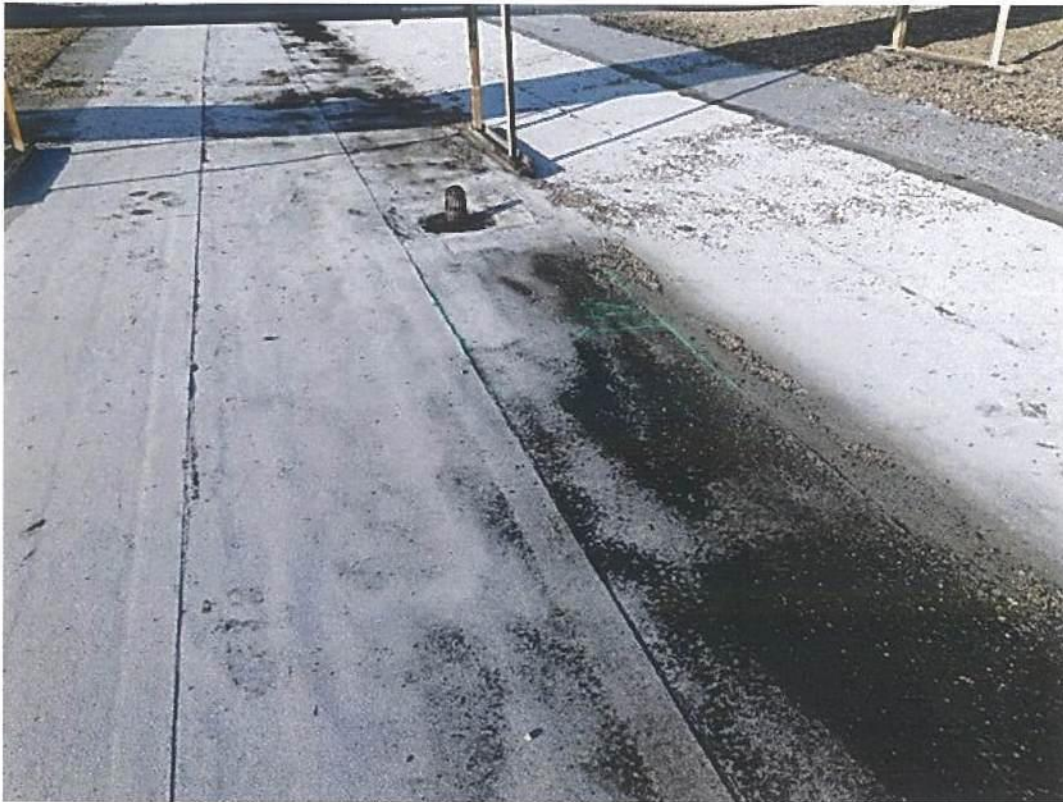
Photo #9763 View of entrapped moisture location #41 at the mineral surfaced modified bitumen roof patch at the west valley line of the Upper Roof north of expansion joint #8.

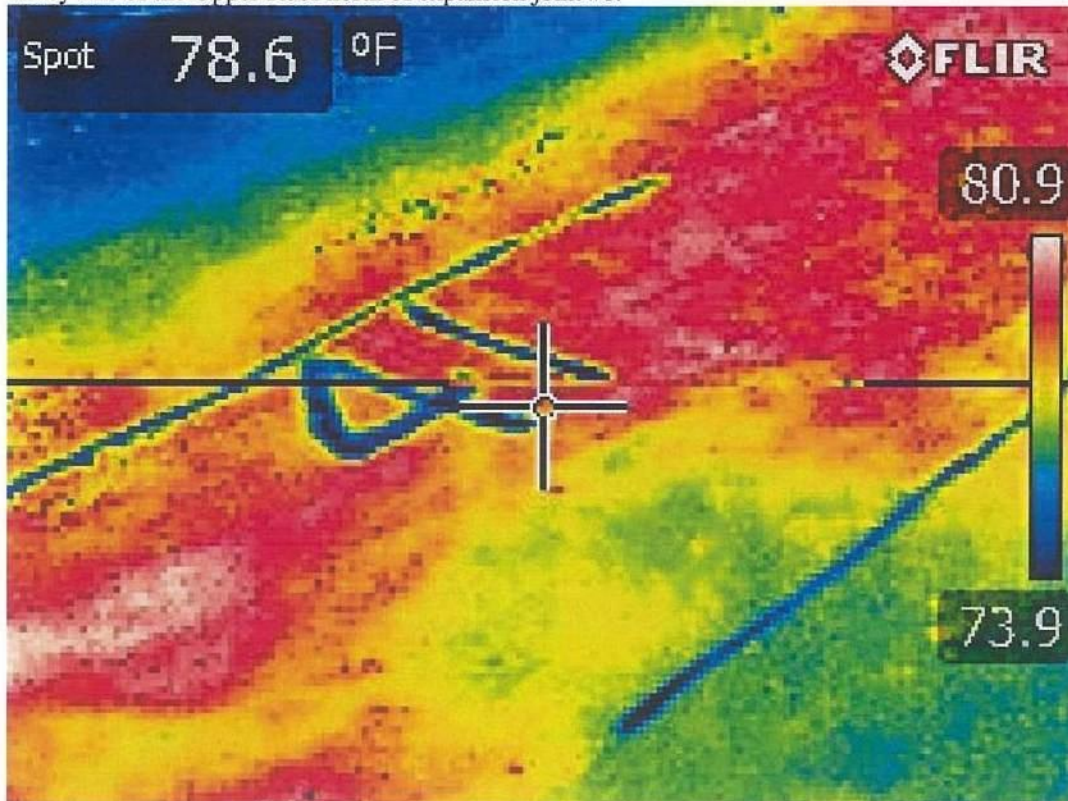
Photo #0524 View of entrapped moisture location #41 represented by red and yellow shaded areas at the mineral surfaced modified bitumen roof patch at the west valley north of expansion joint #8 at the Upper Roof.

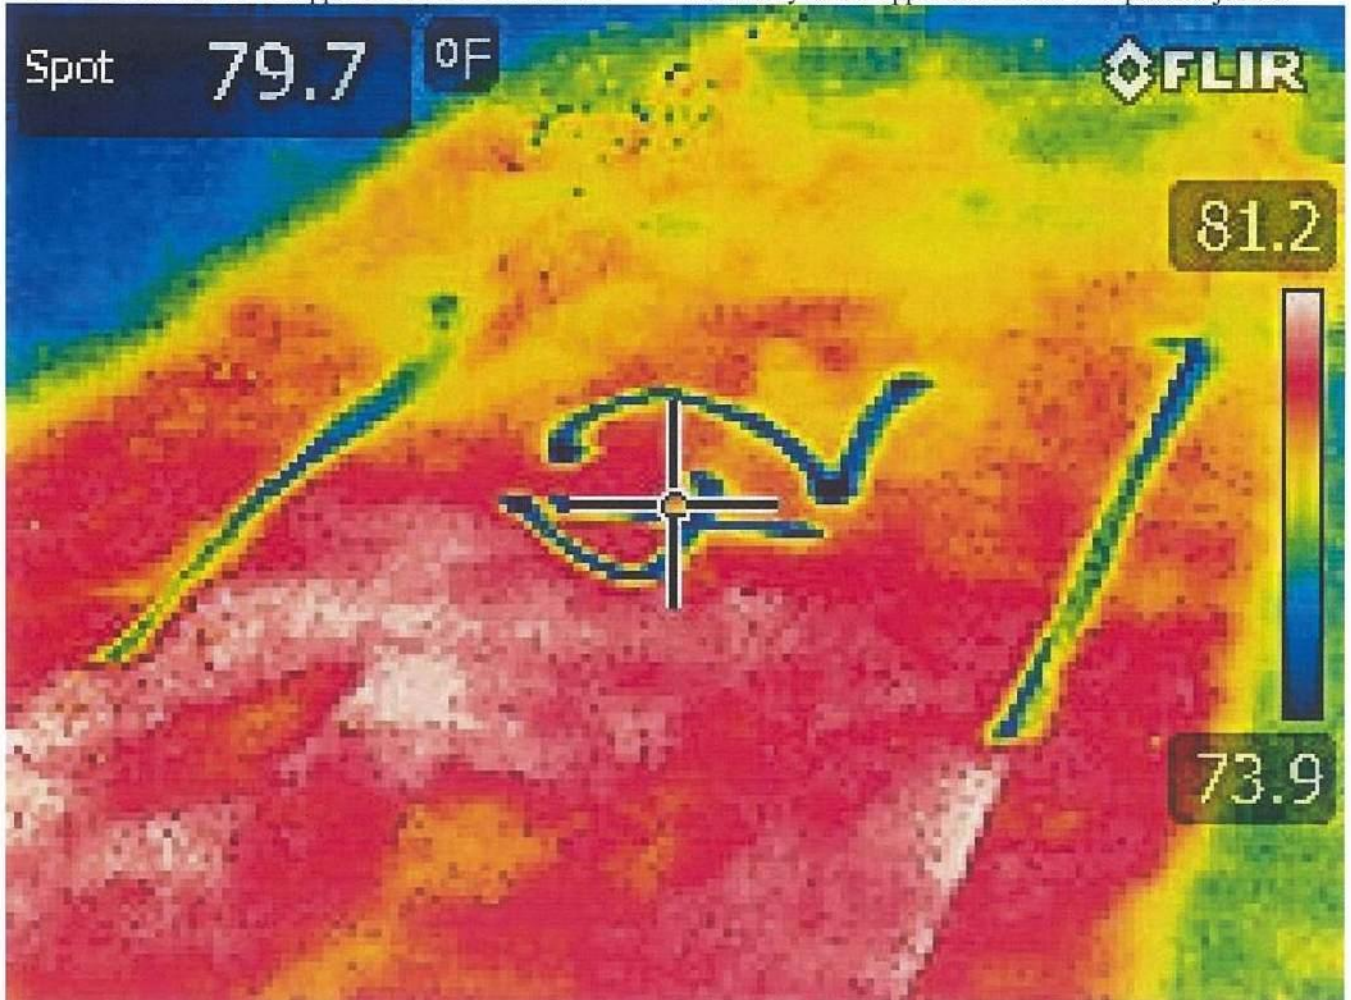
Photo #0526 View of entrapped moisture location #42 in the west valley at the Upper Roof north of expansion joint 8.

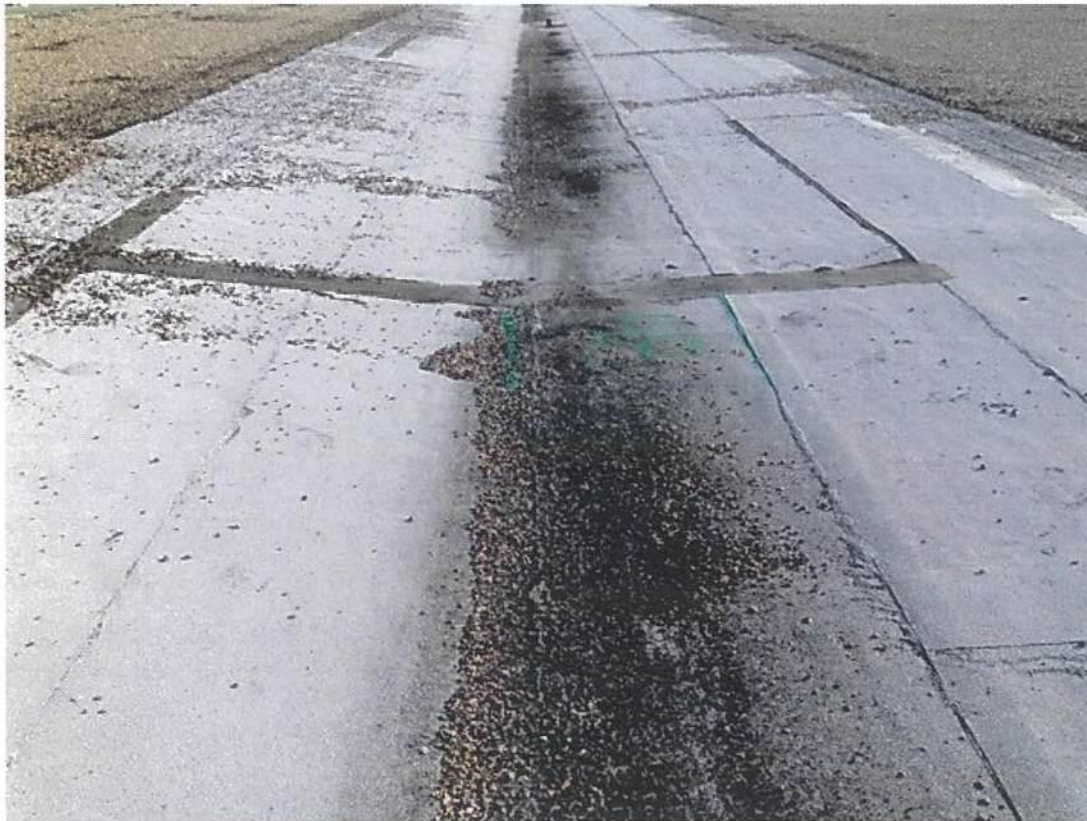
Photo #9766 View of area of entrapped moisture location #43 in west valley modified bitumen patch at the Upper Roof south of expansion joint #9.
