# Building / Site Assessment Report

AFP3 Buildings 001, 002, 118 and 119  
Spirit Aerosystems and Navistar Tenant Space  
3330 N Mingo Rd  
Tulsa, OK 74116

Engineering Services Department  
Project No. 170045.2, Amendment No.1

09 / 30 / 2019

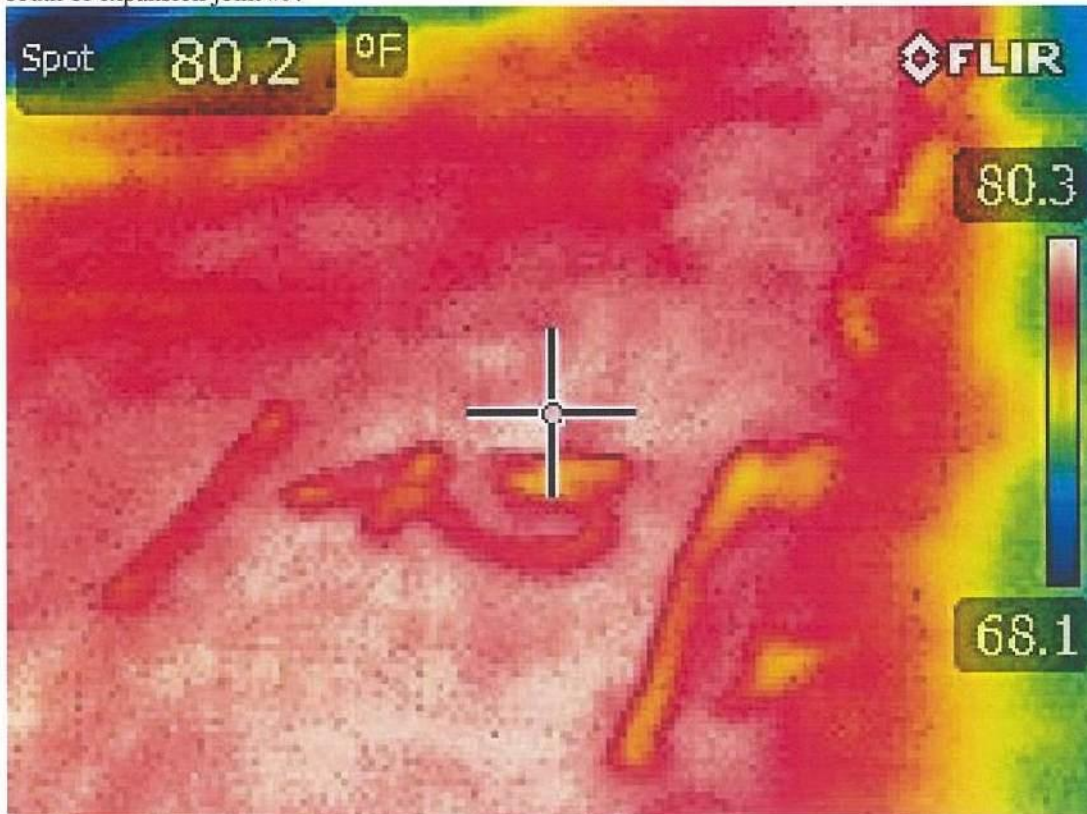
Photo #0528 View of entrapped moisture location in the west valley at the Upper Roof south of expansion joint 9.

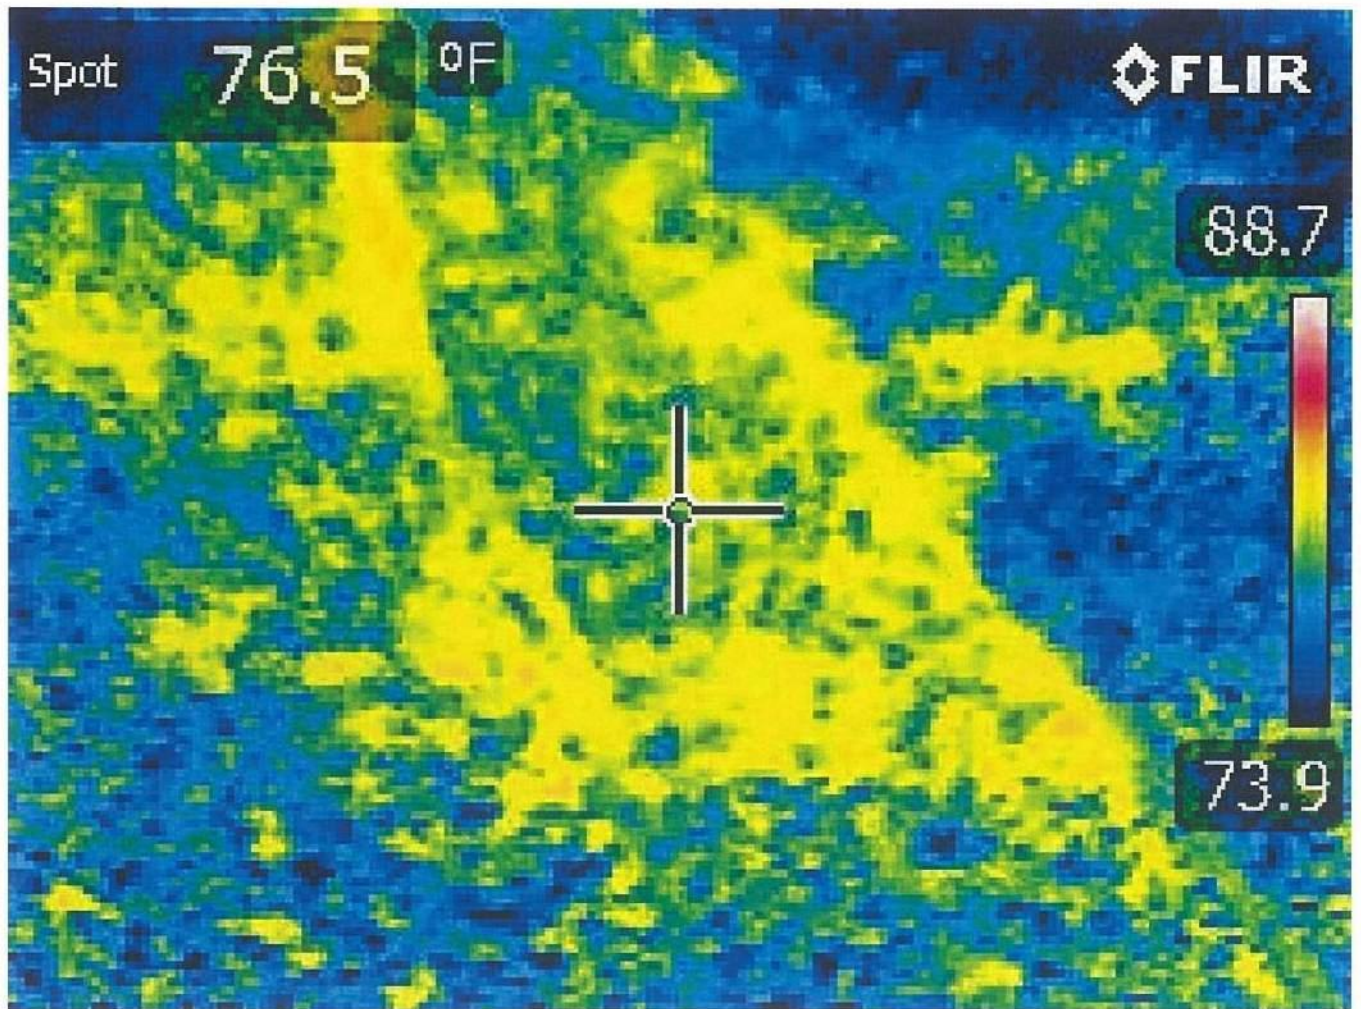
Photo #0530 View of entrapped moisture location #44 near the west valley at the Upper Roof south of expansion joint 9.

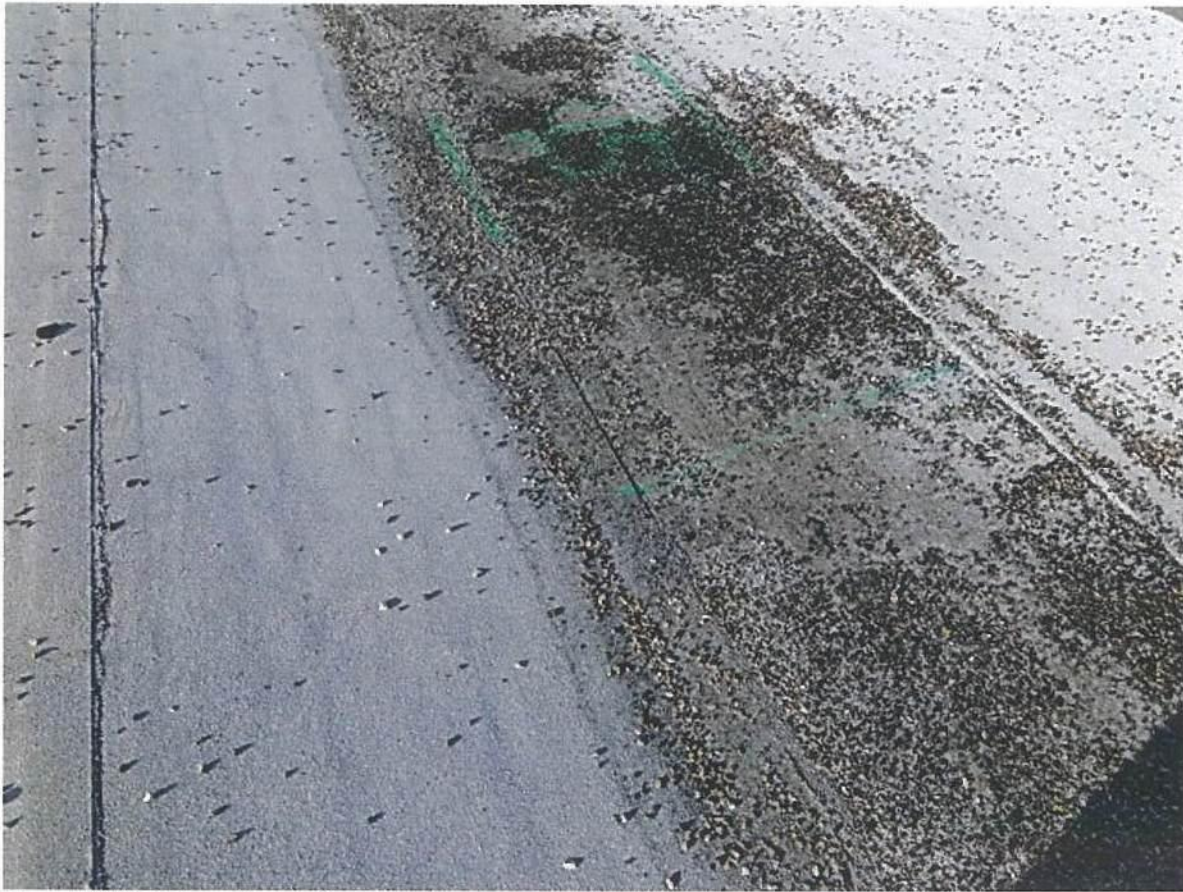
Photo #9769 View of area of entrapped moisture location #45 in east valley modified bitumen patch at the Upper Roof north of expansion joint #9.

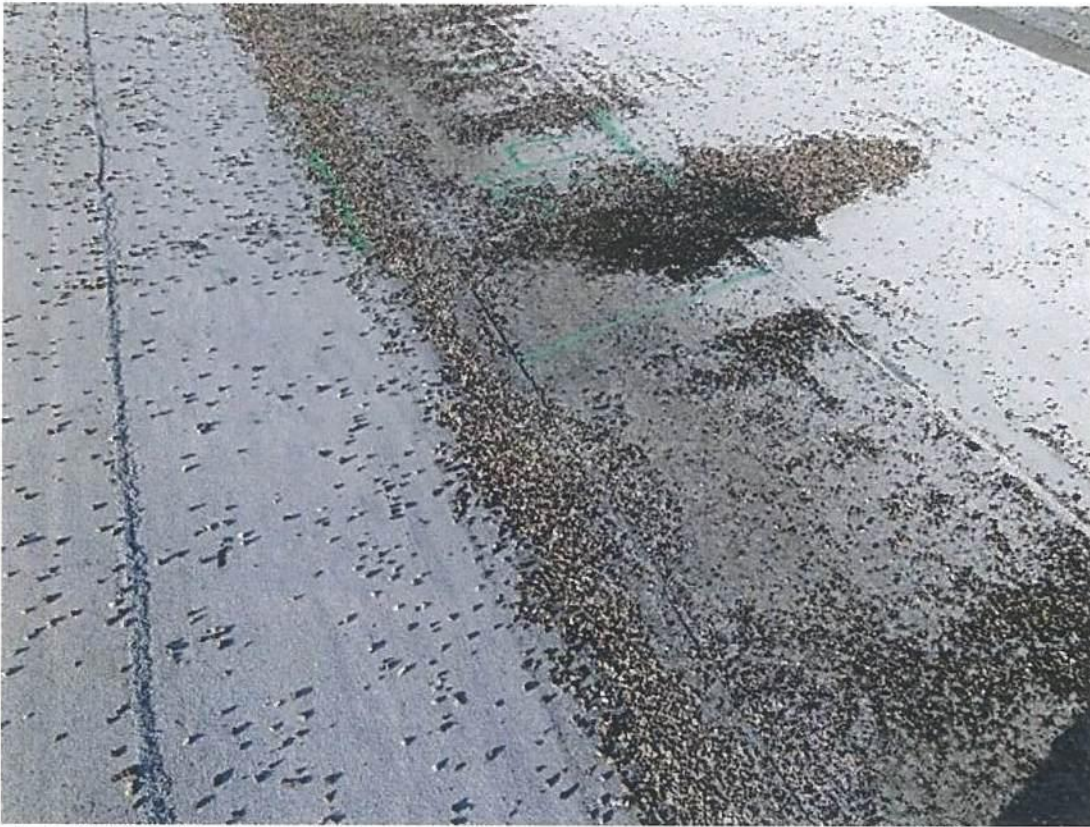
Photo #9770 View of area of entrapped moisture location #46 in east valley modified bitumen patch at the Upper Roof north of expansion joint #9.

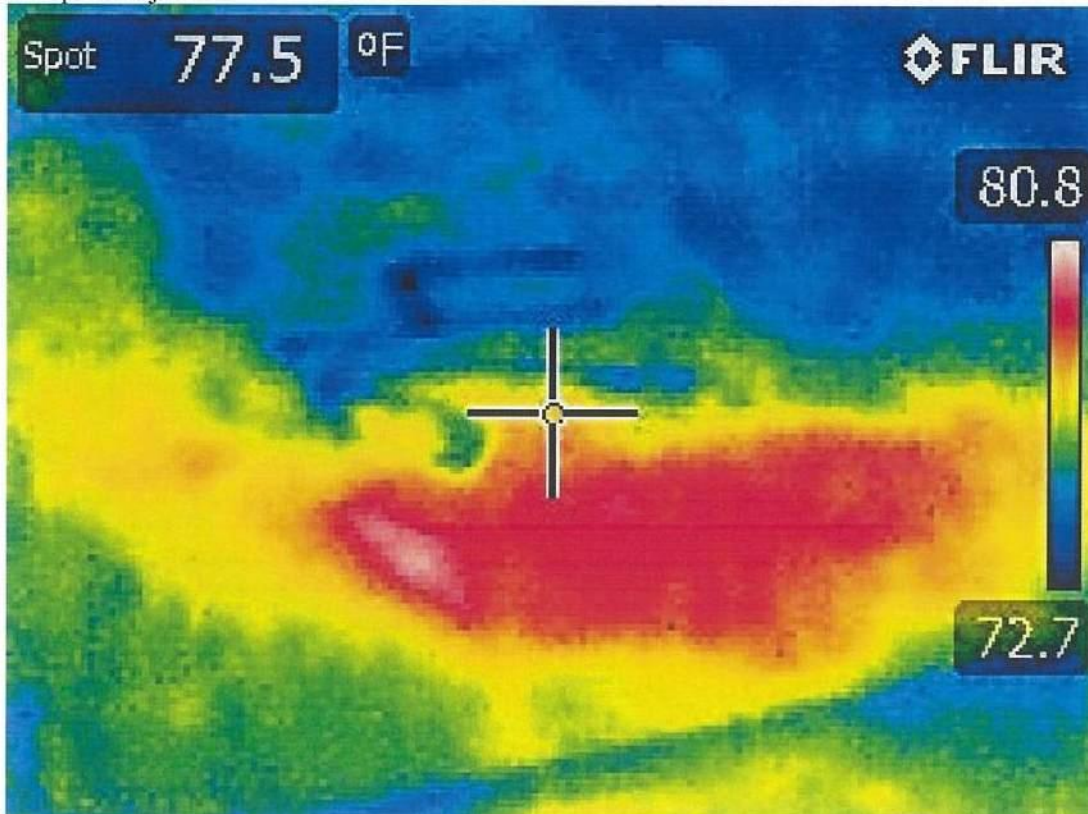
Photo #0534 View of entrapped moisture location #46 in the east valley at the Upper Roof north of expansion joint 9.

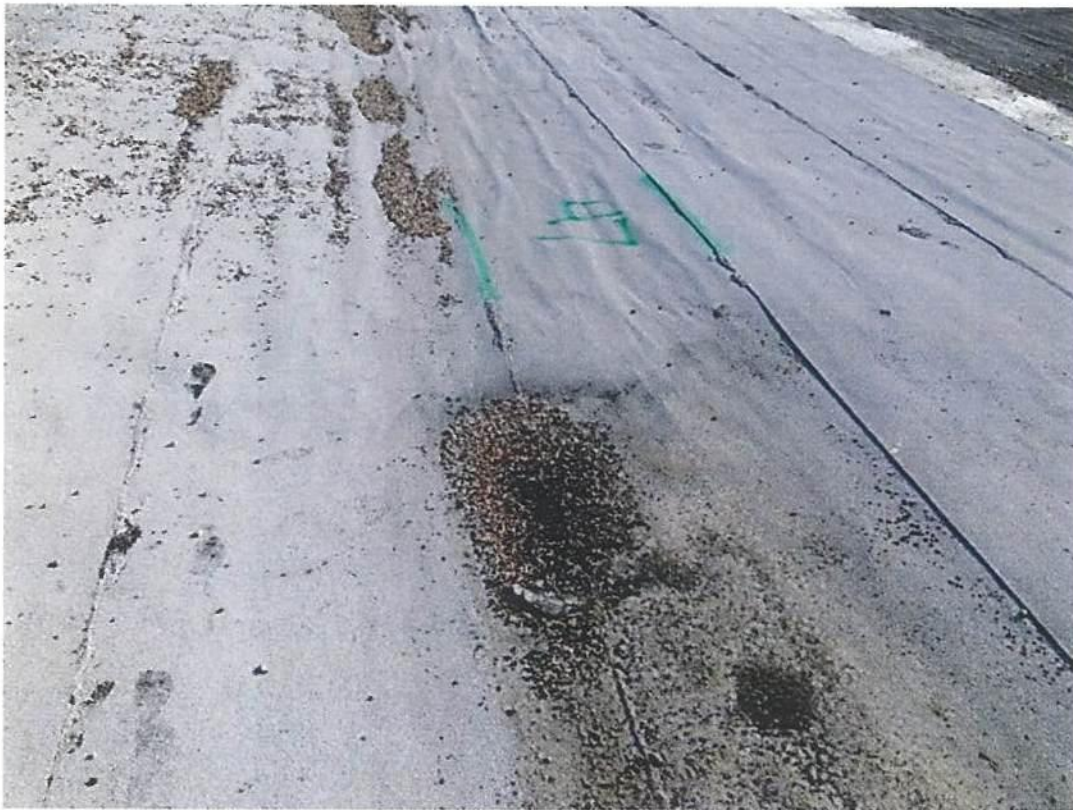
Photo #9768 View of area of entrapped moisture location #47 in west valley modified bitumen patch at the Upper Roof south of expansion joint #10.

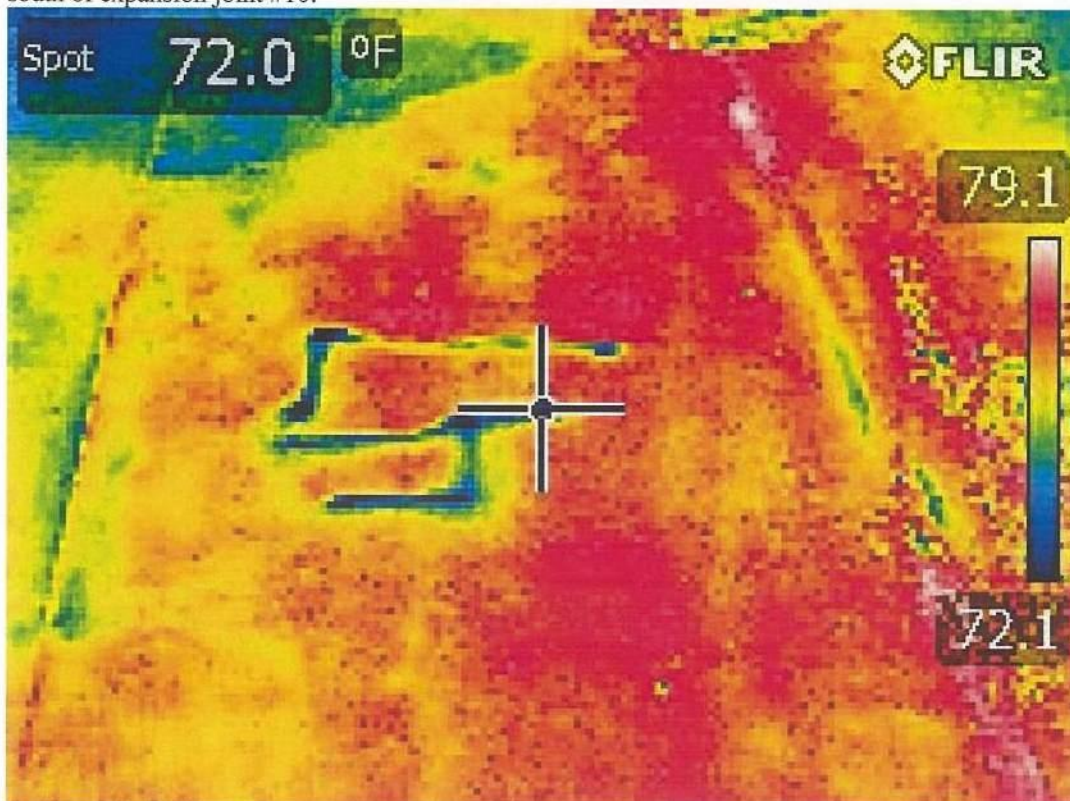
Photo #0536 View of entrapped moisture location #47 in the west valley at the Upper Roof south of expansion joint 10.

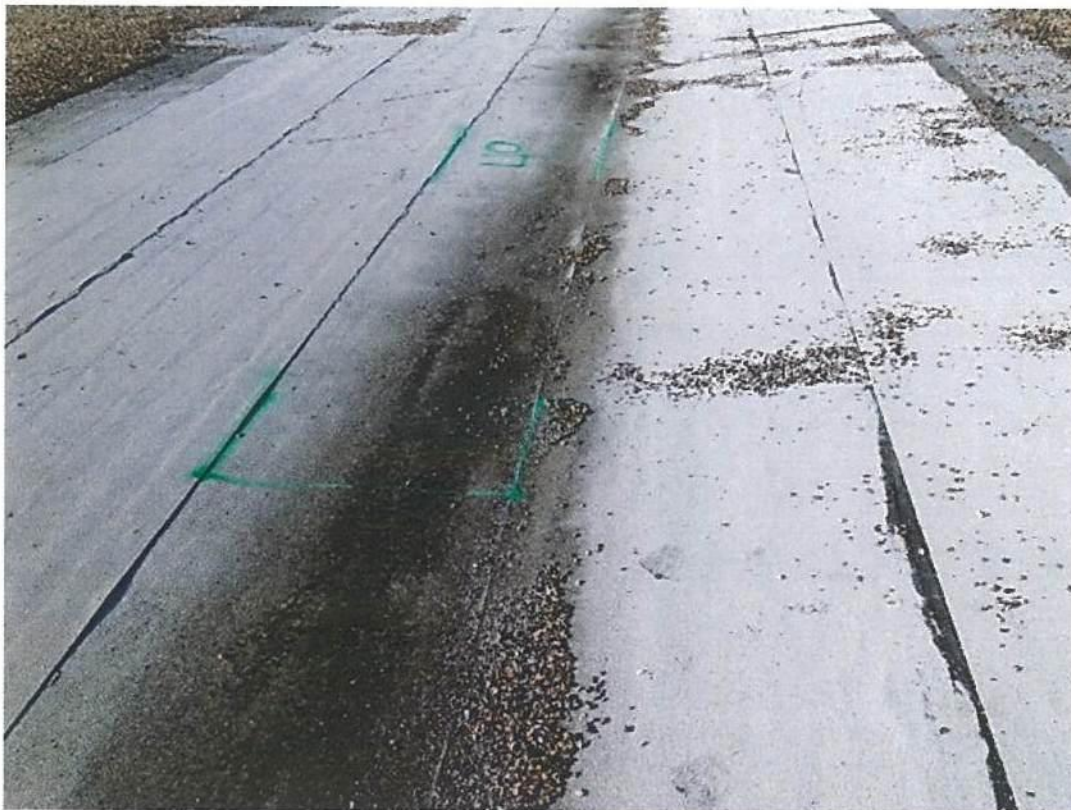
Photo #9765 View of area of entrapped moisture location #48 in west valley modified bitumen patch at the Upper Roof north of expansion joint #9.

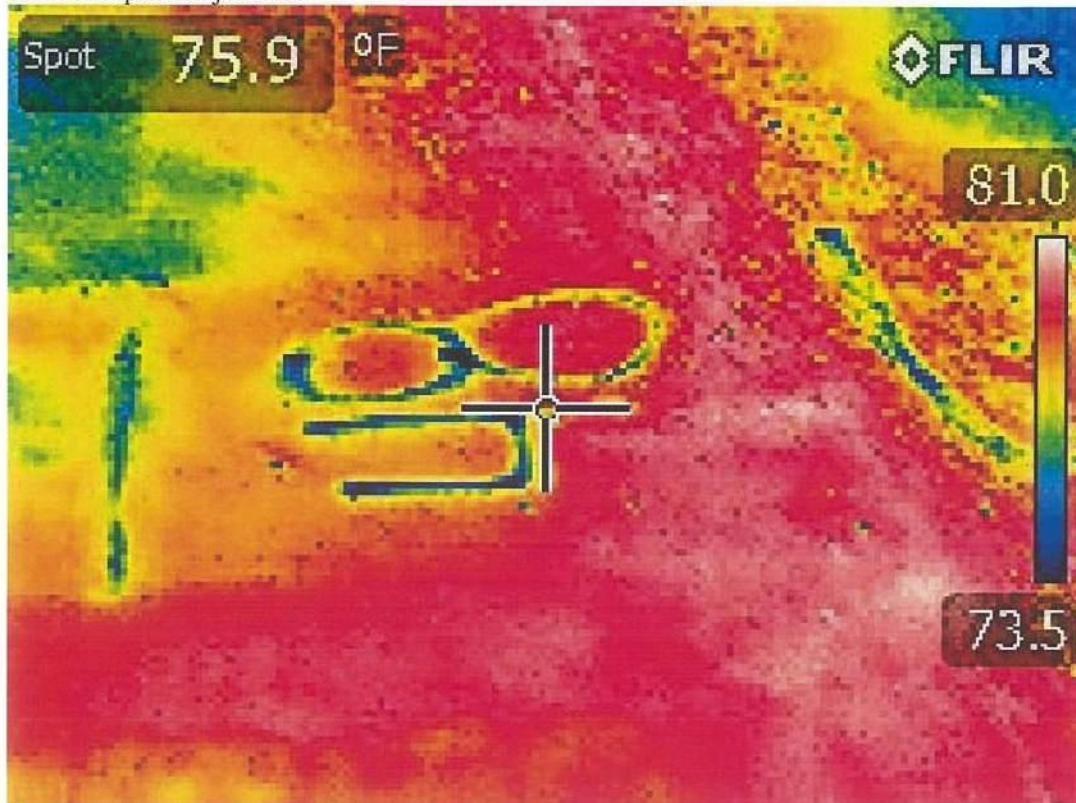
Photo #0538 View of entrapped moisture location #48 in the west valley at the Upper Roof south of expansion joint 9.

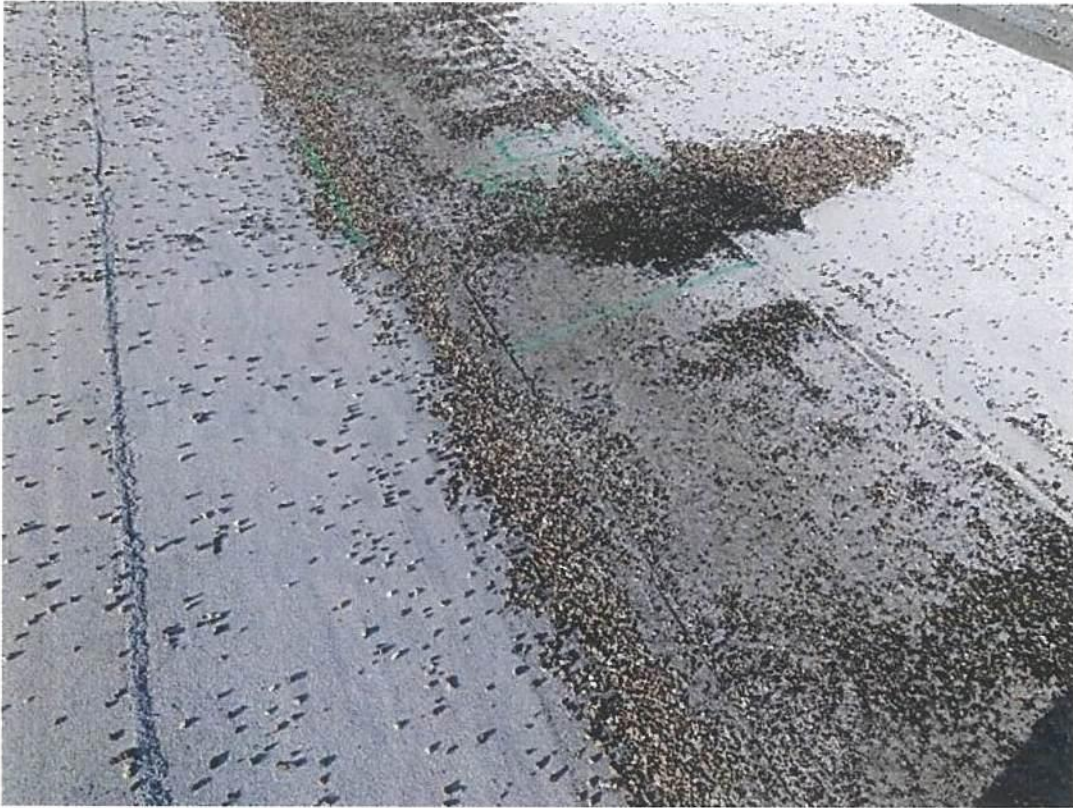
Photo #9770 View of area of entrapped moisture location #49 in west valley modified bitumen patch at the Upper Roof north of expansion joint #9.

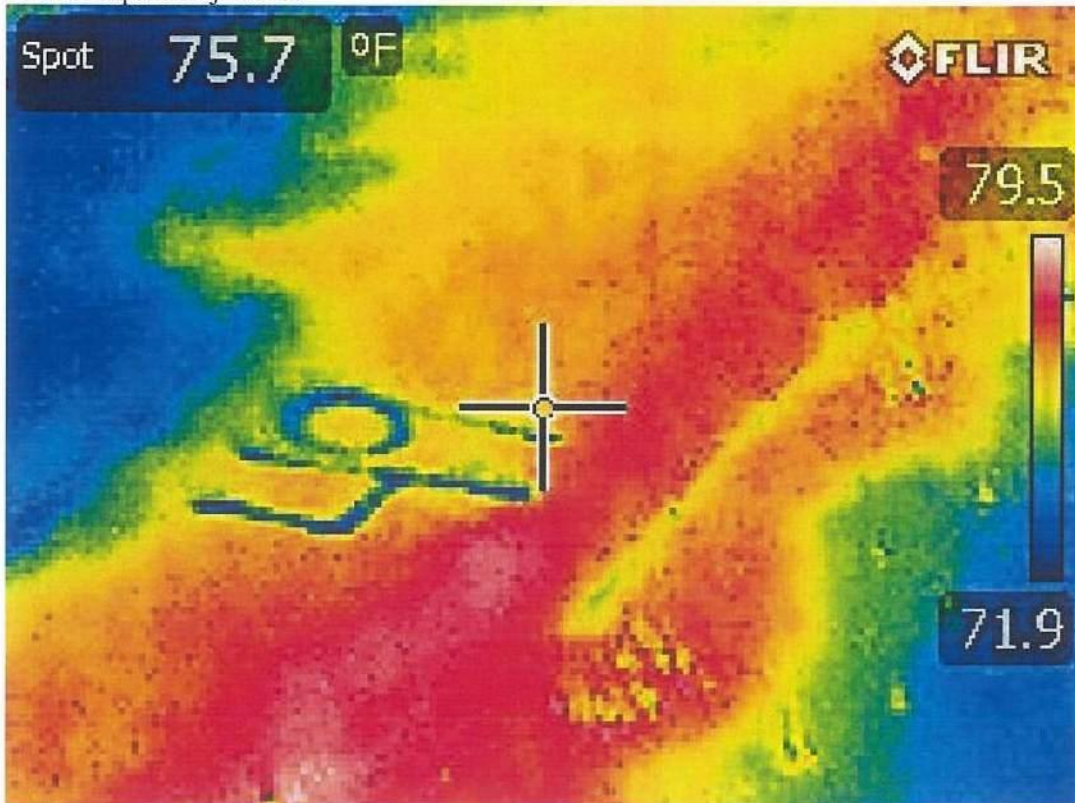
Photo #0540 View of entrapped moisture location #49 in the west valley at the Upper Roof north of expansion joint 9

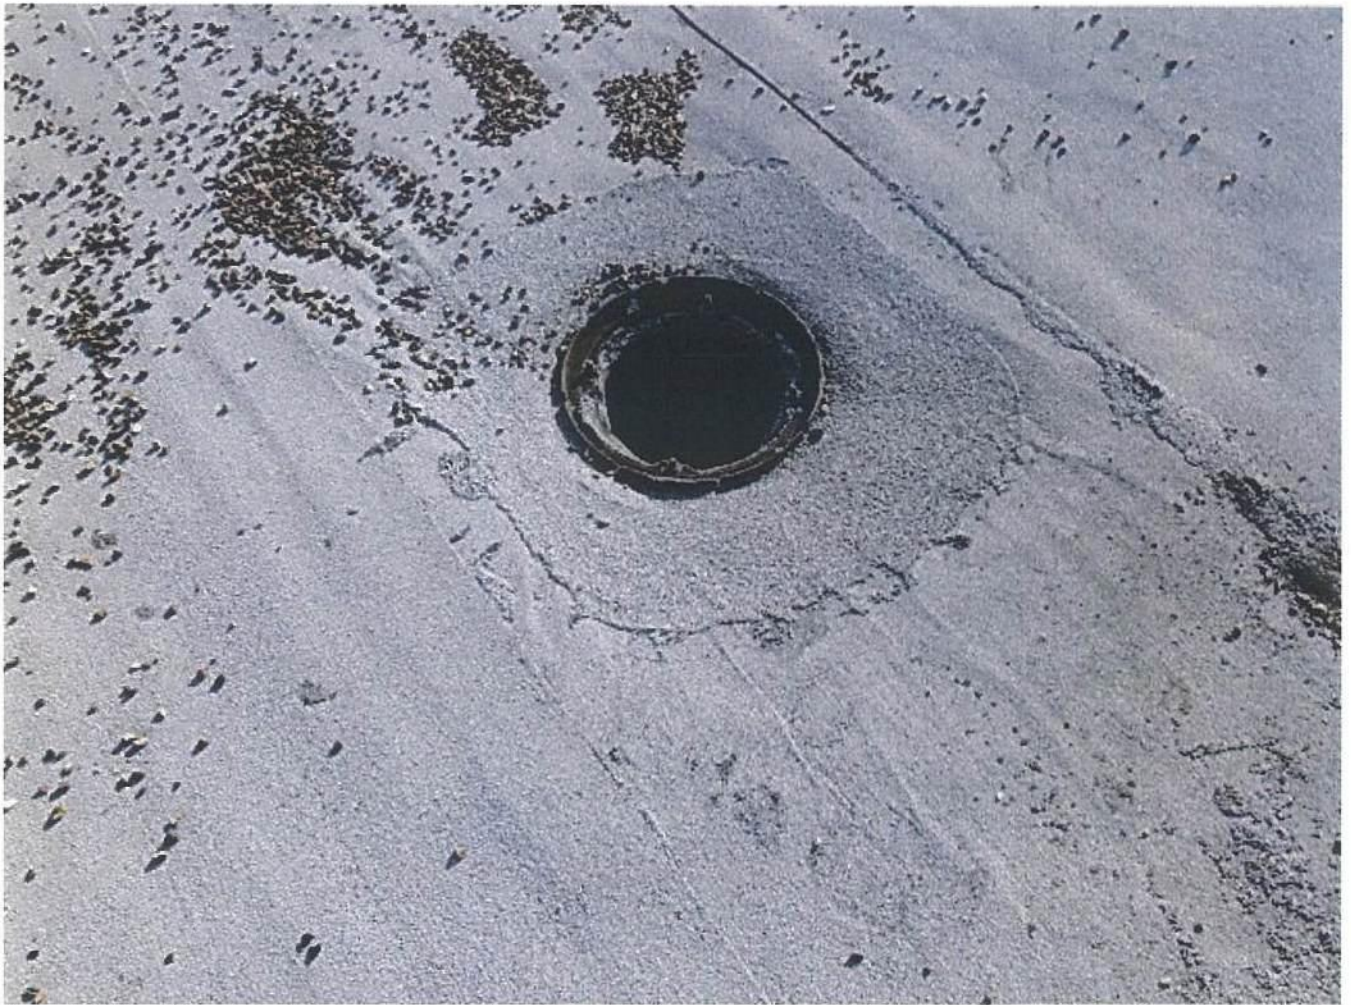
Photo #9771 View of roof drain missing strainer basket at the east valley modified bitumen at the Upper Roof south of expansion joint #10.

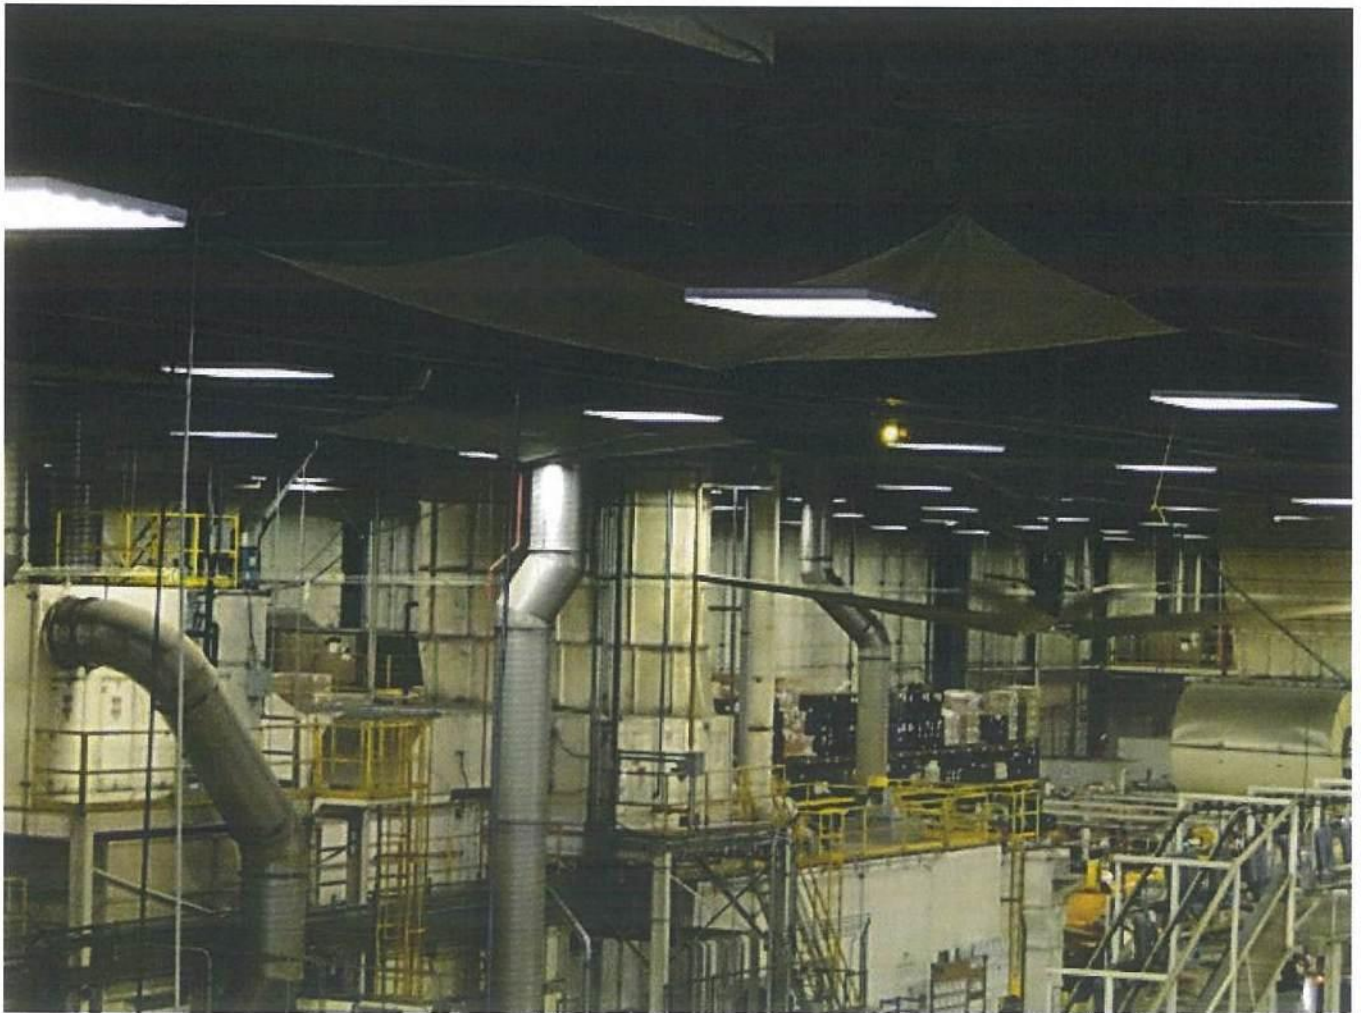
Photo #9721 View of tarps suspended from the roof structure at the Upper Roof Area to prevent roof leaks from damaging manufacturing equipment and products.
