# Building / Site Assessment Report

AFP3 Buildings 001, 002, 118 and 119  
Spirit Aerosystems and Navistar Tenant Space  
3330 N Mingo Rd  
Tulsa, OK 74116

Engineering Services Department  
Project No. 170045.2, Amendment No.1

09 / 30 / 2019

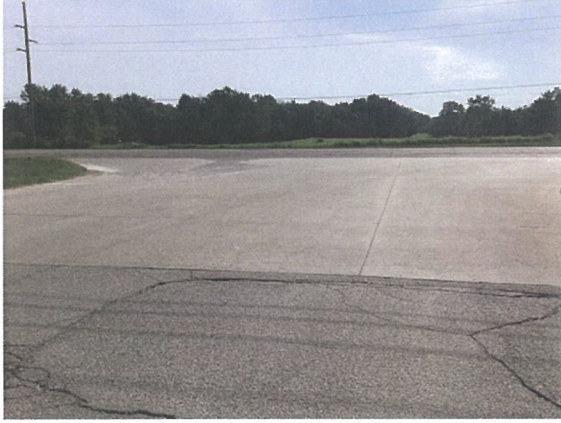
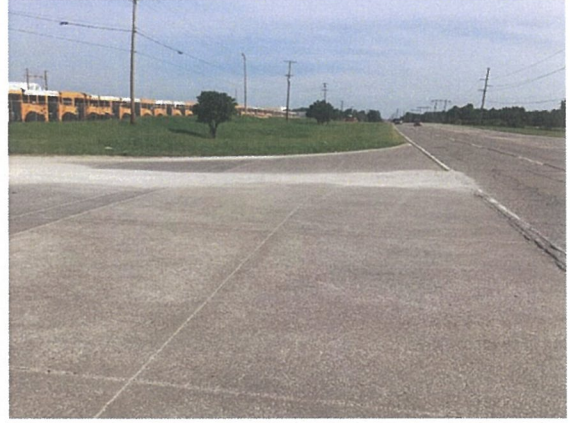
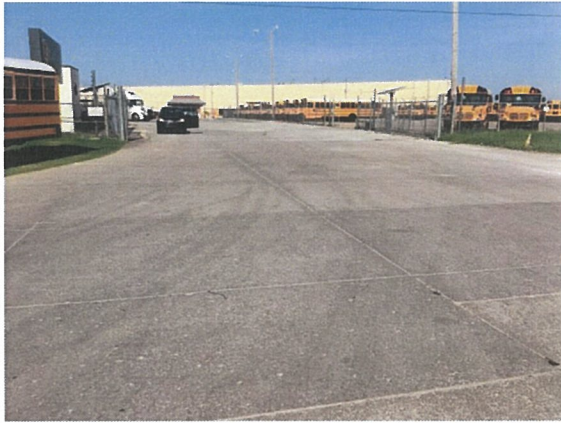
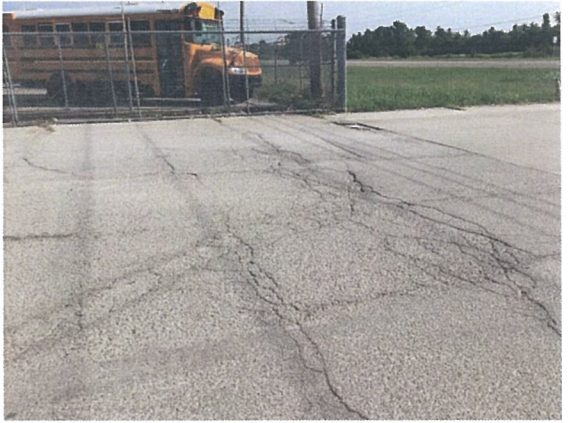
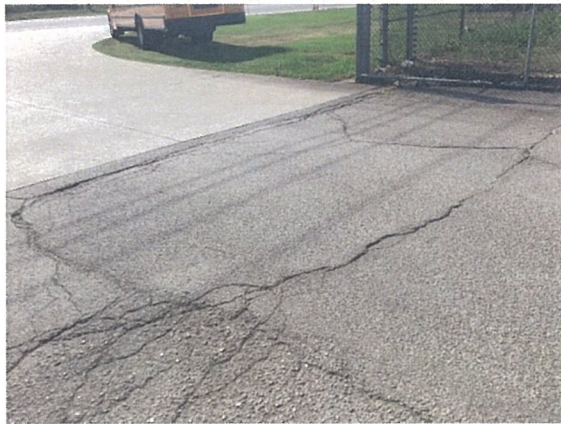
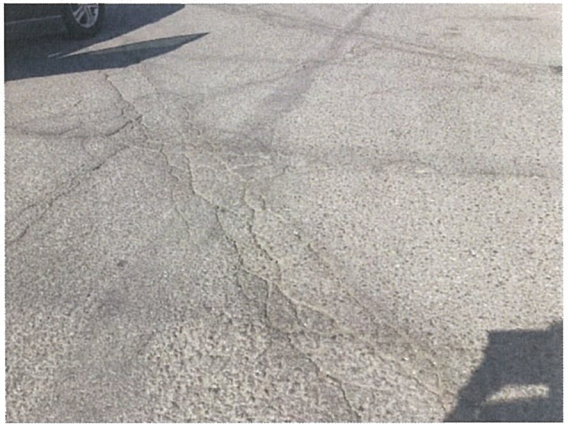
Area 1 Middle Driveway (N Mingo Rd) - Asphalt

The concrete pavement for this driveway is still in good condition but the asphalt pavement appears to have high severity fatigue cracking with spalled interconnected cracks, alligator cracking, potholes and block cracking. There is a visible sign that recent concrete patching was performed on the security check point gate.

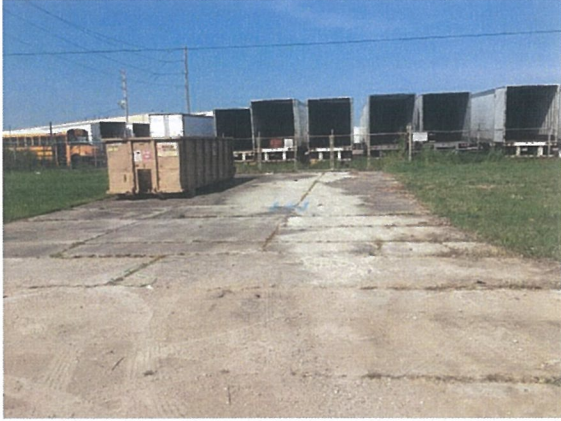
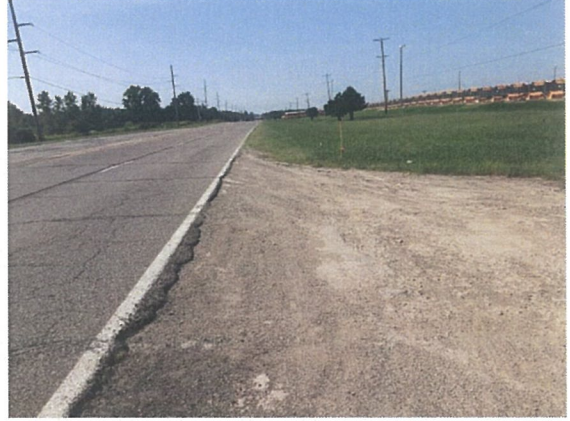
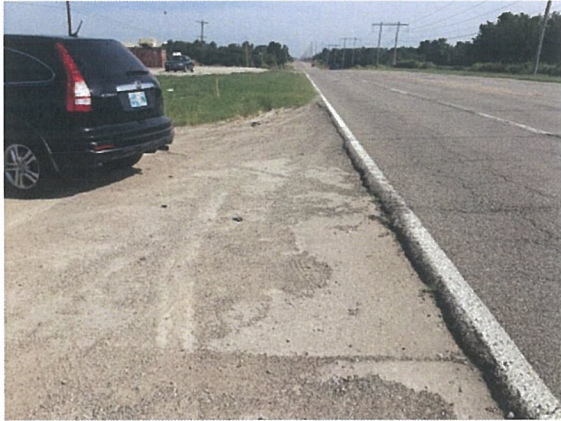
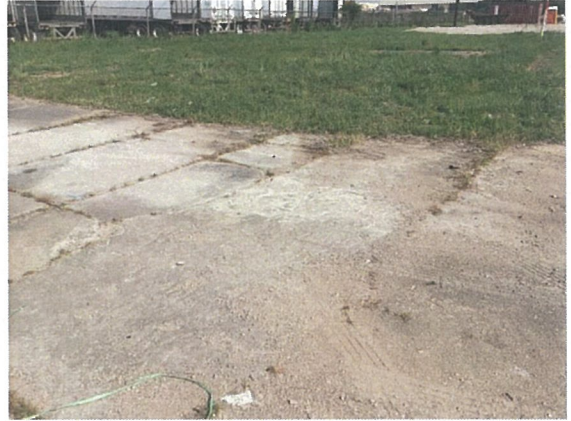
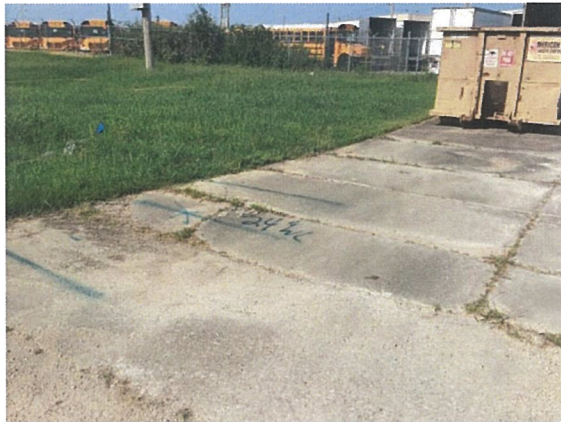
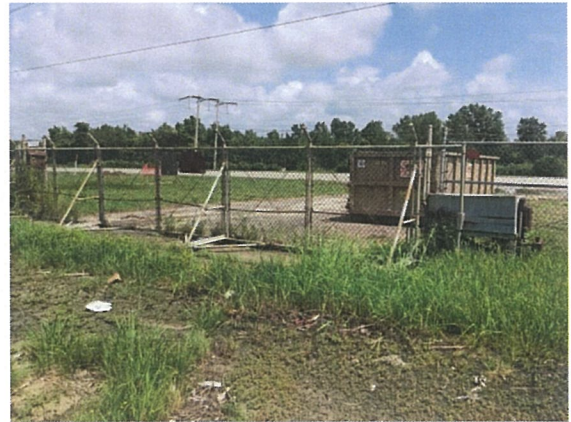
Area 1 North Driveway (N Mingo Rd)

This driveway appears not to be in service. The concrete pavement condition consists of surface deterioration, spalling, block cracking, transverse cracking and shattered slab. This driveway needs to be reconstructed if used in the future.

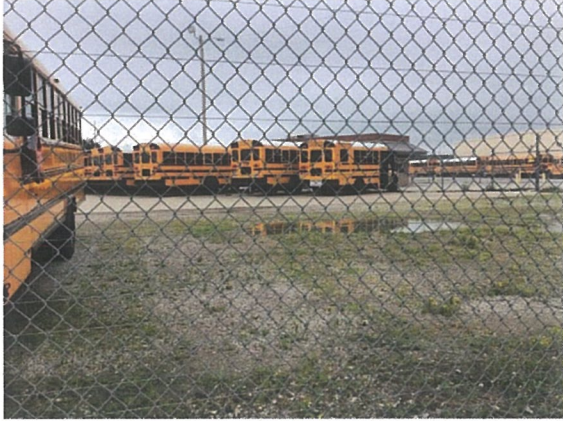
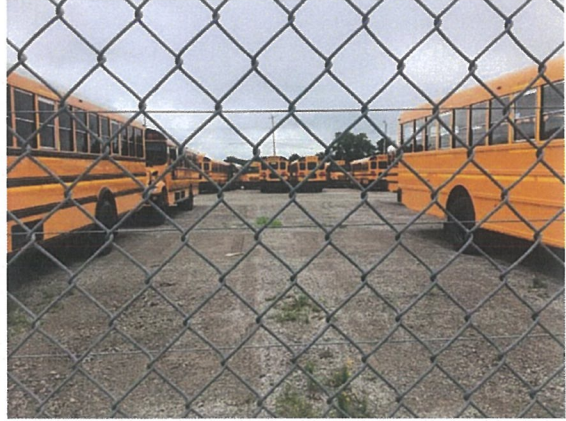
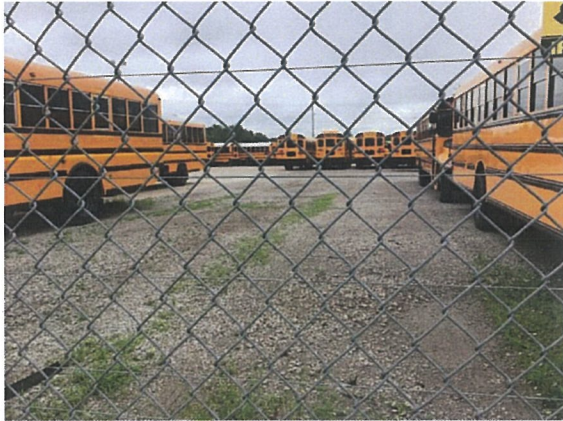
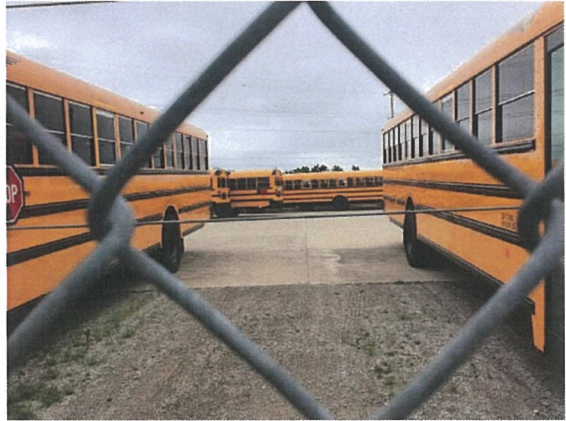
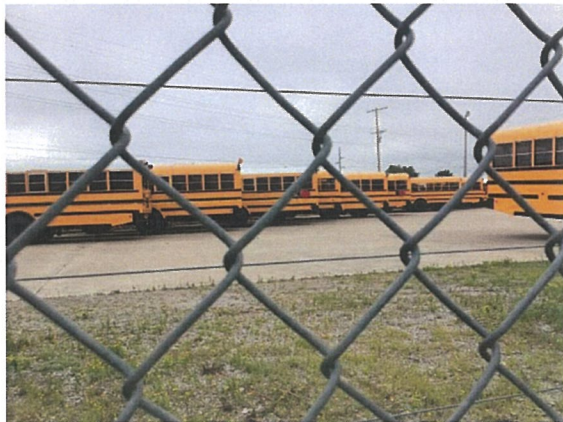
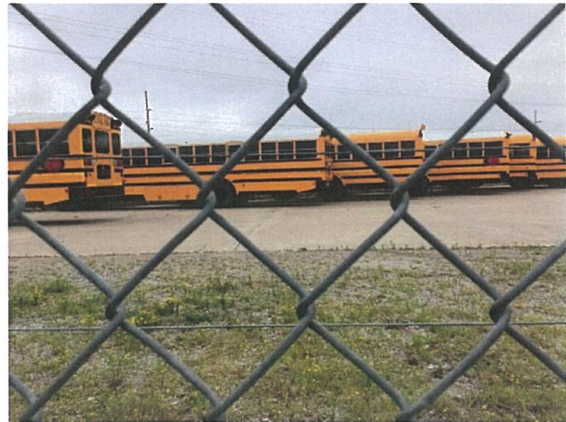
Area 1 Parking Lot – Concrete (Triangular Shape)

The parking lot south of the middle entrance is asphalt pavement and the parking lot north of middle entrance (triangular shape) is concrete pavement. The concrete pavement is still in good condition except some corner cracking near the gate. The asphalt pavement condition consists of potholes (with weeds growing), rutting, alligator cracking, longitudinal and transverse cracking and water ponding due to inadequate pavement slopes. The concrete access road condition consists of surface deterioration, potholes, joint cracking, shattered slabs, deteriorated patching, transverse cracks and numerous broken curbs. A sign of vehicles off-tracking is evident at north intersection.

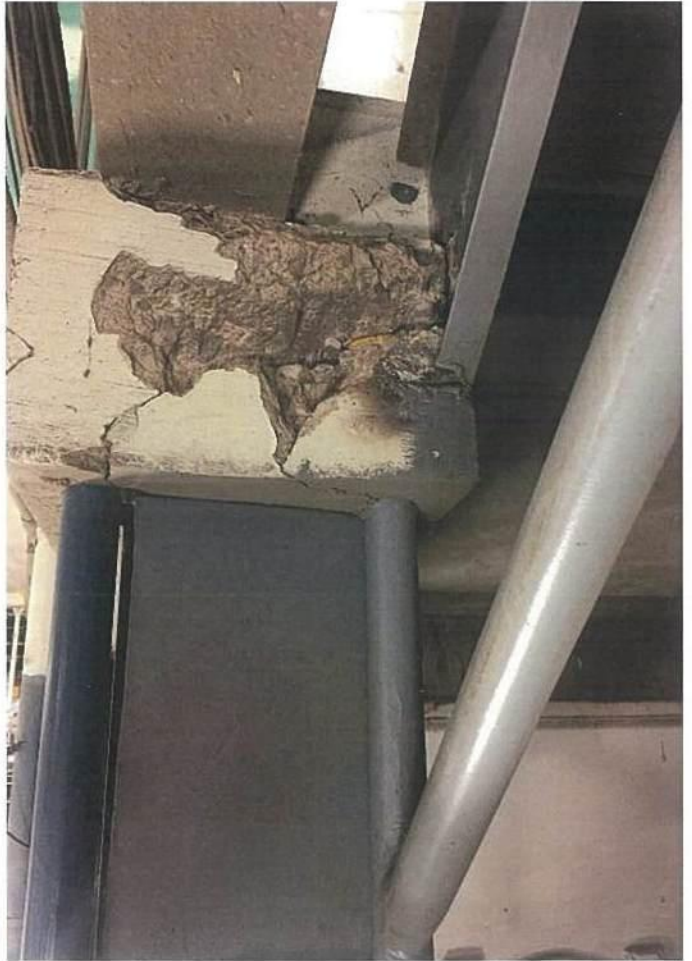
S1

1. Distress was found in the concrete curb at the access stair to the 2<sup>nd</sup> Level Mezzanine near column line 88. Refer to Photo S1. Although it does not appear to affect the structural system, loose fragments of the slab could present hazard to occupants below.

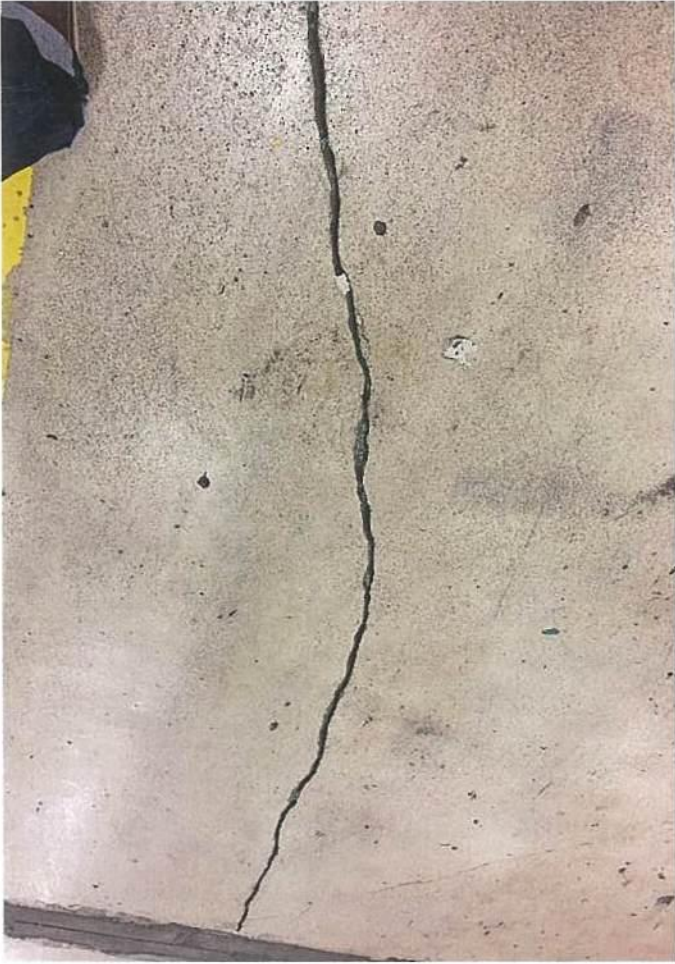
S8

7. There are sections of the slab that have numerous cracks. Some have been routed and filled (refer to Photo S8), others have not (refer to Photo S9). From the flatness check with a steel sphere the cracks do not appear due to slab heave because the area near the crack is relatively flat.

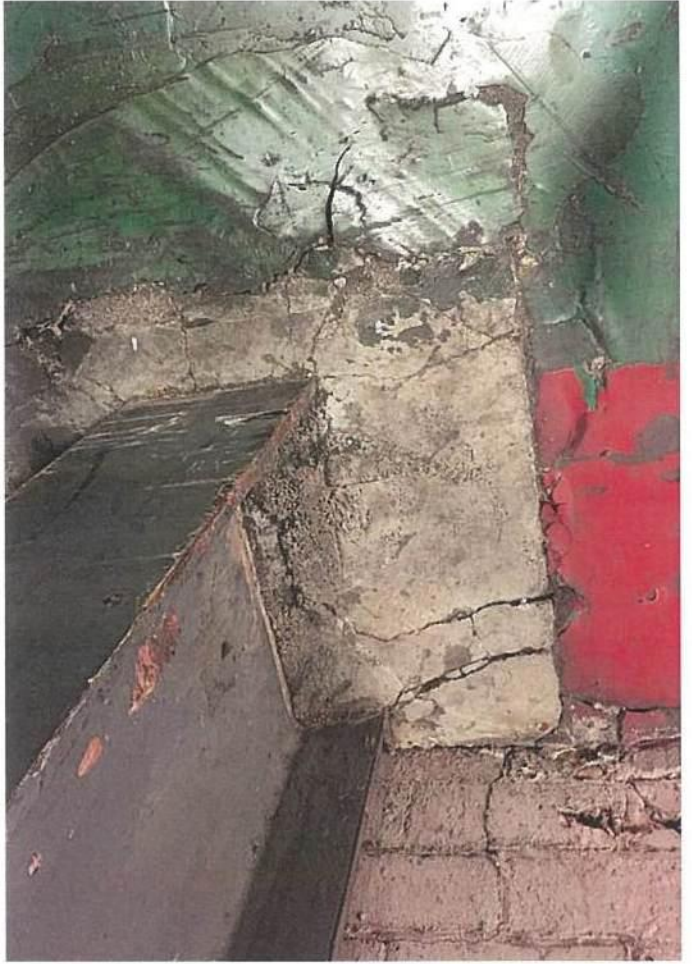
S7

5. The base of the perimeter CMU wall was damaged between column lines 125 and 126 along grid M. Refer to Photo S6.
6. The grout at the base of the column a grid 126M is in disrepair. Refer to Photo S7.

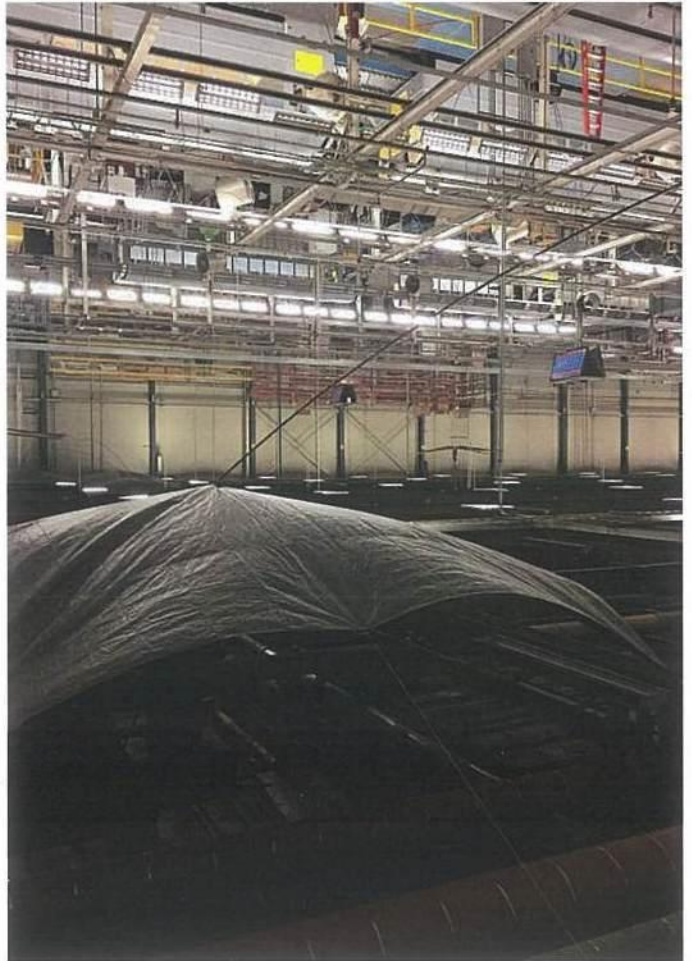
S5

4. There are plastic sheets suspended from the roof framing for the purpose of catch leaks from the roof it appears. Refer to Photo 5. Much of the roof has been replaced so these may be left over rain screens in areas that have been reroofed. Refer to the attached roof inspection report by Roof Consultants. No water was observed in these sheeted areas.

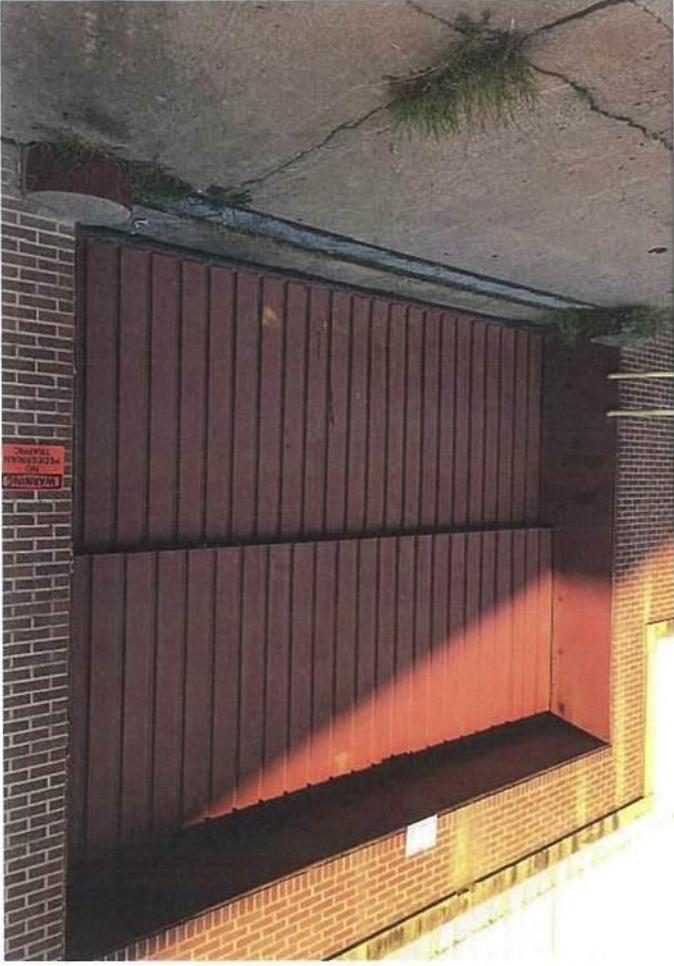
S12

9. An overhead door between grids 91M and 92M showed signs of distress and appeared inoperable. Refer to Photos S11 and S12. Another OH door between grids 108M and 109M appeared damaged.

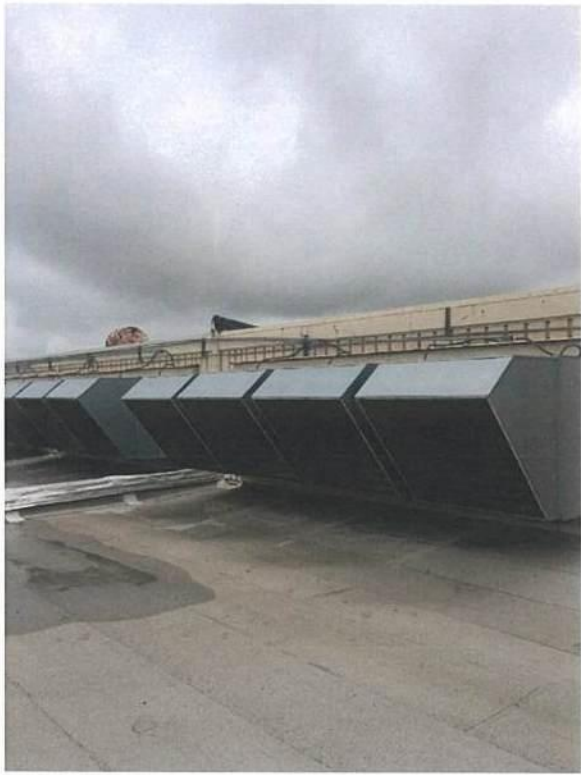
Photo #1

Per Navistar staff, the Navistar portion of Building 001 has over 150 exhaust fans high up at the connection from the higher roof level to the lower roof level (Photo 1). Only 50 fans can be run at one time without creating building pressurization issues. The fans are installed and operate in banks of four, and they differ in age and state of repair. Several fans were observed to possess damaged back-draft dampers (Photo 2), and some fans were observed to be inoperable. Invasive inspection and testing would be required to ascertain how many of the 150 exhaust fans are not operational. A detailed survey of the state of the exhaust fans is recommended. One downblast exhaust fan was noted on the roof; it was not operating (Photo 3). A small downblast exhaust fan was also noted on the lobby roof.

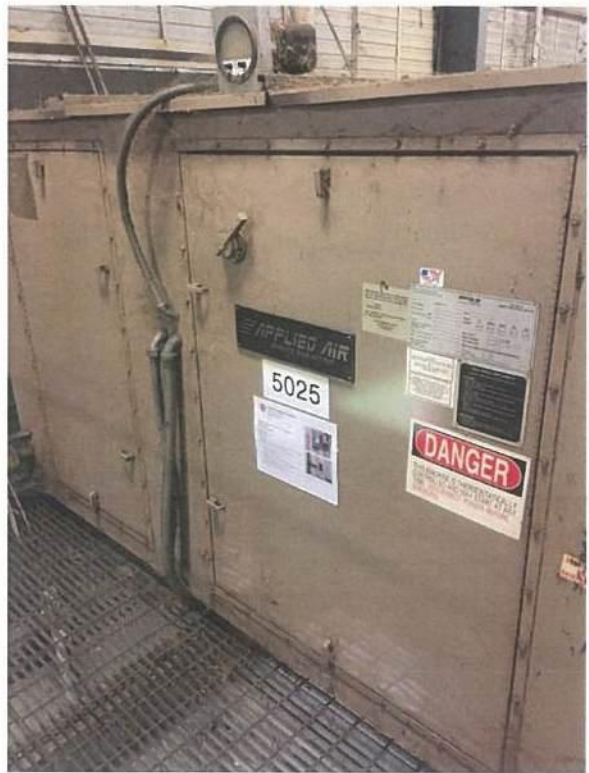
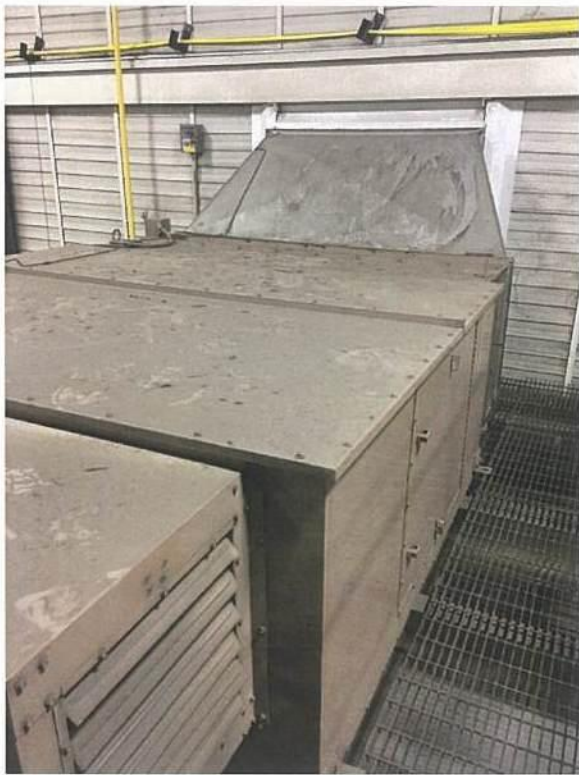
Unconditioned make-up air is provided by twenty (20) gas-fired MAUs installed on raised platforms throughout the shop (Photos 4, 5). The MAUs provide heating in the winter. Of the six inspected, five were operating and one was locked out and tagged out (Photo 6). The age of the units is unclear, but they appear to be about 20 years old, which is near or exceeding their expected median service life. It is recommended that the decommissioned unit be repaired.

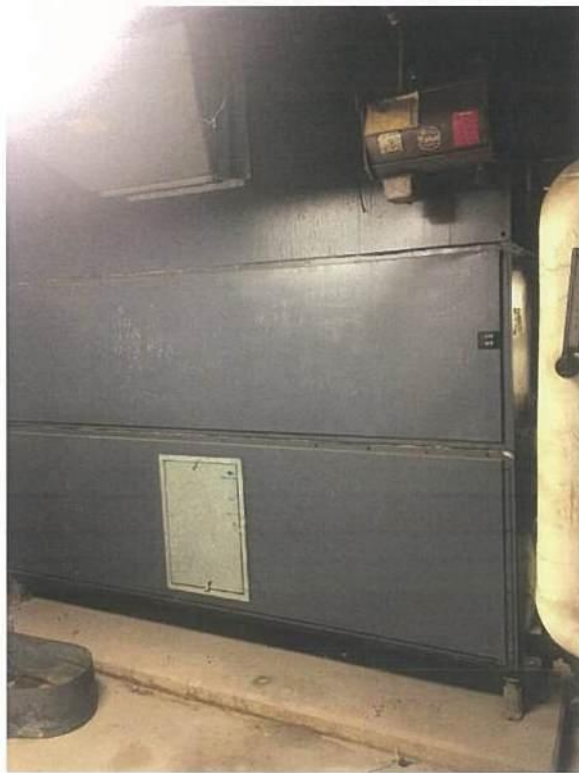
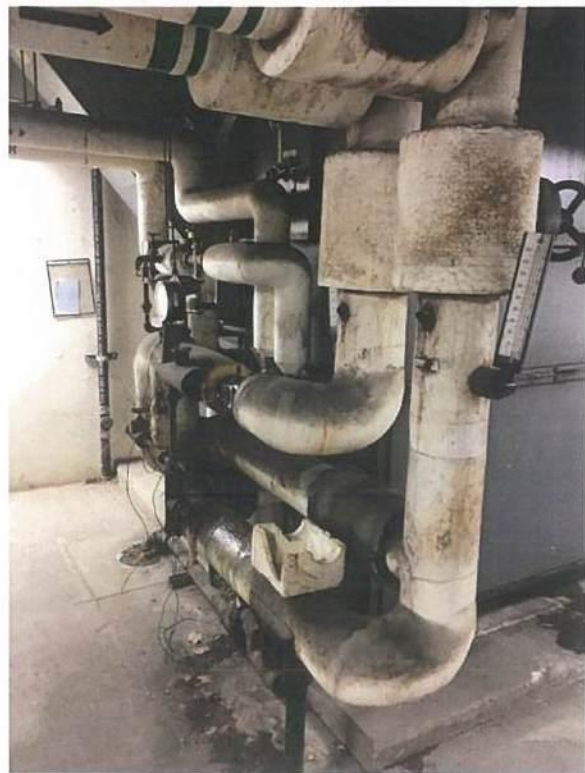
The northernmost mezzanine is served by two (2) hydronic AHUs (Photos 7, 8). Only one was observed to be operating. The age of the units is unclear but they appear to be 25 years old or more, which is at or greater than the median expected service life of their coils and motors. It was necessary to traverse an abandoned area strewn with debris in order to approach the AHUs, and spider-webs indicated that this area is not often accessed. The operating AHU exhibited significant condensation (Photo 9). It is recommended that the leaving-air temperature be adjusted or the AHU and ductwork be better insulated. Like the Spirit Aerosystems side of the Building 001, the Navistar side possesses several of the large hydronic AHUs original to the building, but unlike Spirit they are not in service. Navistar staff indicated that there is no intention to put them in service, due to a fear of potential asbestos insulation in some part of the AHUs or air-distribution system. Cyntergy did

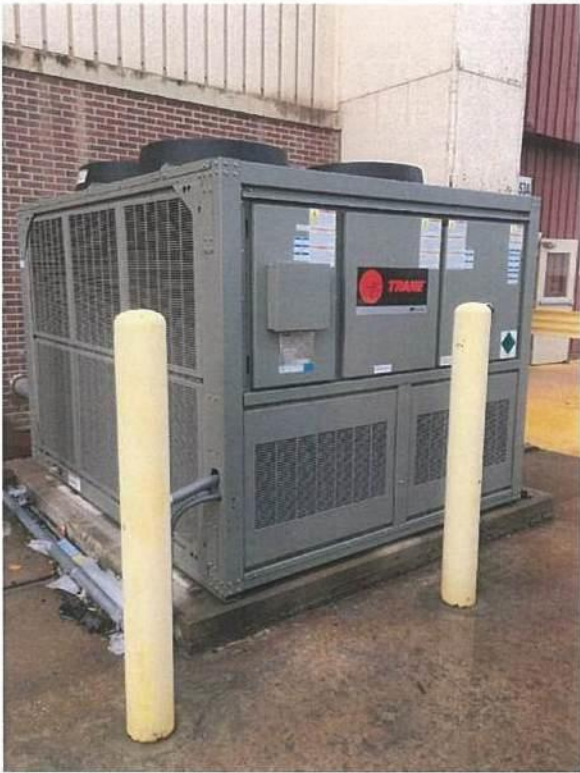
Photo #10

The AHUs are provided with chilled water by a brand new air-cooled chiller (Photo 10). It was operating at the time of the site visit.

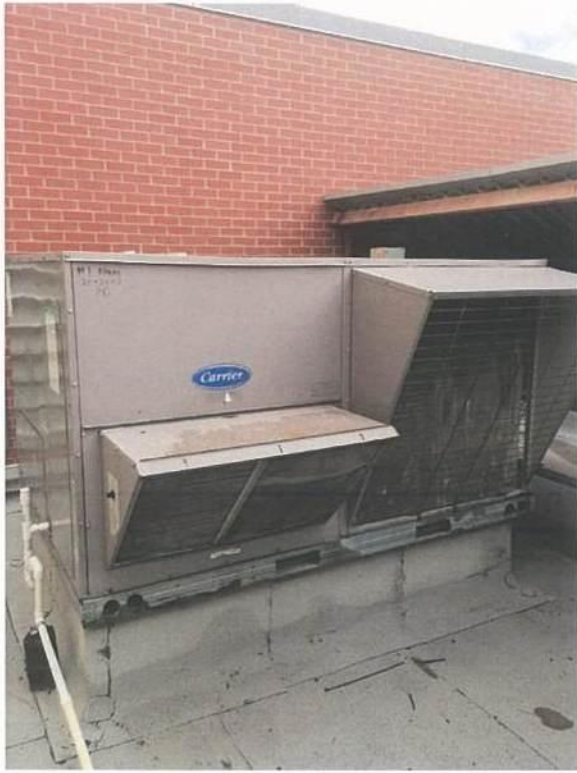
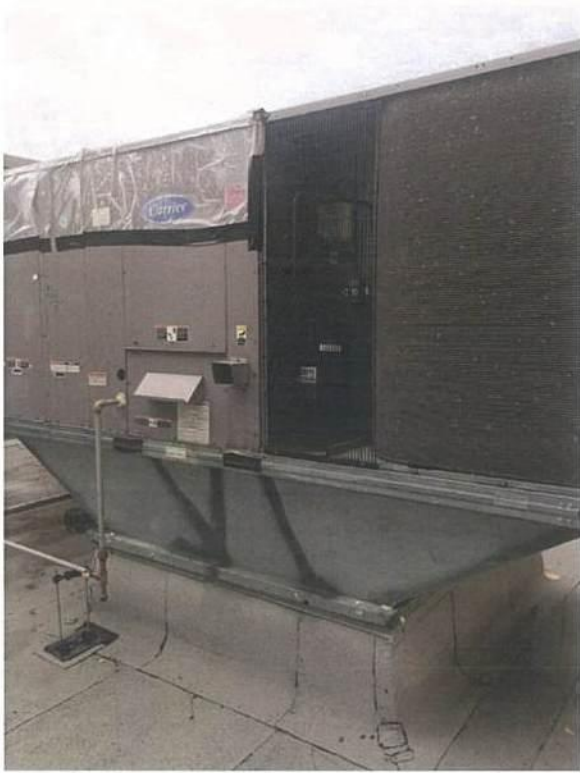
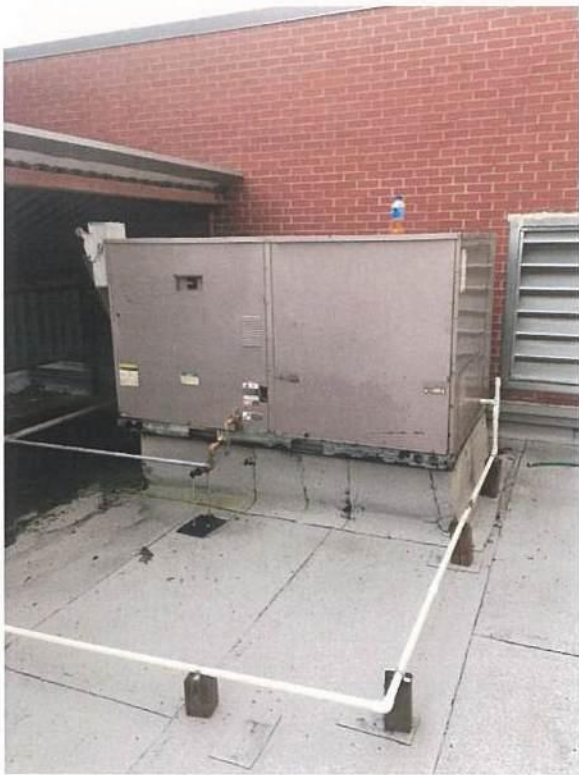
The lobby area was served primarily by four (4) packaged rooftop air handling units (RTUs) in varying states of age and repair (Photos 11, 12, 13). The age of the RTUs was unclear but they appeared to be between 10 and 20 years old, putting them at or near their median expected service life of 15 years. Some were operating at the time of the site visit.

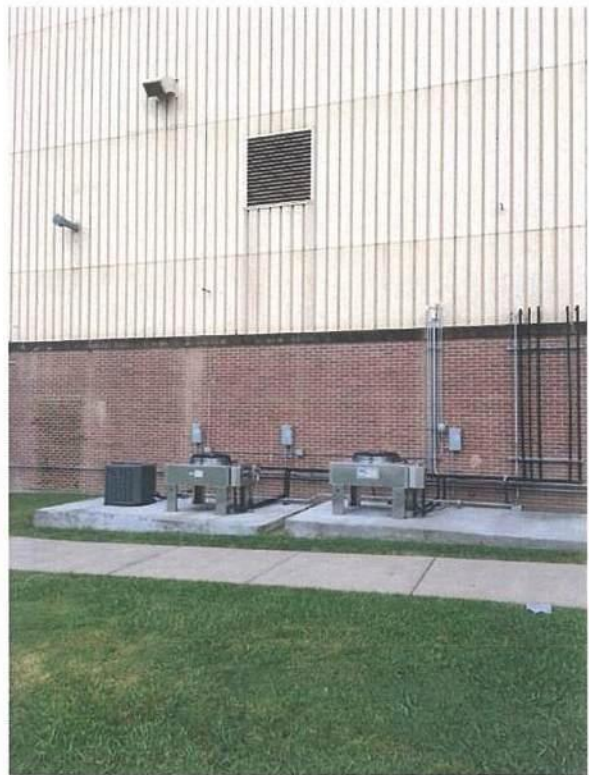
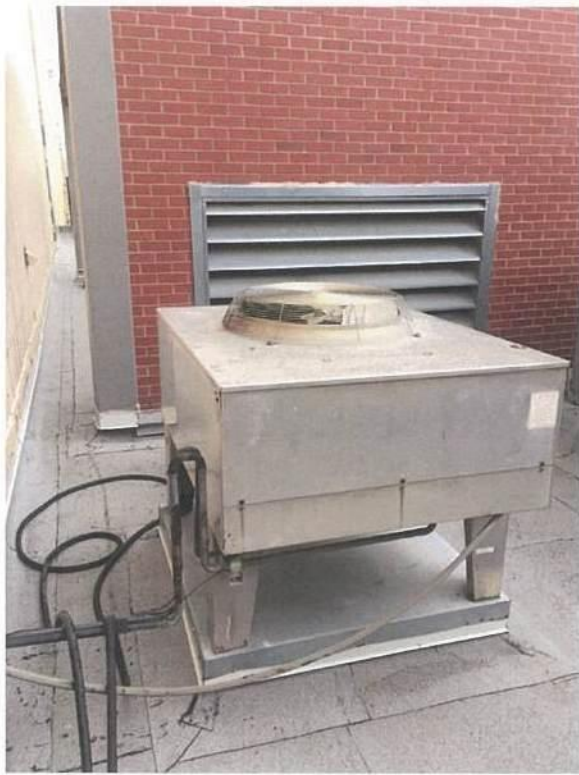
The lobby area was served by several pieces of split-DX type equipment, most of which was brand new (Photos 14, 15). Three out of the four units appeared to be for computer rooms, and the fourth appeared to be a traditional residential-style split system. The brand new equipment was operating at the time of the site visit.

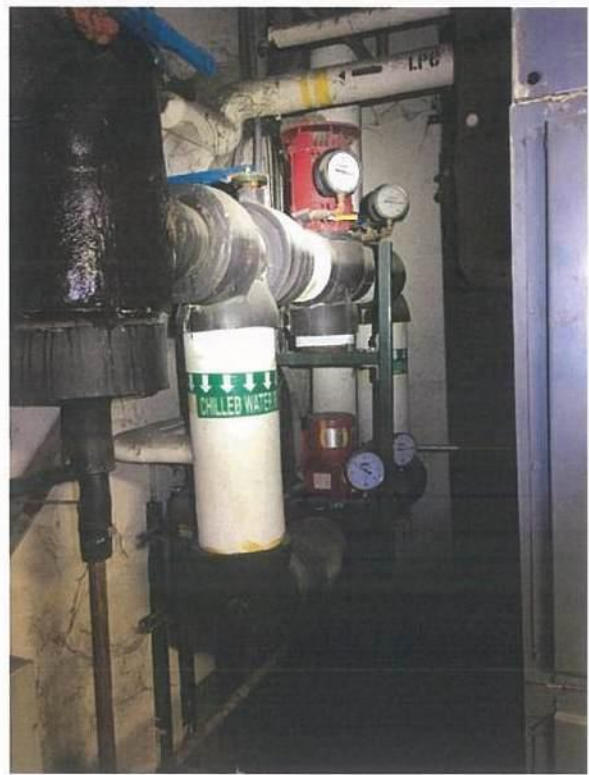
Photo #16

Chilled water for the hydronic AHUs is circulated by two small in-line pumps (Photo 16). They appeared to be 10 or more years old, which is the median service life expectancy of this type of pump. It appeared the pumps had not been touched in some time.

The amount of exterior hydronic piping was minimal but in excellent condition. The interior hydronic piping in the AHU mechanical room was dirty but generally appeared to be in adequate condition. Condensation on the insulation was observed in some areas, primarily near the pumps (Photo 16). This condensation was accompanied by evidence of local corrosion and microbiological growth. It is recommended that the insufficient insulation be repaired and the microbiological growth be removed.

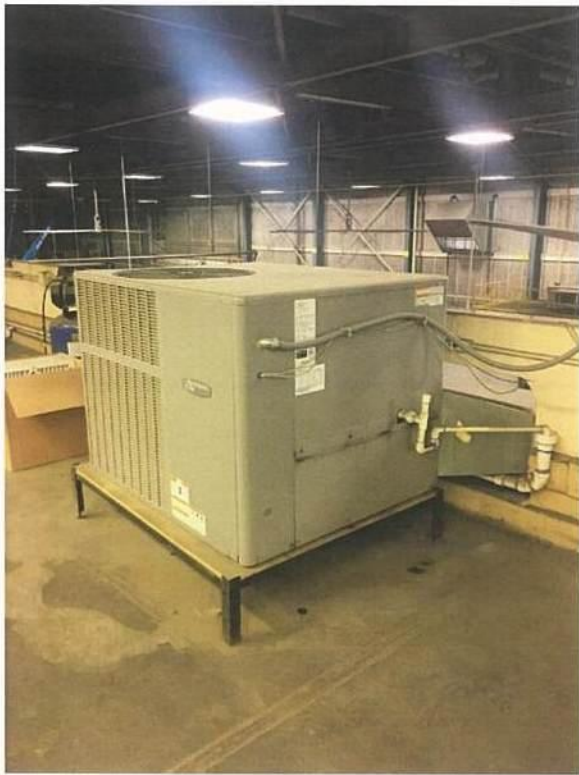
Photo #17

Packaged air conditioners are installed in several locations throughout the mezzanines (Photo 17) and are ducted to the specific spaces they serve. Their ages were unclear and variable, and a brand new unit was observed to be stored and ready for potential installation. Navistar staff indicated that the new packaged unit was being added because the current units were not sufficient to meet their needs.

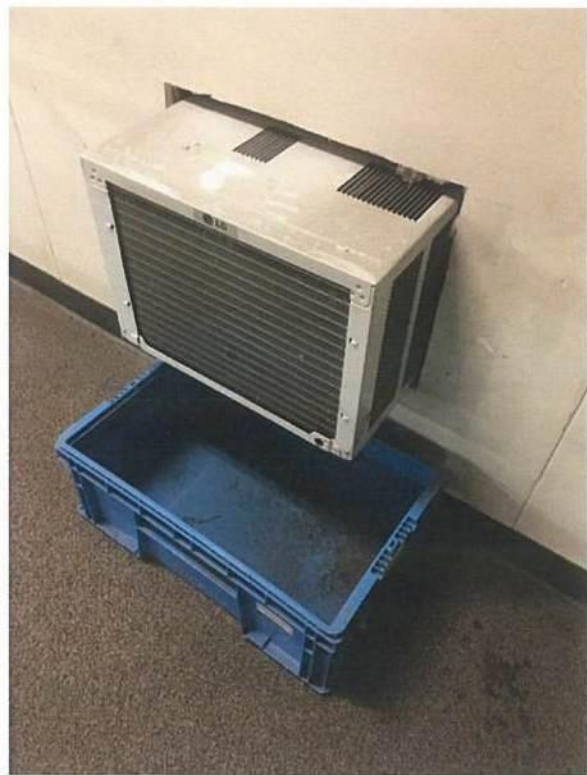
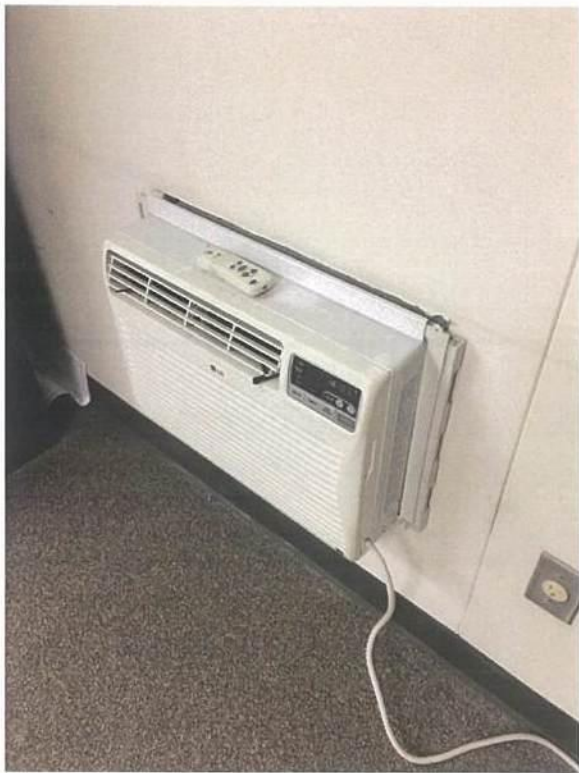
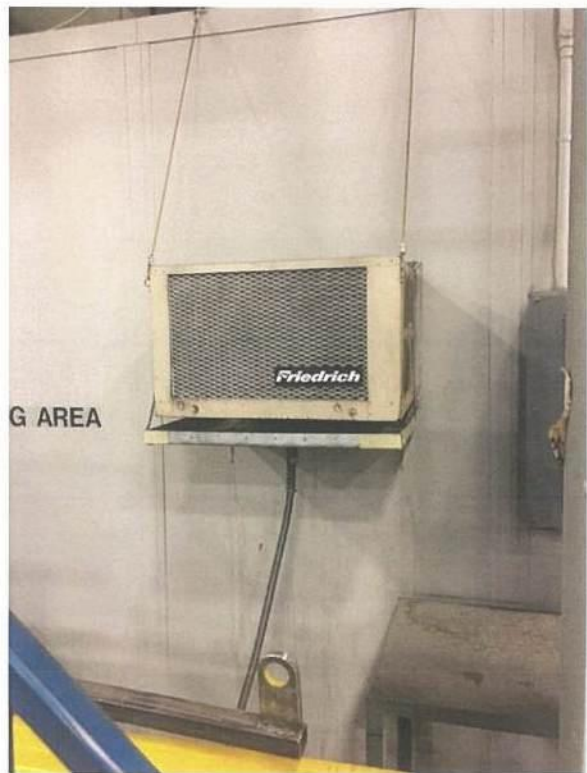
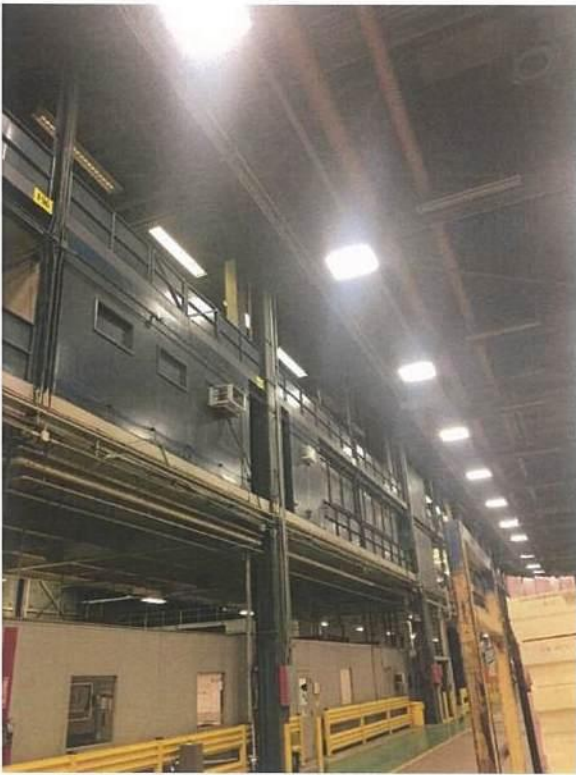
The mezzanines were dotted with dozens of residential style window units (Photos 18, 19, 20, 21) ranging from brand new to decades-old. It is unclear how many units were still in operation. Because these units are relatively expensive to repair, it is recommended simply to replace them as they break.

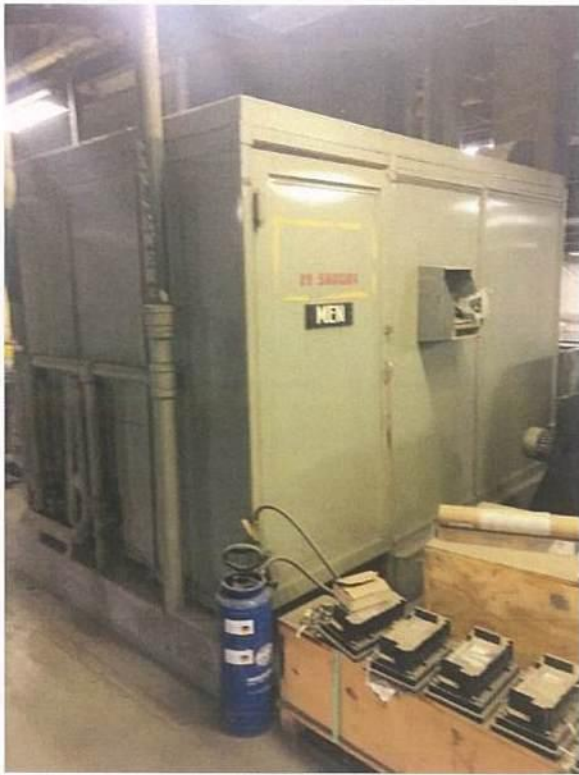
Photo #36

Abandoned plumbing fixtures were observed in some mezzanine areas (Photos 36, 37). It is unclear to what extent these are operable or how dry-trap issues are currently prevented in these areas.

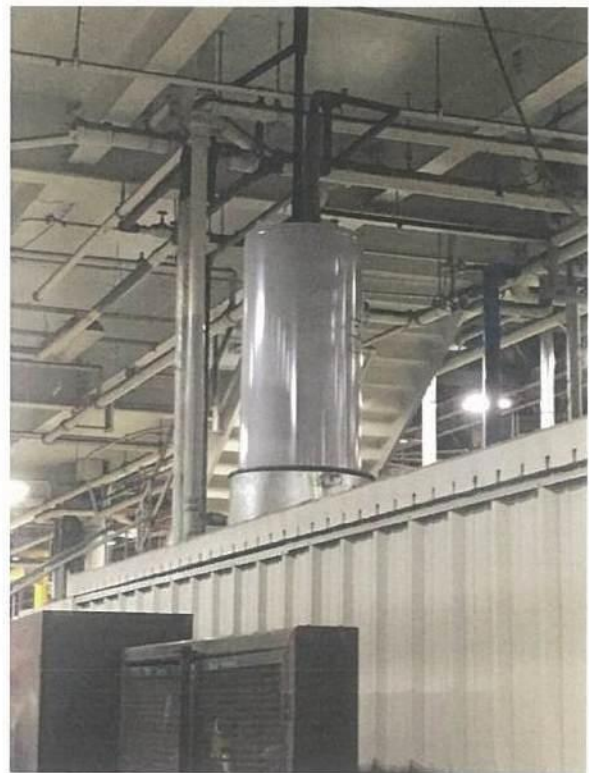
Photo #39

Electric tank-type water heaters (Photos 39, and 40) were observed to serve the first floor mezzanine restrooms and wash areas. They appeared to vary in age from brand new to 15 years, which is near or greater than the median life expectancy of this type of water heater.

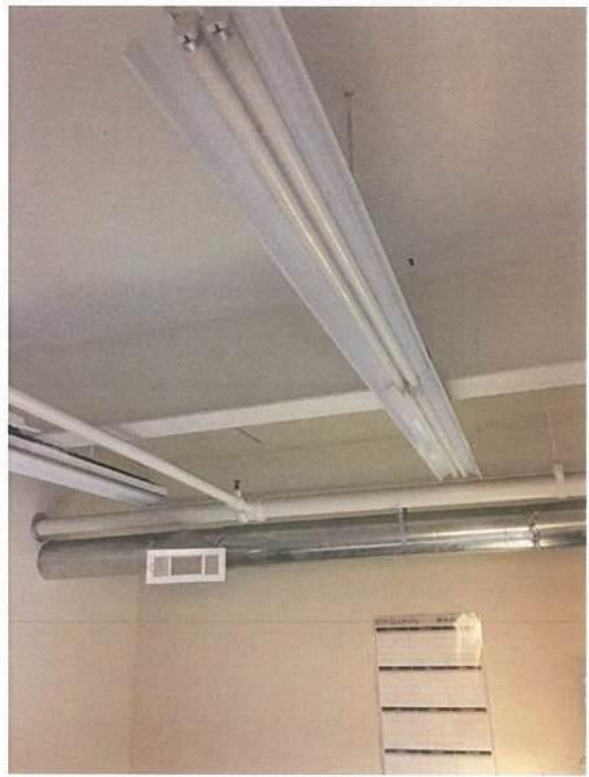
Photo #41

Ductwork was observed to be in various states of age depending on the location in the building. The southern end of the space includes ductwork original to the building (Photo 41) and its insulation appears to be in poor condition. It is not clear if this ductwork is in service. Unless it is in service, it is recommended that this ductwork remain undisturbed. The more northern areas of the facility include progressively new ductwork. In occupied mezzanine areas, uninsulated round duct has been added in an attempt to get more airflow into individual offices (Photo 42). Navistar staff indicated that this was insufficient and comfort conditions are not consistently maintained.

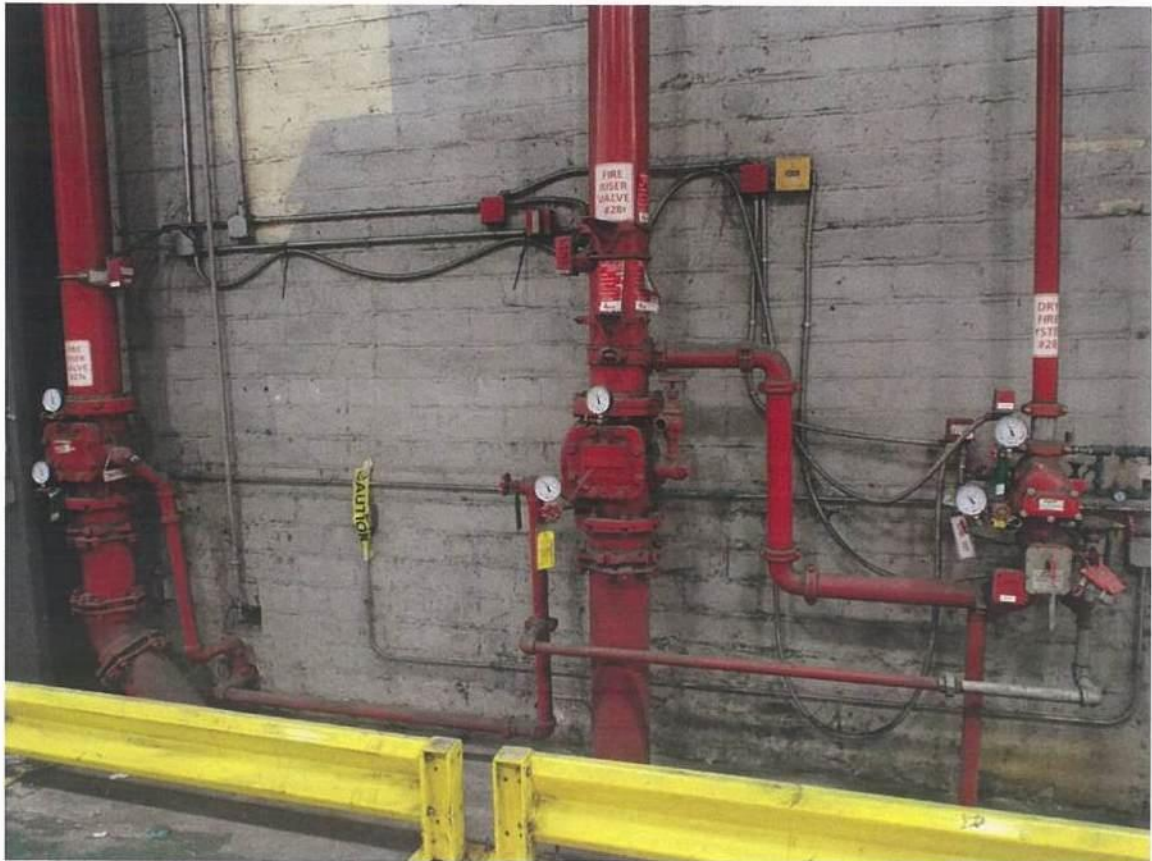
1. The fire suppression risers appear to be original.

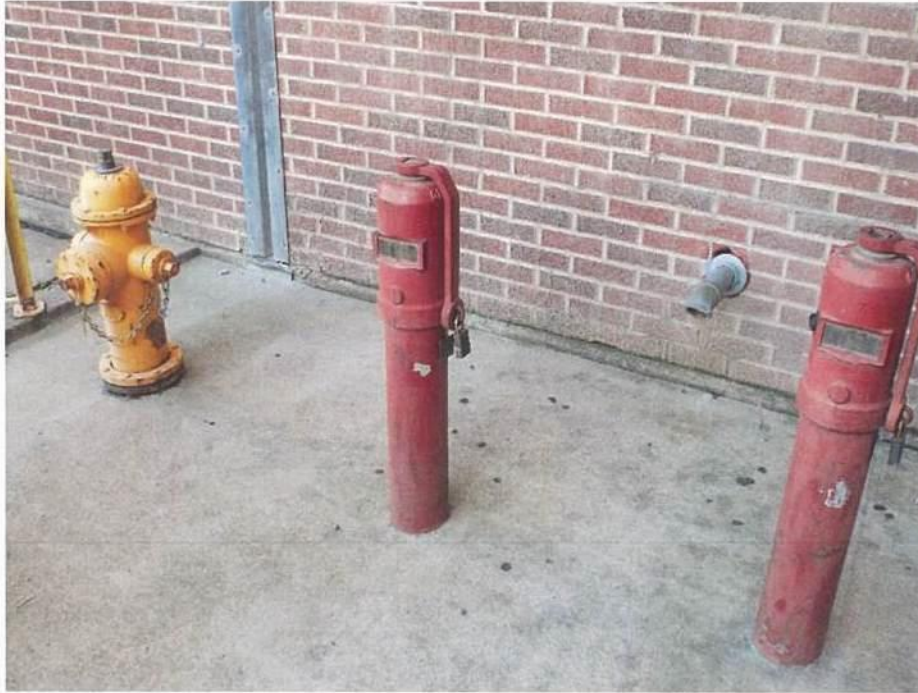
2. The shut off valves are post indicating valves located outside.

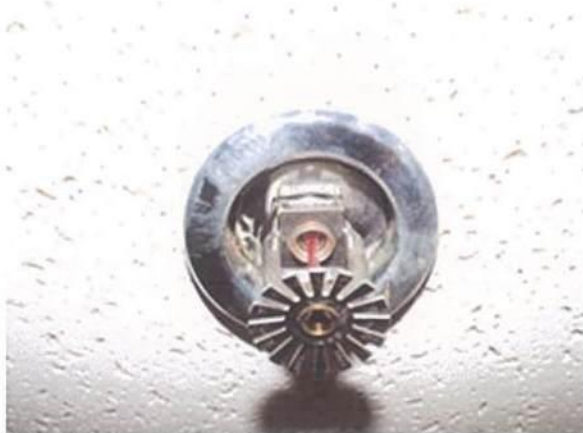
1. Sprinklers will need to be recertified or replaced by the time they are 50 years old.
2. The original 1940's sprinklers have been replaced with more recent 1988 and 2007 sprinklers.

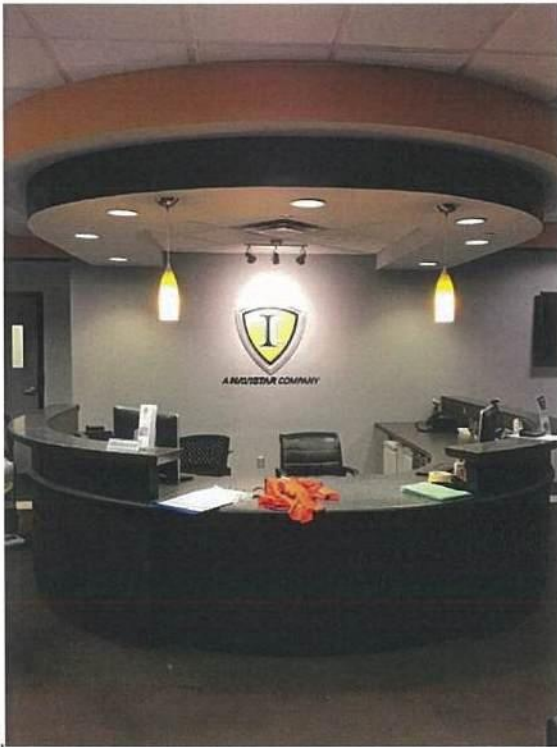
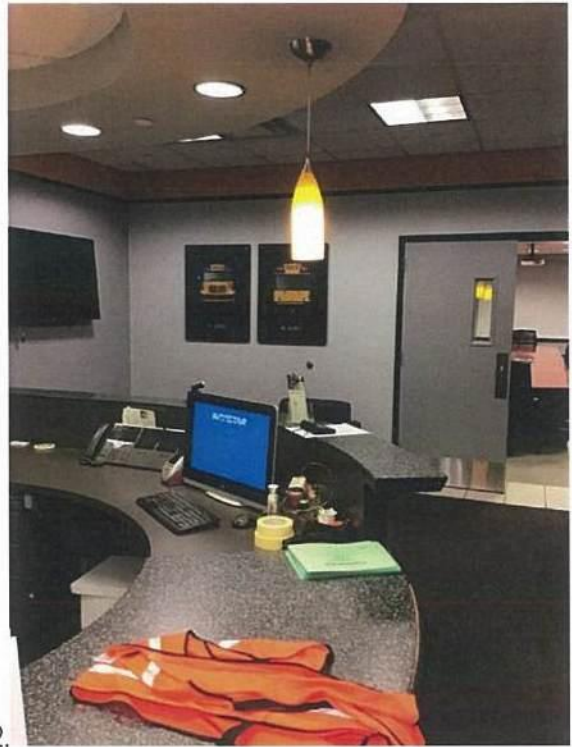
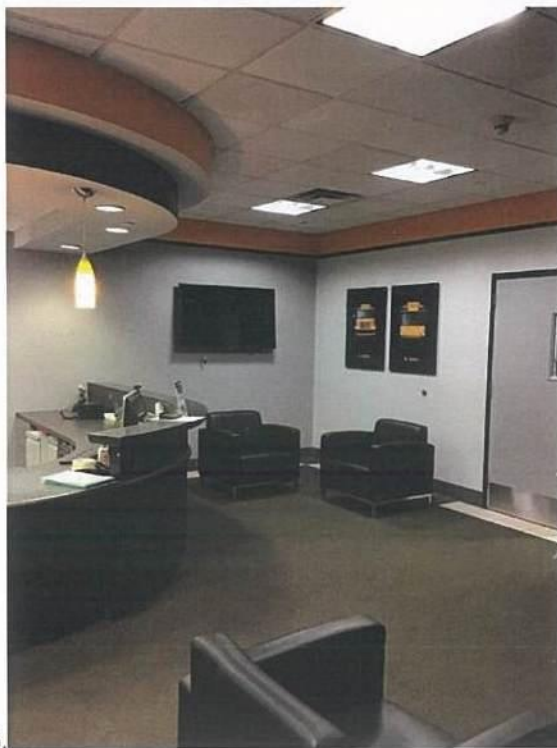
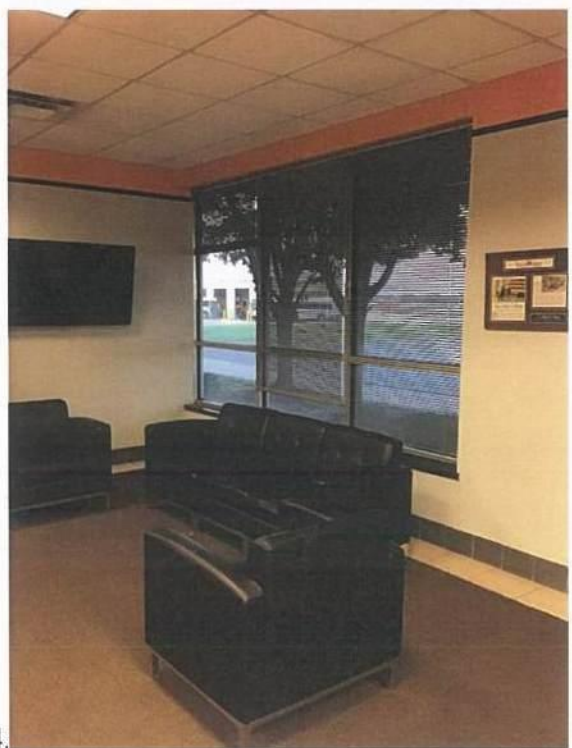
Reception Area

Carpet is worn and painted walls are in good shape. Logo behind desk is outdated. Acoustical ceiling tiles are not sagging and are free from stains, area is well lit. This area has been well maintained for guests, has seating area with viewing area of safety video before entering further into the building or the production floor. See pictures 1-4.
