# Building / Site Assessment Report

AFP3 Buildings 001, 002, 118 and 119  
Spirit Aerosystems and Navistar Tenant Space  
3330 N Mingo Rd  
Tulsa, OK 74116

Engineering Services Department  
Project No. 170045.2, Amendment No.1

09 / 30 / 2019

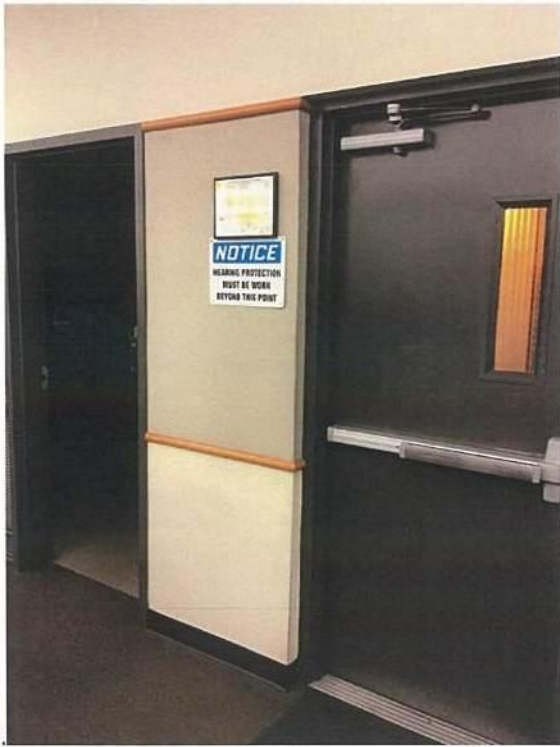
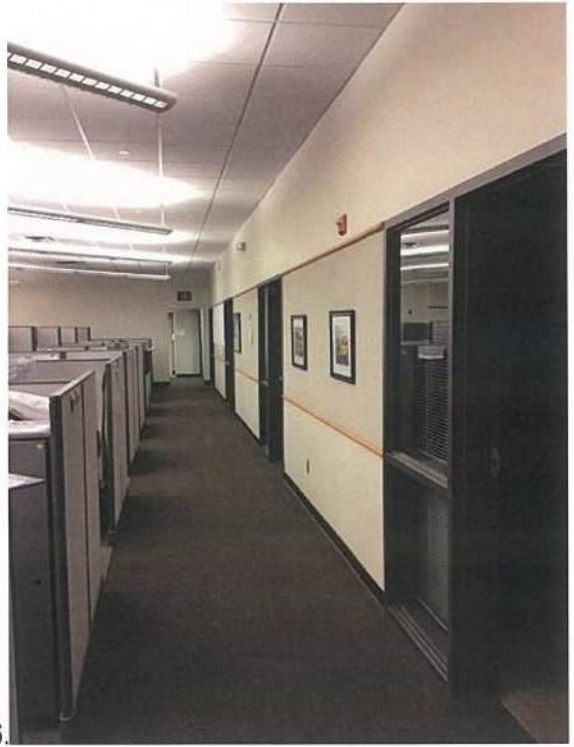
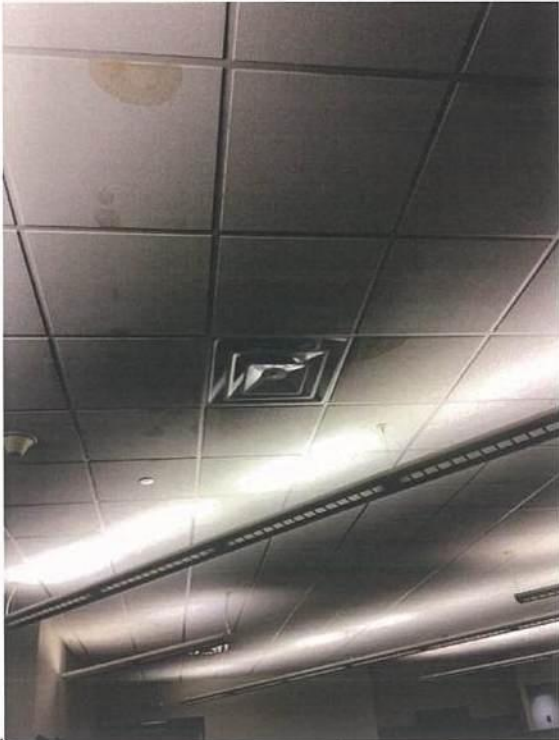
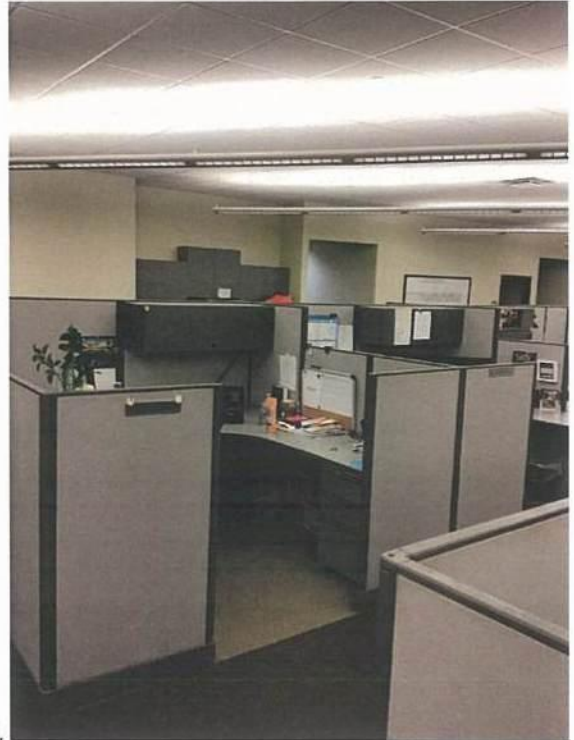
Office Area

Carpet is worn and there are different patterns installed depending on the open office space, individual workstations, and conference rooms. Walls are covered with wall covering from handrail height to top of door frame height with wood cap top trim and wood bottom handrail. Conference rooms have wall protection band above handrail height. There are multiple places where acoustical ceiling tiles have stains. The millwork has been maintained. When walking through to reach the production area it felt like the floor was raised to maybe hold electrical wires running underneath, this could not be confirmed by our escort. See pictures 5-14.

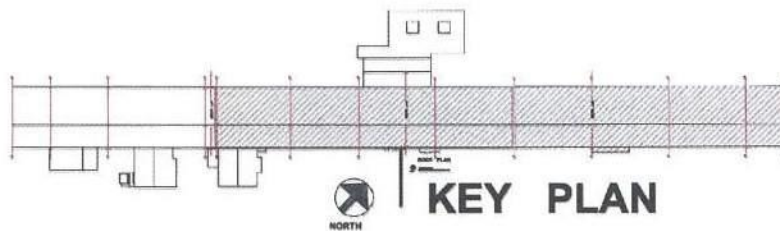
**ROOF KEY PLAN DRAWING**

Because the B001 building is more than 4,000 feet long, we have subdivided the spaces by numbering roof expansion joints at approximately 400 feet on center represented by red lines on the above Key Plan Drawing. The shaded areas from expansion joint #4 to #12 on the above drawing represent the Navistar IC Bus, LLC Plant. Unshaded areas of the Main Building from expansion joint #0 to #4 and 3 smaller areas on the southeast side are occupied by Spirit Aero Systems. The B001 Building has High roofs on the west side and low roofs on the east side separated by an offset wall represented by a black line running the length of the building.

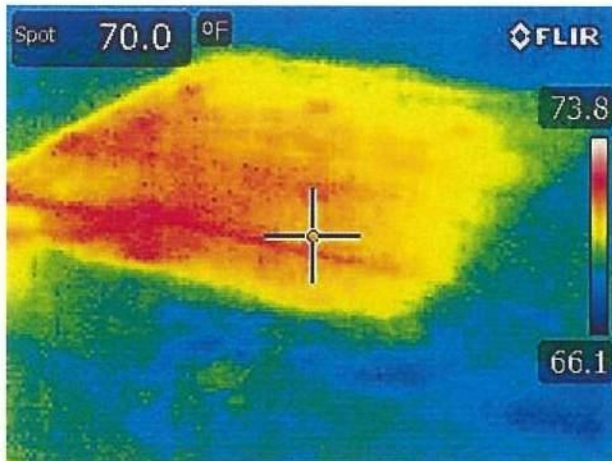
**Photo #00466** Infrared photo of Location #13 in The Lower Roof between expansion joints #5 & 6.

**Recommendation:** Remove and replace roof at areas of entrapped moisture to assist in future leak troubleshooting. It is likely that entrapped moisture in the Modified Bitumen patches that are installed in Upper Roof Gravel Surfaced Valley Areas between roof expansion joints 7 and 10 are caused by moisture migrating from the adjacent Gravel Surfaced Roofs. These Gravel Surfaced Roofs were reported to be the oldest roofs on the building and should be scheduled for replacement.

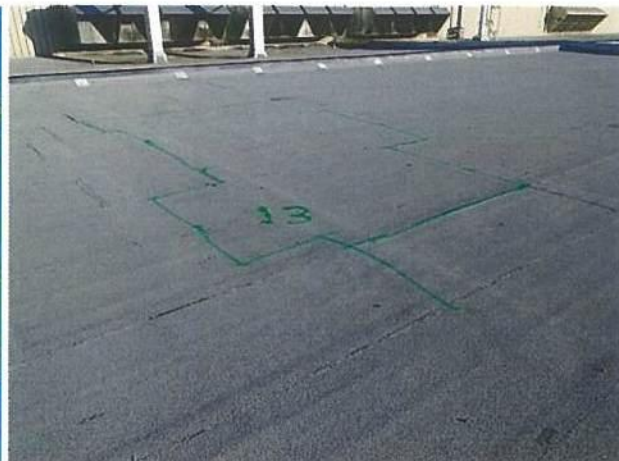
**Photo #9710** Entrapped moisture Location #13. Size 12'x20'.

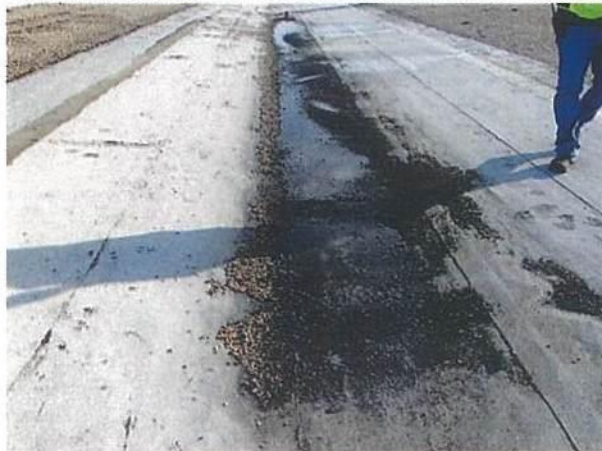
**DETERIORATED ROOFING CAUSED BY PONDING CONDENSATE WATER**

**Photo #9760** Ponding in valley line caused by Condensate allowed to drain on roof.

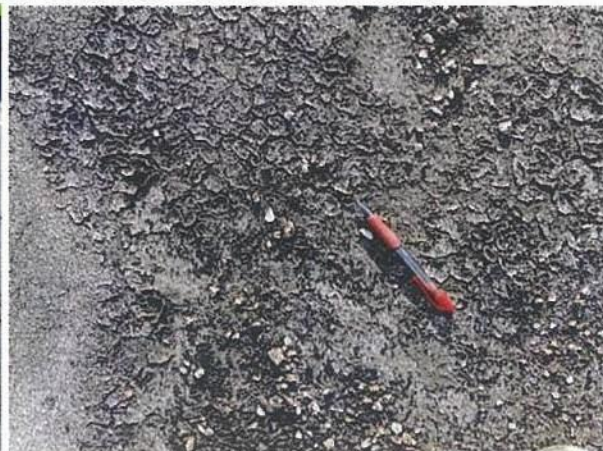
**Photo #9761** Delaminated capsheet due to long term exposure to ponding condensate water.

Long term exposure of the Modified Bitumen capsheet to ponding water and ultraviolet sunlight has caused delamination and cracking of the capsheet surface and premature failure of its weather resistance.

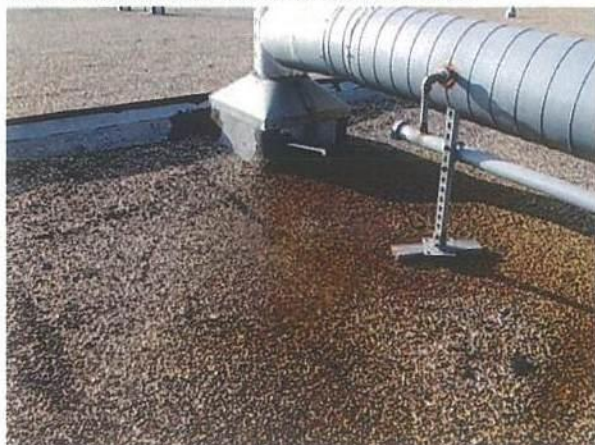
**Photo #9764** Condensate draining on roof.

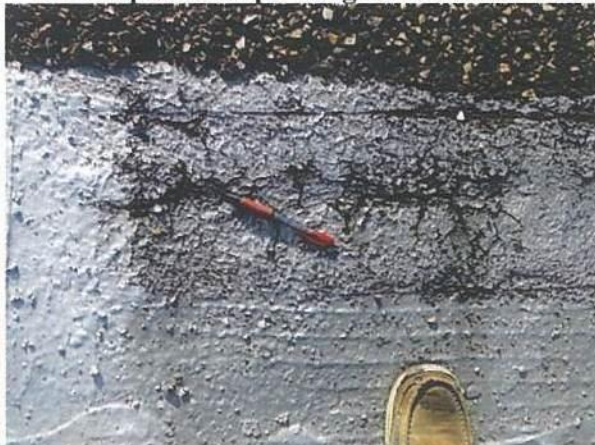
**Photo #9767** Split Built-Up Roof near valley.

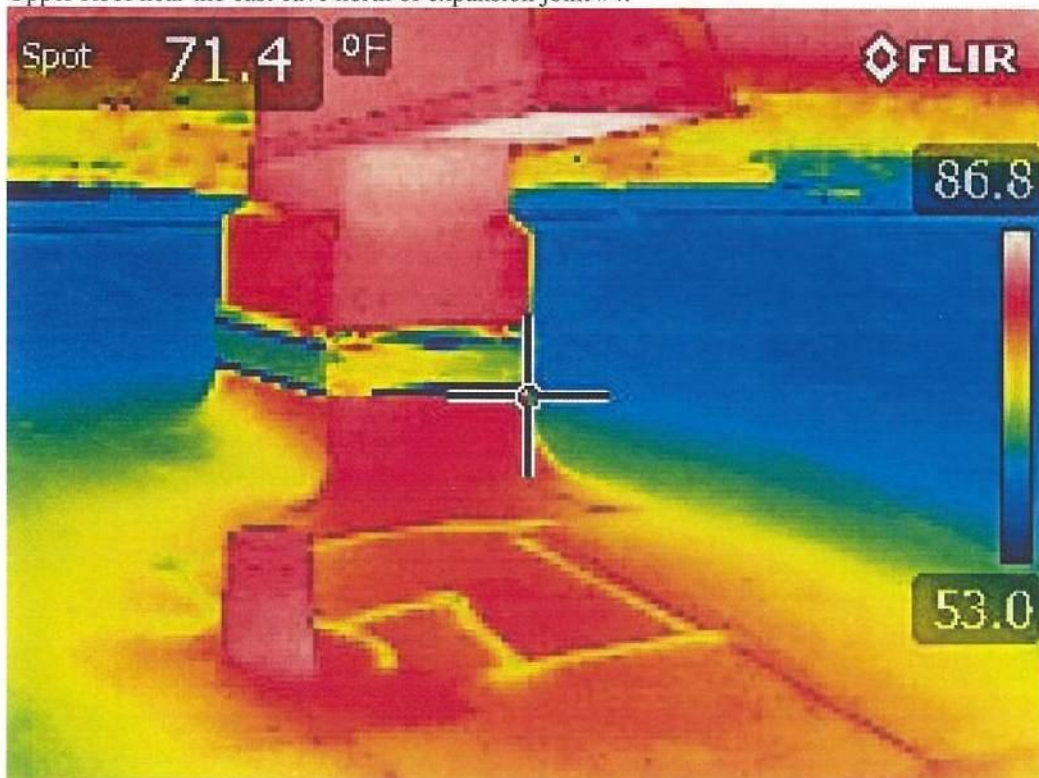
Photo #0462 View of area of entrapped moisture location #11 represented by red shaded area between plumbing vent and exhaust fan curb near the east eave of the Upper roof north of expansion joint #4.

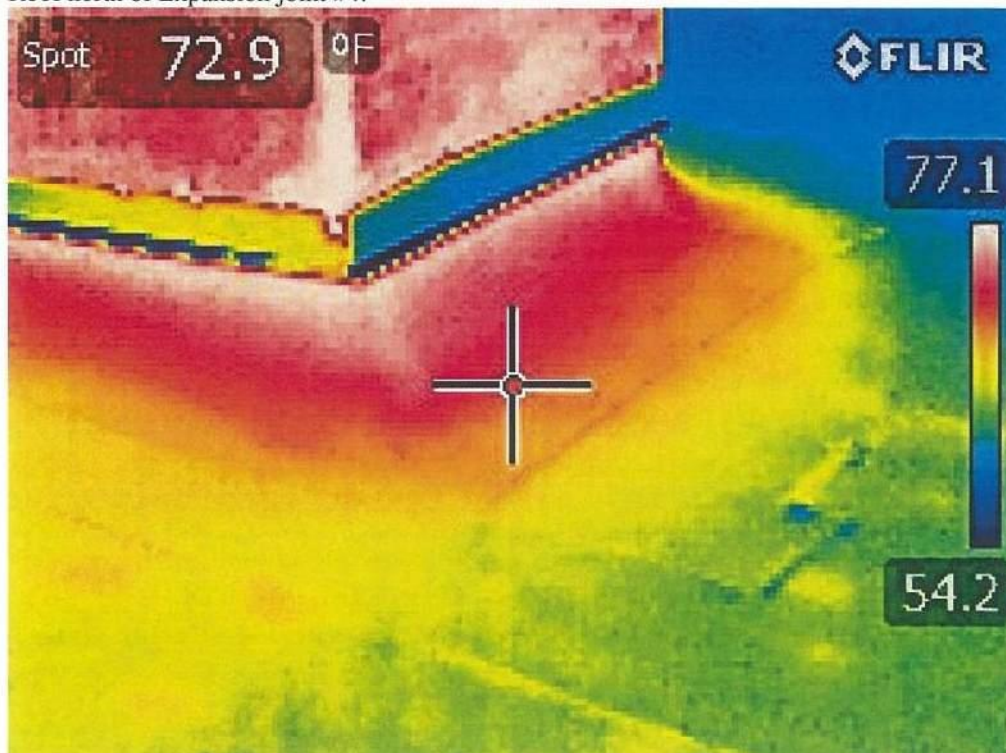
Photo #0464 View of area of entrapped moisture #12 represented by red, orange and yellow shaded area near an abandoned exhaust fan curb near the east eave of the Upper roof north of expansion joint #4.

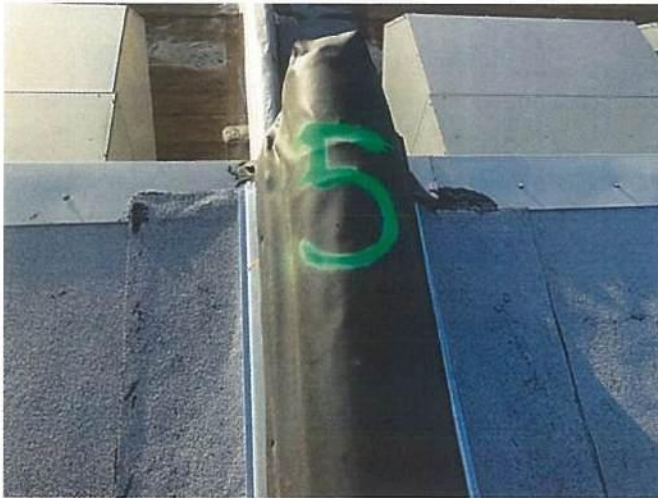
Photo #9703 View of Upper roof expansion joint #5.

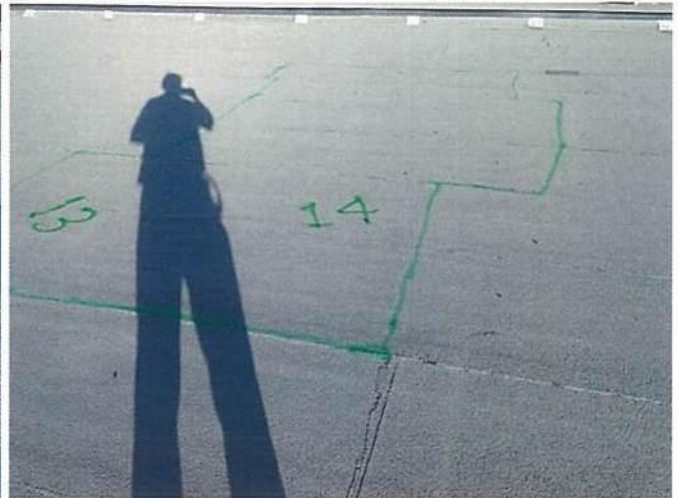
Photo #9711 View of large area of entrapped moisture #14 South of expansion joint #6 at the Lower East roof.

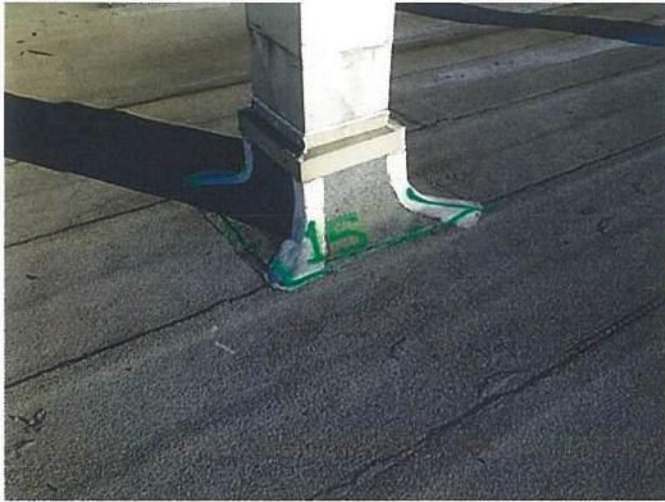
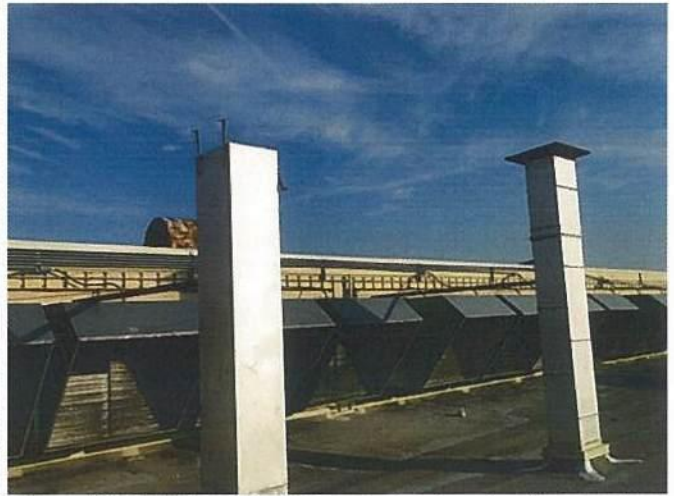
Photo #9712 View of entrapped moisture location #15 at base of a flue stack at the Lower roof south of expansion joint #6. Photo #9725 View of missing weather hood at flue stack at Entrapped moisture location #15.

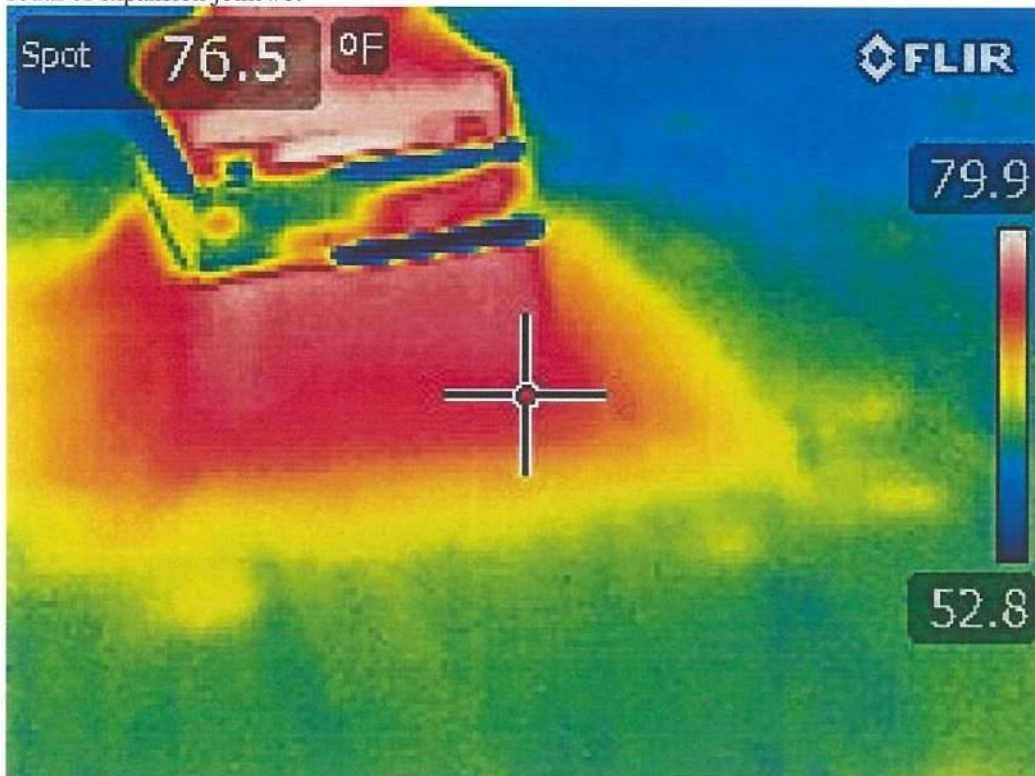
Photo #0474 View of entrapped moisture location #17 represented by red and yellow shaded areas at the base of an exhaust fan curb at the east 1/2 of the Upper Roof area south of expansion joint #6.

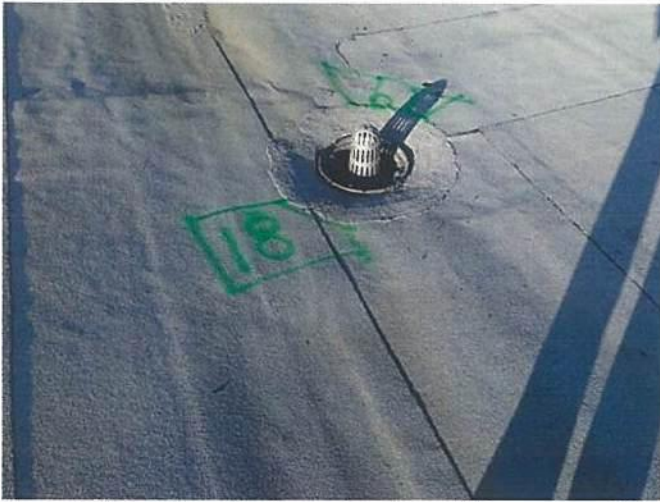
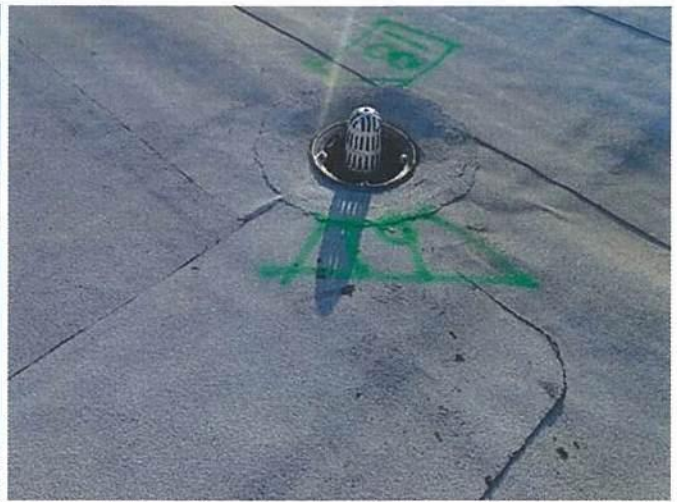
Photo #9704 View of entrapped moisture #18 near a roof drain Near the north side of the Upper Roof expansion joint #5. Photo #9705 View of entrapped moisture #19 at roof drain Near the north side of the Upper Roof expansion joint #5.

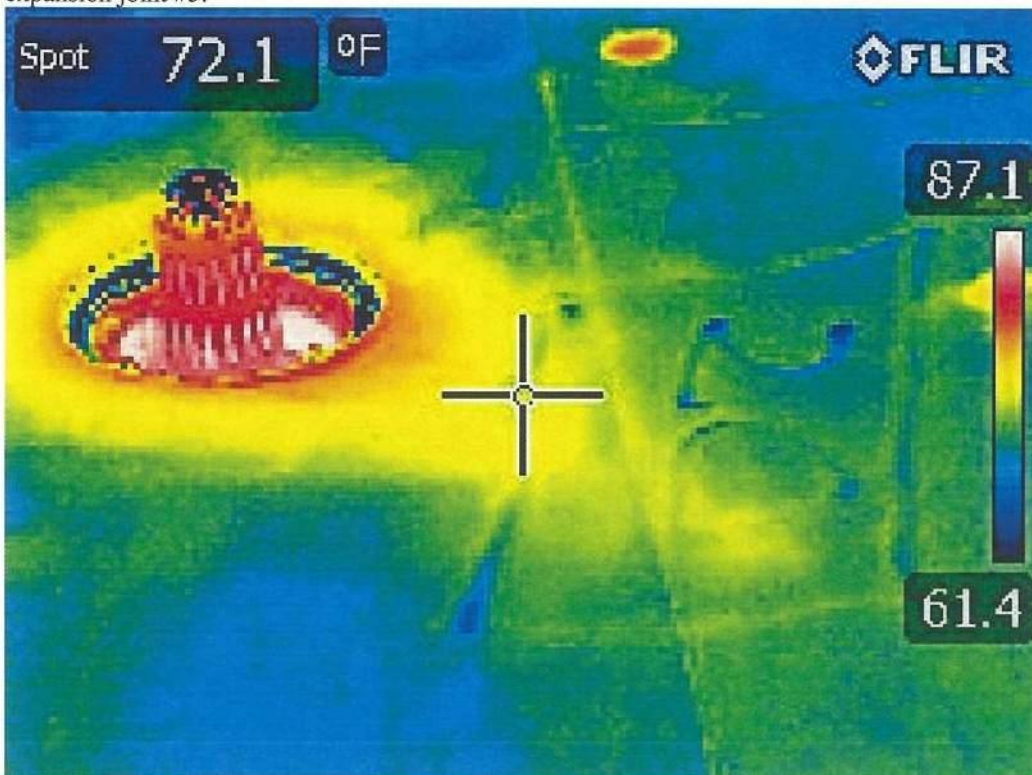
Photo #0478 View of entrapped moisture location #20 represented by yellow shaded area near the rim of a roof drain at the west valley of the Upper Roof area north of expansion joint #5.

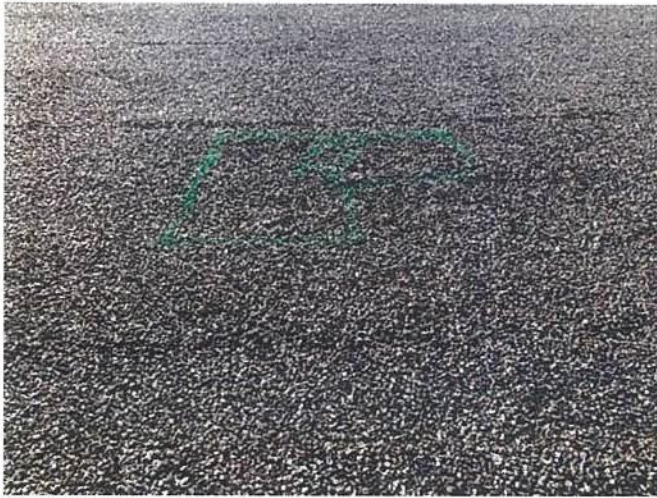
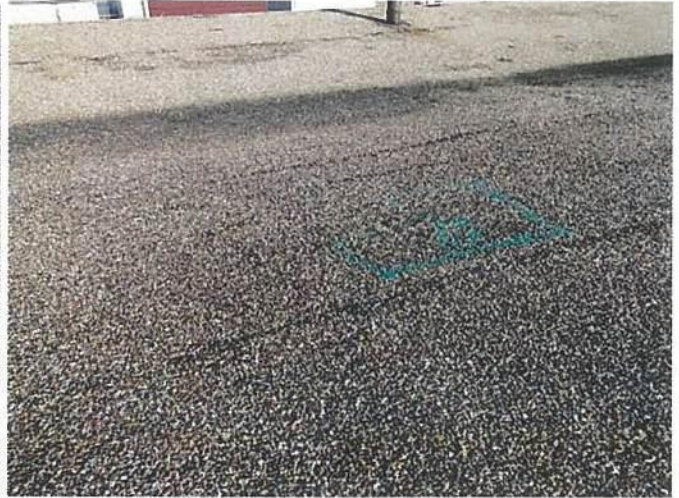
Photo #9715 View of entrapped moisture location #22 at the gravel surfaced built up roof area at the Upper roof north of expansion joint #6. Photo #9737 Entrapped moisture location #22

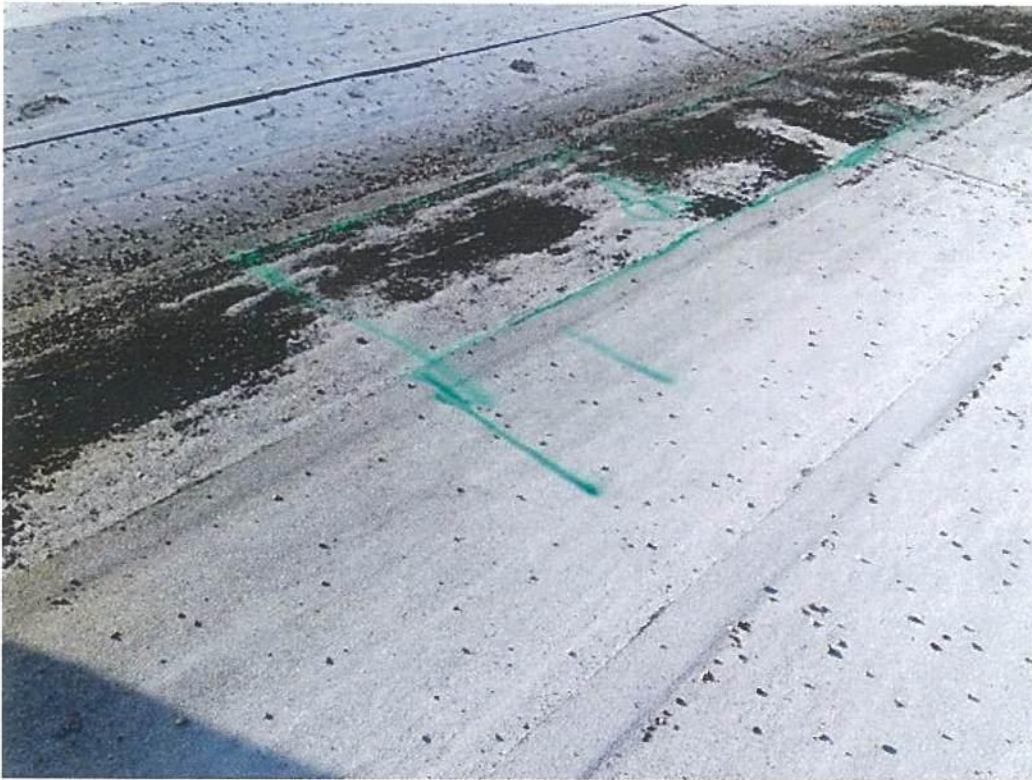
Photo #9749 View of entrapped moisture location #28 at the mineral surfaced modified bitumen roof patch at the east valley line of the Upper Roof south of expansion joint #8.

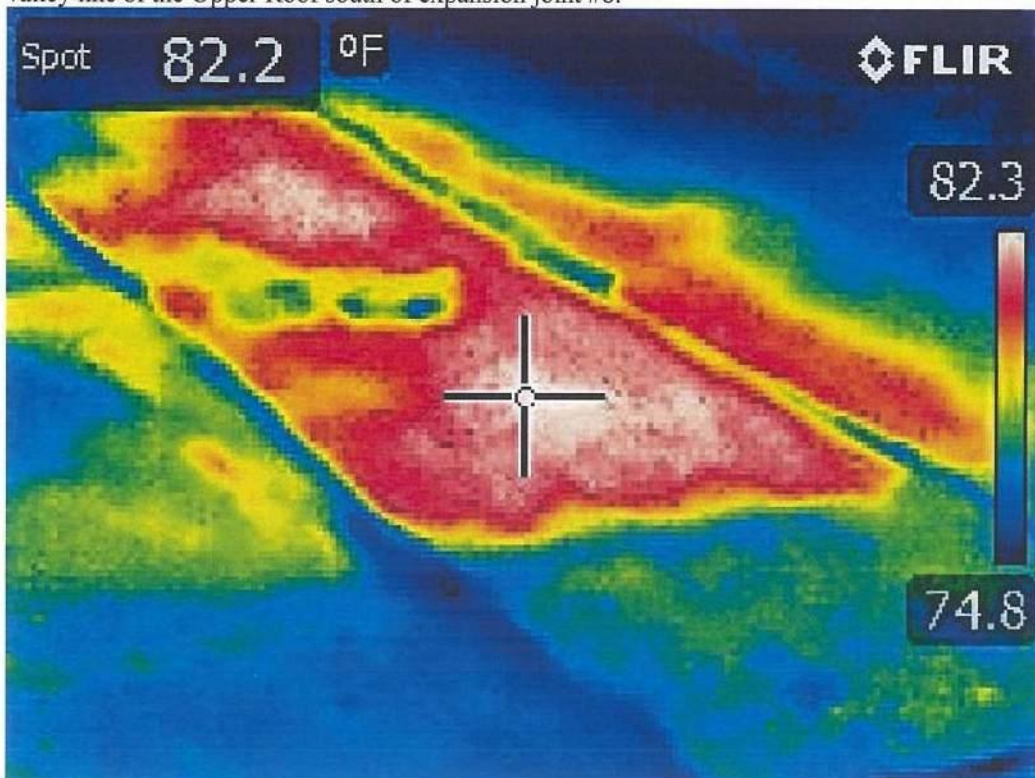
Photo #0492 View of entrapped moisture location #28 represented by red and yellow shaded areas at the mineral surfaced modified bitumen roof patch at the east valley south of expansion joint #8 at the Upper Roof.

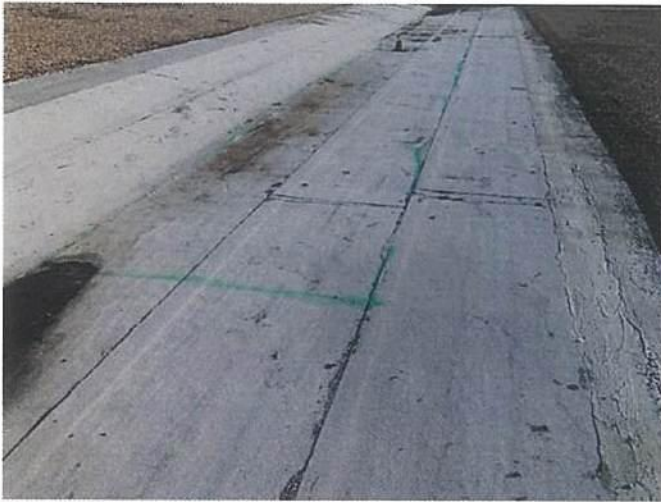
Photo #9746 View of entrapped moisture location #33 at the mineral surfaced modified bitumen roof patch at the west valley line of the Upper Roof south of expansion joint #8.

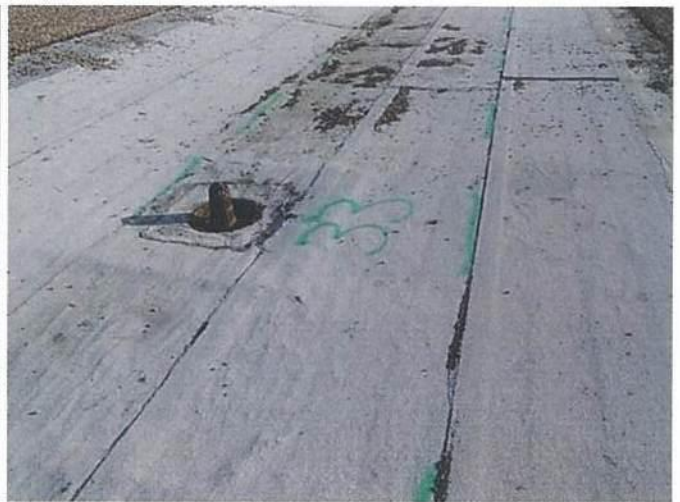
Photo #9747 View of entrapped moisture location #33 at the mineral surfaced modified bitumen roof patch at the west valley line of the Upper Roof south of expansion joint #8

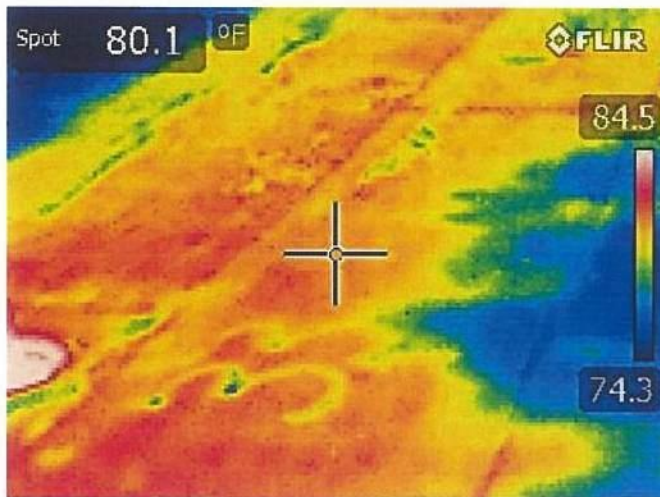
Photo #0506 View of entrapped moisture location #33, represented by red and yellow shaded areas at the mineral surfaced modified bitumen roof patch at the west valley south of expansion joint #8 at the Upper Roof.

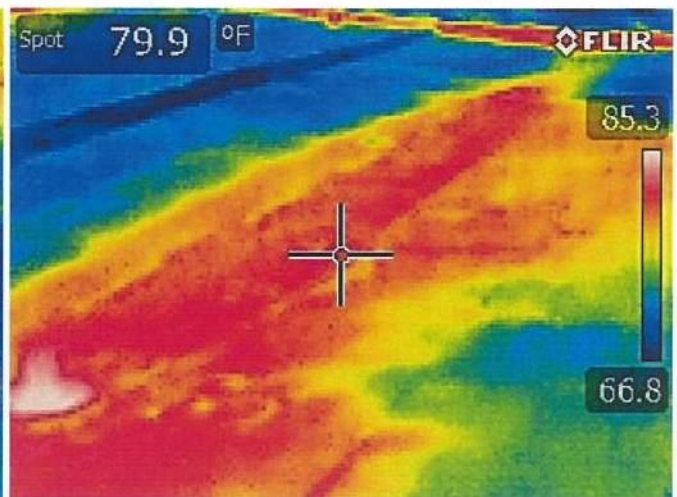
Photo #0508 View of entrapped moisture location #33 represented by red and yellow shaded areas at the mineral surfaced modified bitumen roof patch at the west valley south of expansion joint #8 at the Upper Roof.

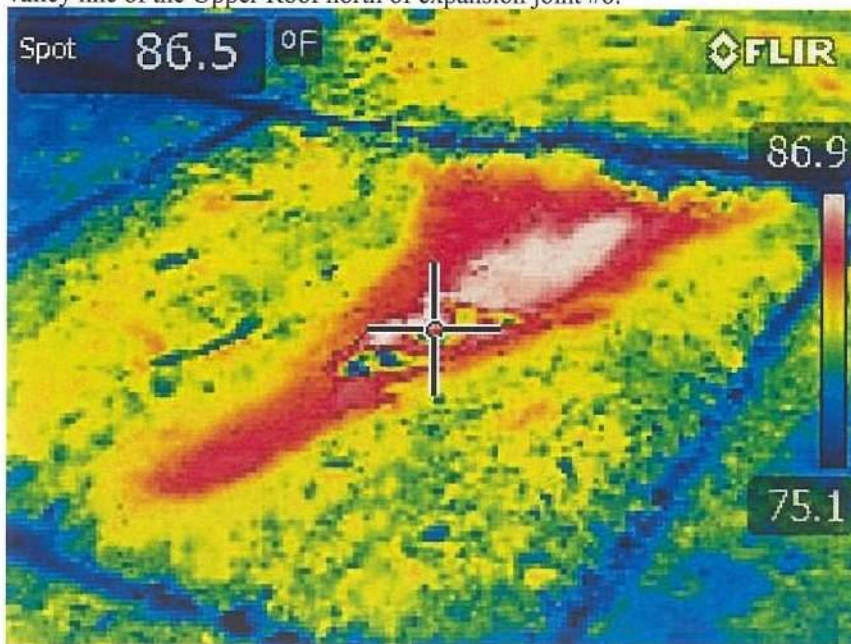
Photo #0510 View of entrapped moisture location #34 represented by red and yellow shaded areas at the mineral surfaced modified bitumen roof patch at the east valley north of expansion joint #8 at the Upper Roof.

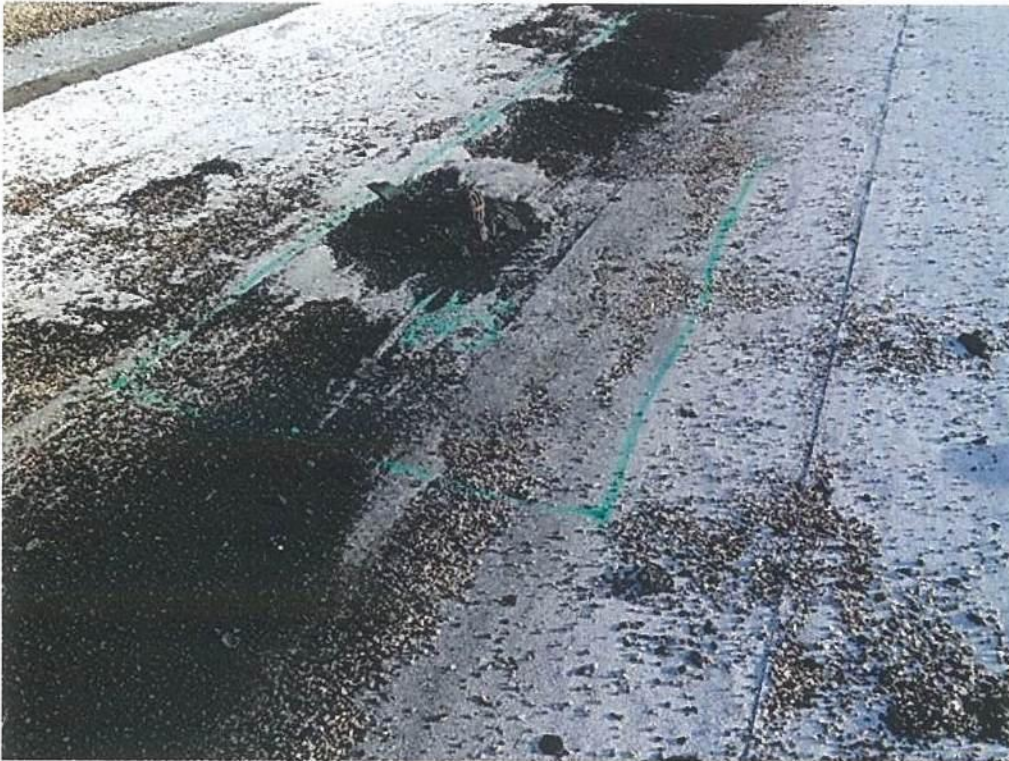
Photo #9751 View of entrapped moisture location #35 at the mineral surfaced modified bitumen roof patch at the east valley line of the Upper Roof north of expansion joint #8.

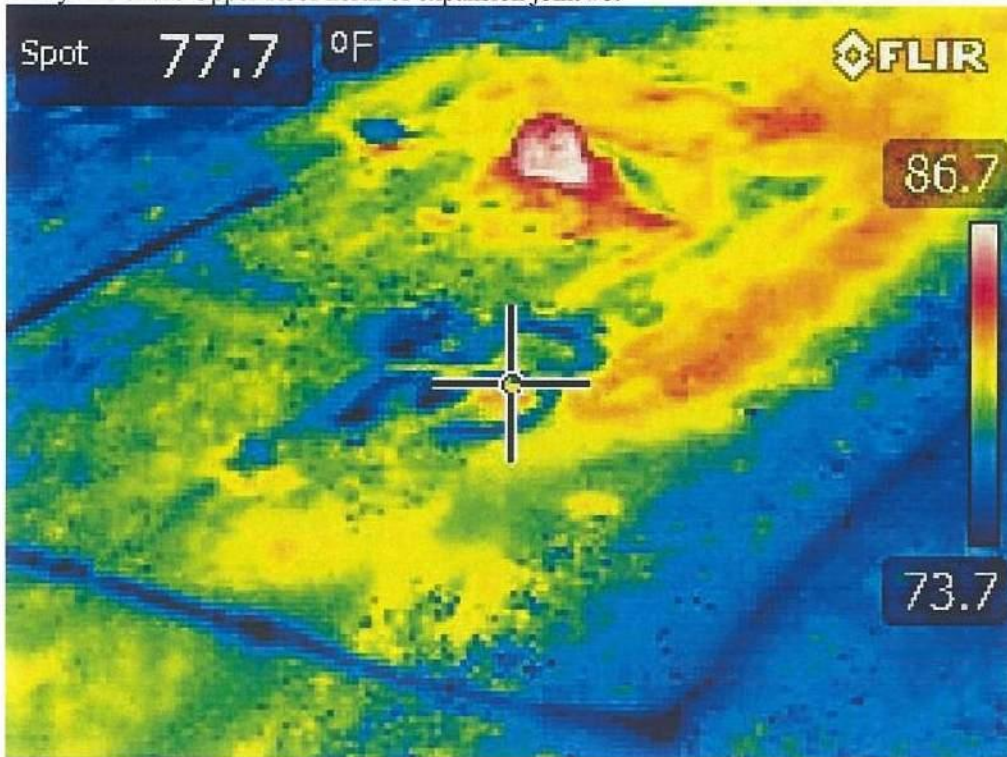
Photo #0512 View of entrapped moisture location #35 represented by red and yellow shaded areas at the mineral surfaced modified bitumen roof patch at the east valley north of expansion joint #8 at the Upper Roof.

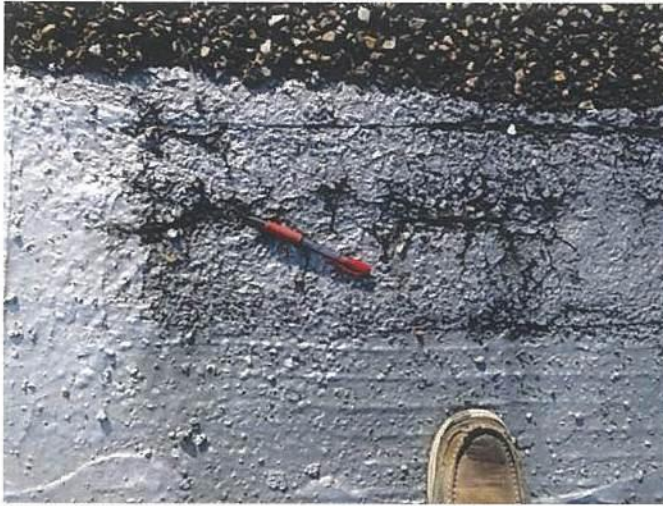
Photo #9767 View of split and deteriorated built-up roof membrane near area of entrapped moisture location #42.

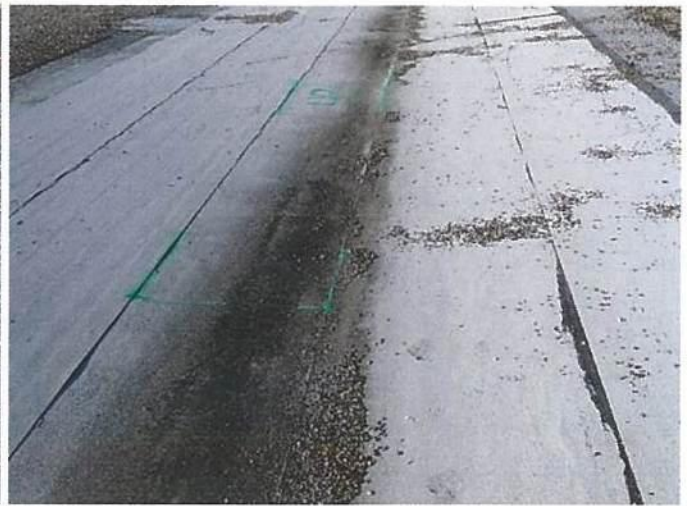
Photo #9765 View of entrapped moisture location #42 in the west valley at the Upper Roof north of expansion joint 8.

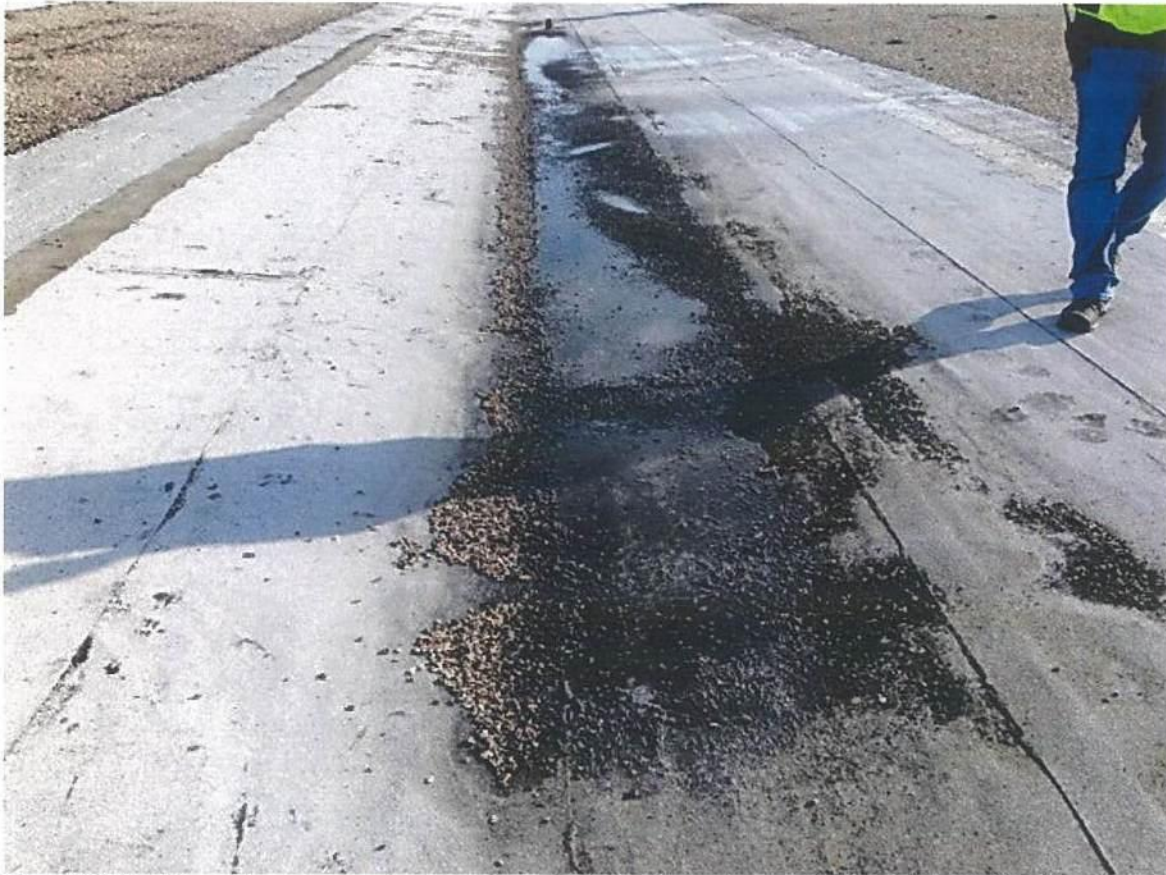
Photo #9760 View of ponding condensate water which has drained across the roof and ponding in valley near location #41 & 42 at the mineral surfaced modified bitumen roof patch at the west valley line of the Upper Roof north of expansion joint #9.

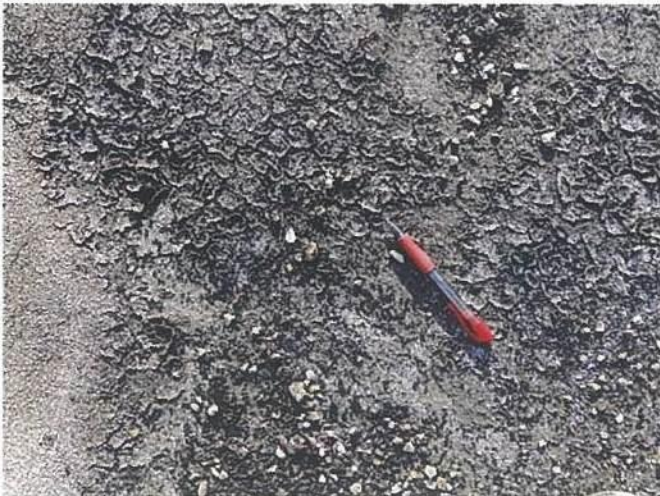
Photo #9761 View of delaminated mineral surfaced modified bitumen roof patch at the west valley north of expansion joint #8 at the Upper Roof due to long time exposure to ponding water.

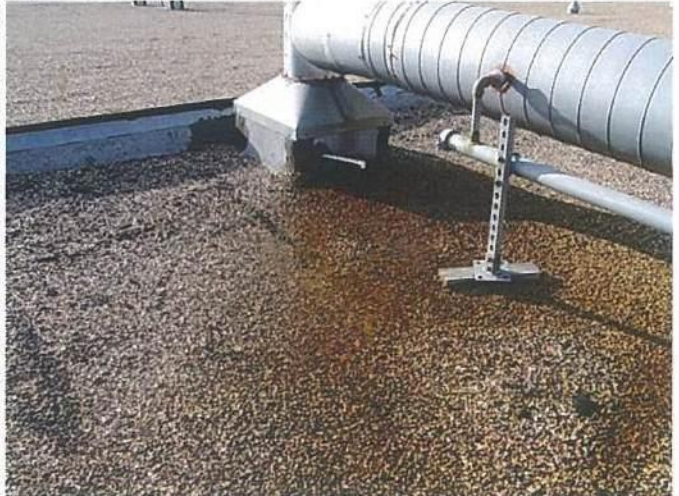
Photo #9764 Condensate water piped through curb at Duct roof penetration. Water drains across the roof causing roof membrane rotting and leaks at location #41.

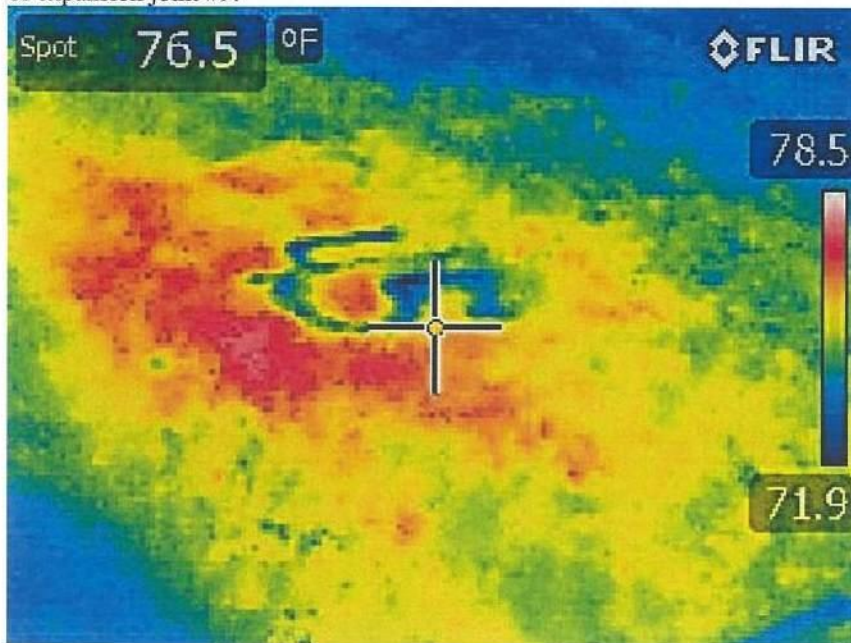
Photo #0532 View of entrapped moisture location #45 in the east valley at the Upper Roof north of expansion joint 9.

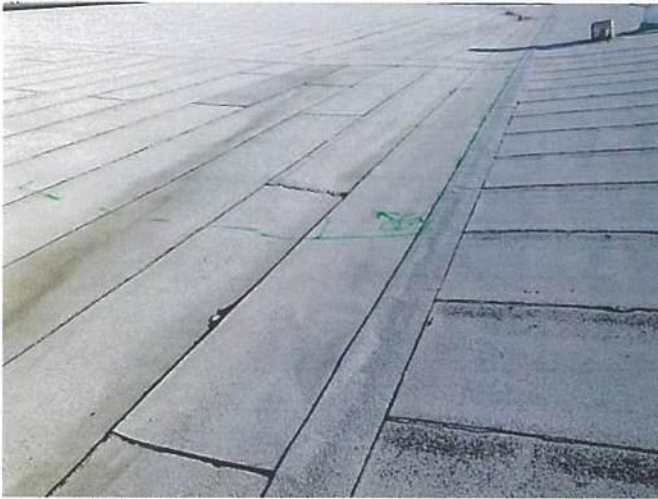
Photo #9772 View of entrapped moisture location #50 at the Upper Roof near the east valley north of expansion joint #11.

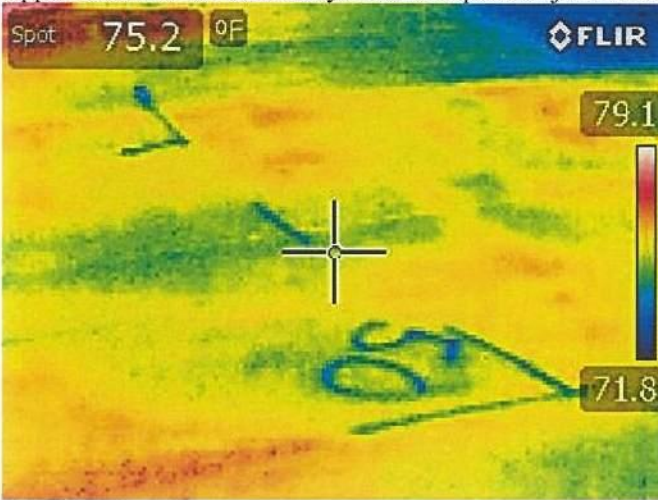
Photo #0546 View of entrapped moisture location #50 at the Upper Roof near the east valley north of expansion joint #11.

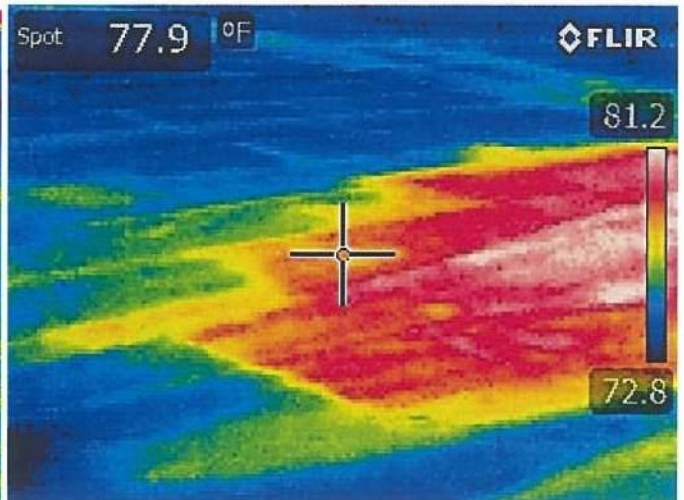
Photo #0554 View of entrapped moisture location #50 at the Upper Roof near the east valley north of expansion joint #11.

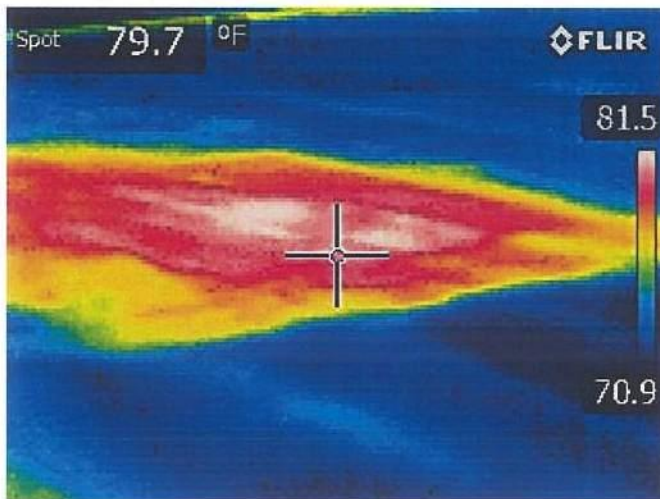
Photo #0556 View of entrapped moisture location #50 at the Upper Roof near the east valley north of expansion joint #11.

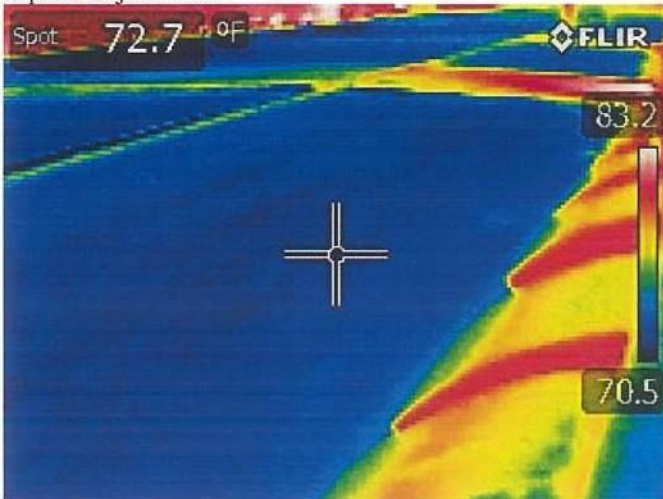
Photo #0542 View of the Lower Roof as seen from the Upper Roof. Exhaust fan hoods in offset wall beneath the Upper Roof Retain heat, but the Lower Roof north of expansion joint is cool.

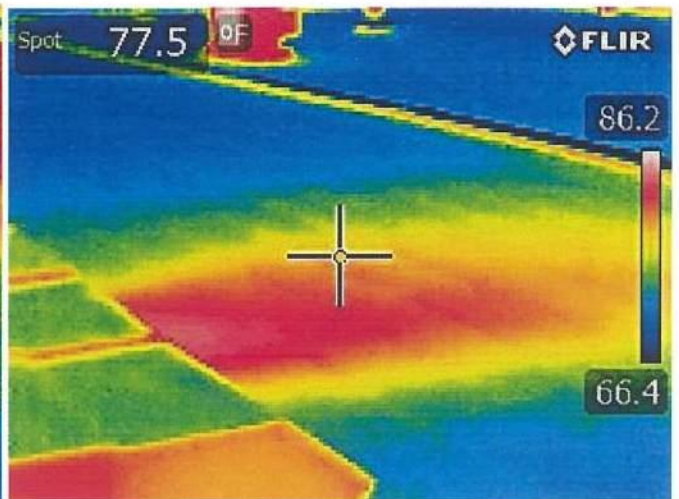
Photo #0544 View of heat from air blown out of exhaust fans in the offset wall at the Lower Roof north of expansion joint 10 as seen from the east eave of the Upper Roof.
