23-908 108 N. Trenton Ave. Environmental Cleanup

With this Competitive Sealed Proposal (CSP) request, we are searching to secure services to remove, transport, enclose, and properly dispose regulated asbestos containing materials (RACM), lead-based paint, and potential low level radioactive materials from the city-owned Auction Site Building No.104 at 108 North Trenton, Tulsa, OK.

Building 104 at 108 North Trenton was constructed in the 1920's to serve as the headquarters for Dresser-Rand Corporation, a supplier of oil and gas drilling equipment. The facility is adjacent to the BNSF railroad mainline and in a historically live-work neighborhood. In 1993 the property was transferred to the City of Tulsa and used as overflow equipment and file storage associated with the city's Auction Site. 108 North Trenton Avenue is comprised of one 15,200 square foot (sf) two-story building with basement which is part of a larger 2.95-acre parcel of land that is used as the Tulsa Auction Site.

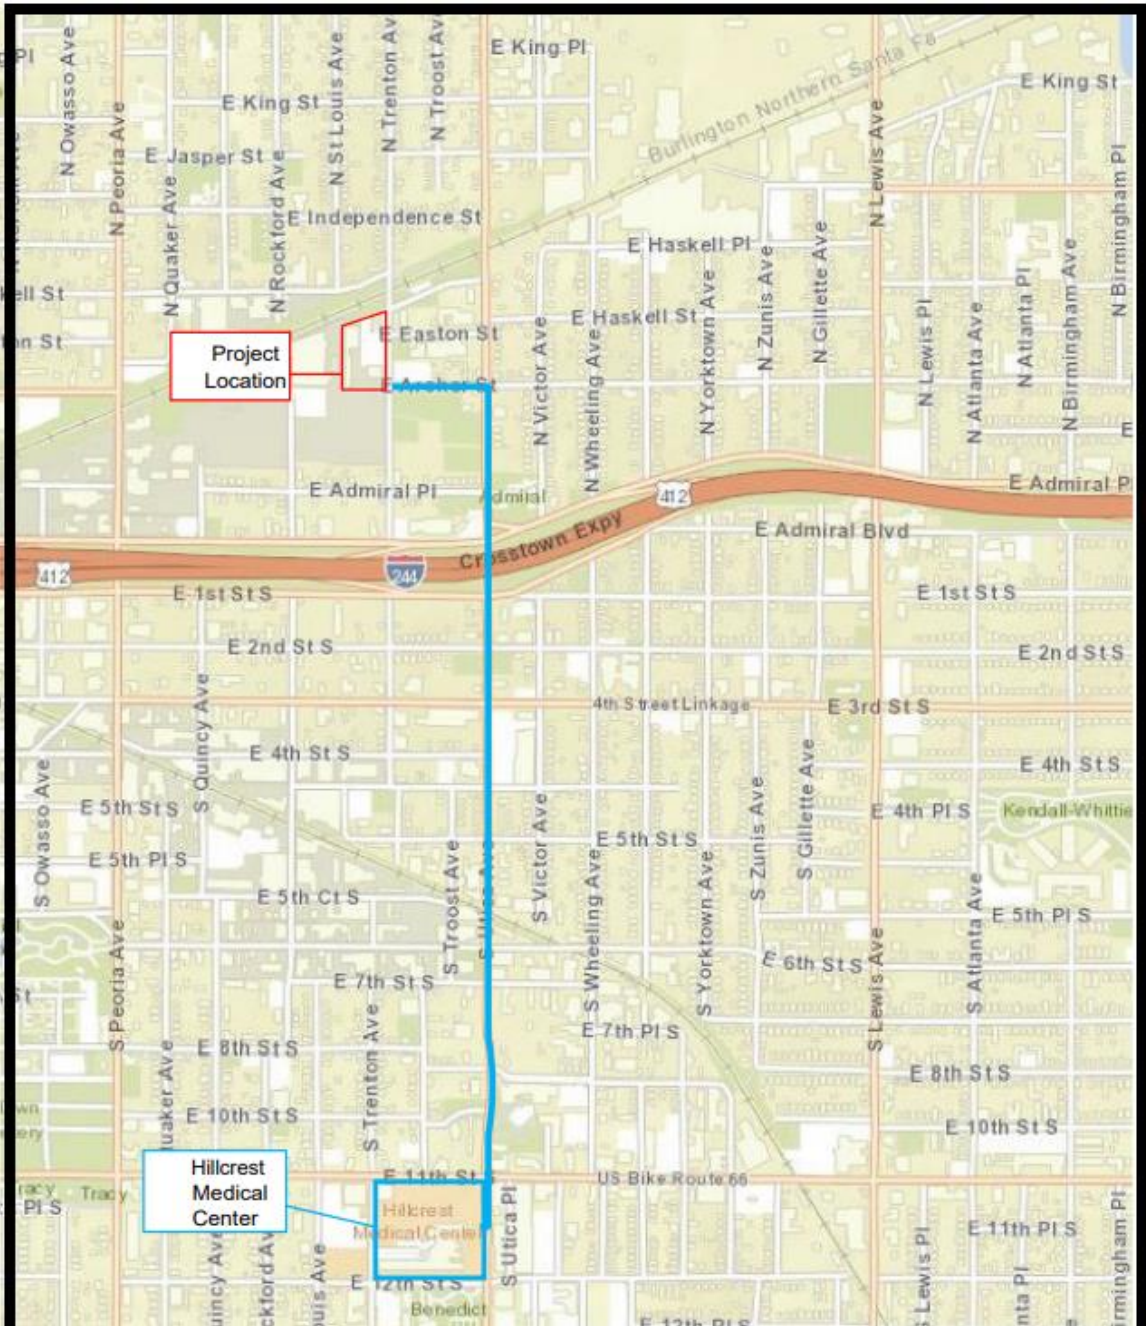
Nearest Medical Facility Route

ROUTE TO MEDICAL FACILITY CITY OF TULSA SURPLUS YARD 108 NORTH TRENTON AVENUE, TULSA, OKLAHOMA		
SCALE:	DATE:	FIGURE NO.
1" = 75'	8-27-2019	FIGURE 1
APPROVED BY:	DRAWN BY:	PROJECT NO.
JLJ	JWS	2320-001-011

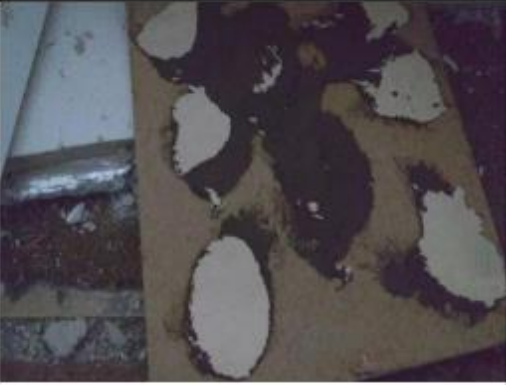
<p style="writing-mode: vertical-rl; transform: rotate(180deg);">PHOTO 1</p>

<p>HA-1: White ceiling tile with brown mastic.</p>	<p style="writing-mode: vertical-rl; transform: rotate(180deg);">PHOTO 2</p>

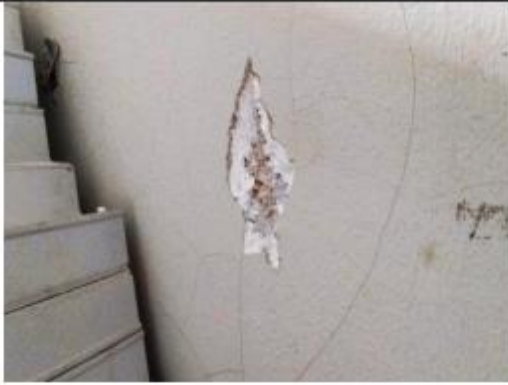
<p>HA-2: White plaster.</p>
<p style="writing-mode: vertical-rl; transform: rotate(180deg);">PHOTO 3</p>

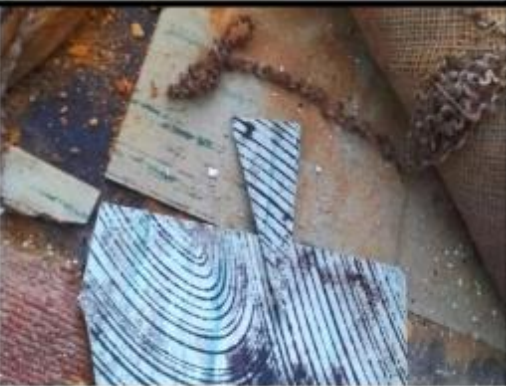
<p>HA-3: Tan and green floor tile with black mastic.</p>	<p style="writing-mode: vertical-rl; transform: rotate(180deg);">PHOTO 4</p>   <p>HA-4: Tan floor tile with black mastic.</p>
<p style="writing-mode: vertical-rl; transform: rotate(180deg);">PHOTO 5</p>

Materials	Asbestos Content	Quantity
Brown ceiling tile mastic	10% Chrysotile	16,000 SF ¹
Tan and green 9"x9" floor tile	10% Chrysotile	16,000 SF
Black floor tile mastic	5% Chrysotile	16,000 SF
Black wall mastic	10% Chrysotile	100 SF
White window sealant	5% Chrysotile	1,000 LF ²

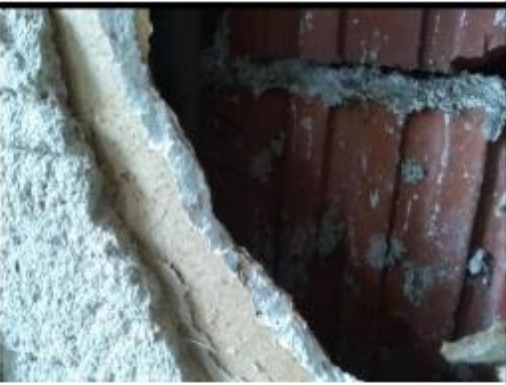
<p>HA-5: White drywall.</p>	<p style="writing-mode: vertical-rl; transform: rotate(180deg);">PHOTO 6</p>

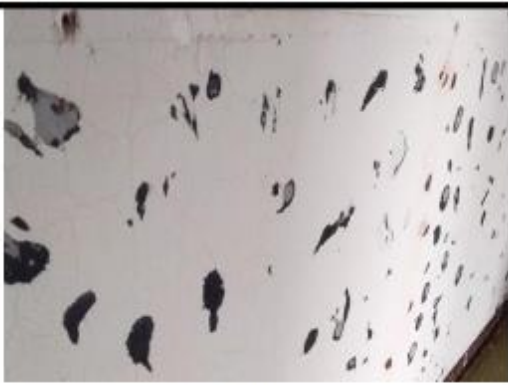
<p>HA-6: Black mastic.</p>

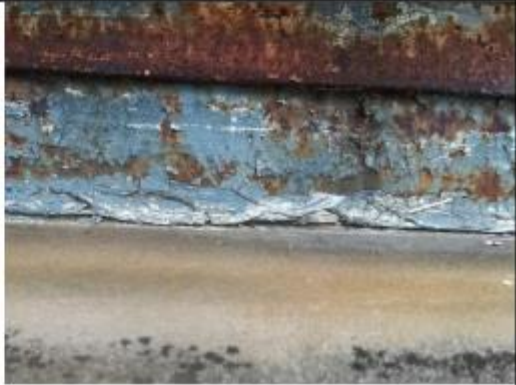
<p style="text-align: center;">HA-8: White window sealant.</p>
<p style="writing-mode: vertical-rl; transform: rotate(180deg);">PHOTO 9</p>	<p style="writing-mode: vertical-rl; transform: rotate(180deg);">PHOTO 10</p>
<p style="writing-mode: vertical-rl; transform: rotate(180deg);">PHOTO 11</p>	<p style="writing-mode: vertical-rl; transform: rotate(180deg);">PHOTO 12</p>

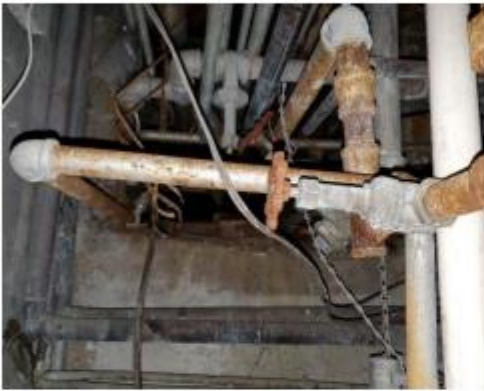
<p style="text-align: center;">Uninsulated pipes at crawl space in basement.</p>	<p style="writing-mode: vertical-rl; transform: rotate(180deg);">PHOTO 22</p>

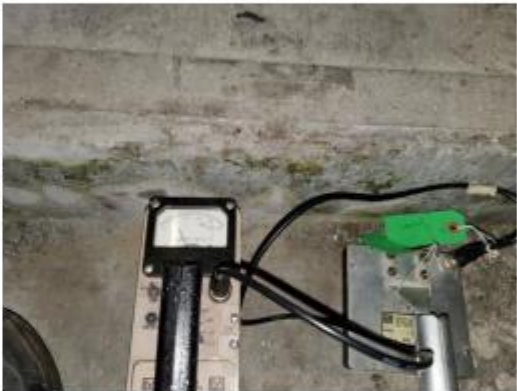
<p style="text-align: center;">Ludlum meter reading background levels on concrete steps.</p>
<p style="writing-mode: vertical-rl; transform: rotate(180deg);">PHOTO 23</p>	<p style="writing-mode: vertical-rl; transform: rotate(180deg);">PHOTO 24</p>

A City of Tulsa employee reported that Building 104 had radiation contamination. Tulsa Hazmat was called to the facility to test the area. They used two (2) Ludlem analyzers and one (1) Rad Seeker meter as well as one (1) Urtradiac to survey the building for radiation. They found an area slightly above background levels in the stairwell to the basement. Employees from DEQ’s Radiation Management Program came out and took radiation swipe samples from the basement stairs, took samples of the non-slip treads from the stairs, and took readings with a handheld radiation meter. The handheld survey meter results were far below the limits listed in 10 CFR 20.1301. Some of the individual swipe samples analyzed by the lab exceeded the removable contamination limit in Appendix B of OAC 252:410, but the average of the results is well below the limit. The non-slip strip material was below acceptable limits. DEQ’s Radiation Management Program couldn’t find a manmade source of radiation and suspected that it could be naturally occurring radiation in the brickwork and/or radon.
