ANALYSIS OF BROWNFIELD CLEANUP ALTERNATIVES

U.S. Environmental Protection Agency
Subgrantee: The City of Tulsa, Oklahoma
Tulsa Evans Fintube Property
Grant No. BF00F71001-0
Parcels # 1, #2, and #3
150/186 North Lansing Avenue, Tulsa, OK

Project Title: City of Tulsa – Evans/Fintube Project ABCA

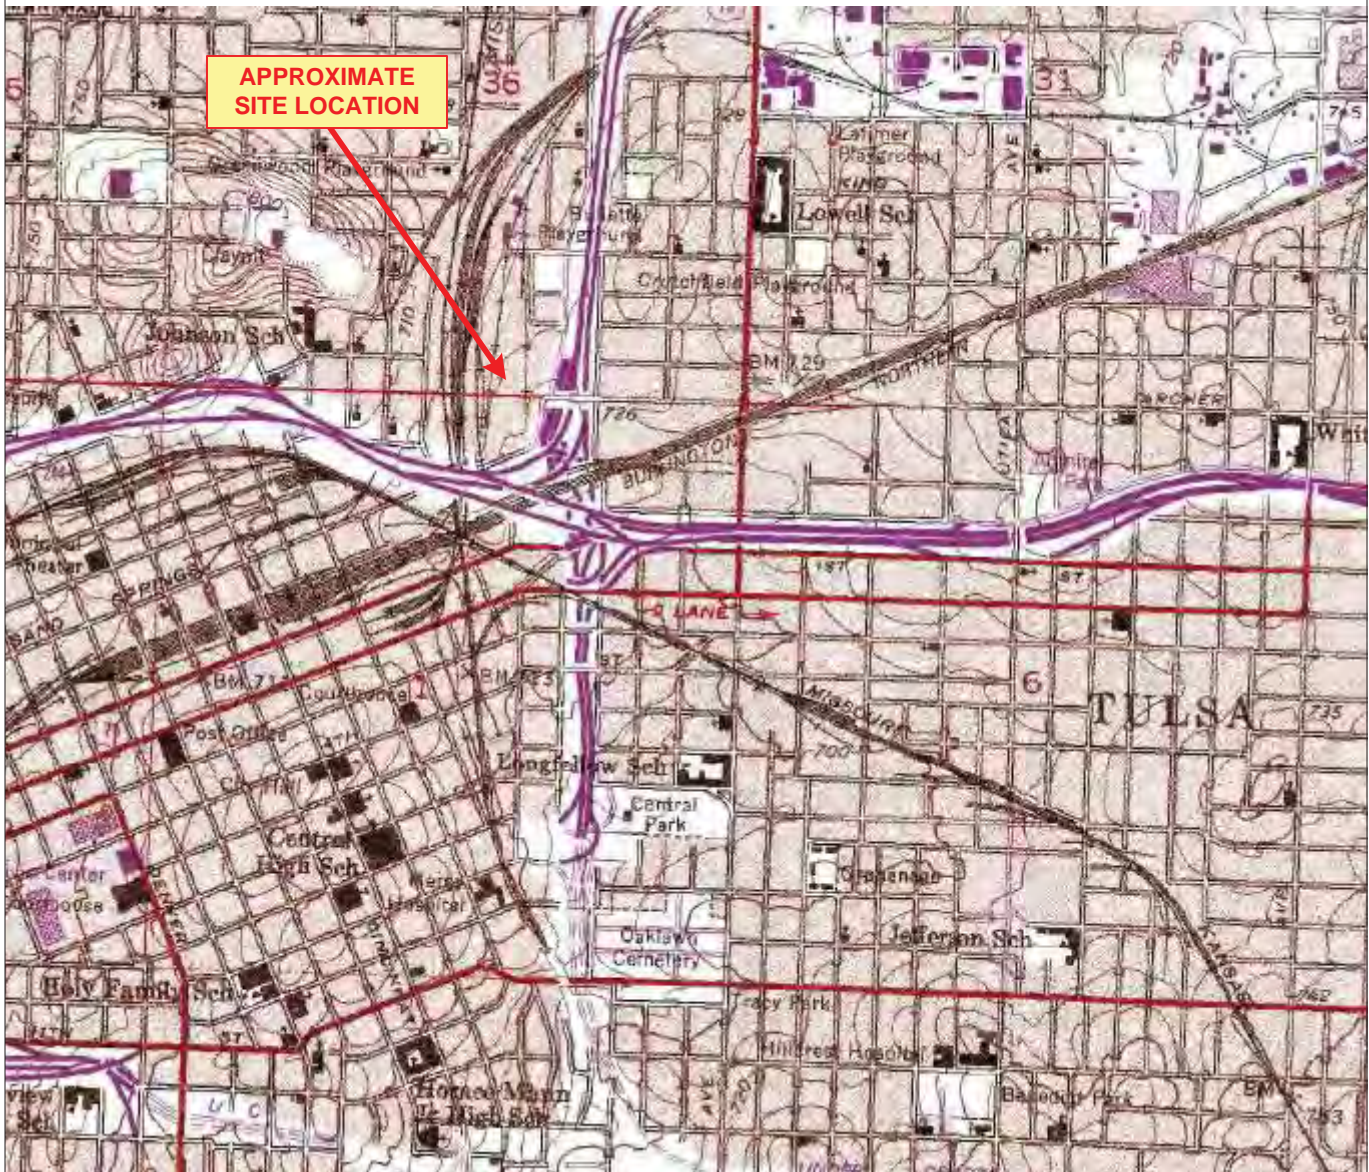
TOPOGRAPHIC MAP		
FINTUBE TBA TULSA, OKLAHOMA		
SCALE: 1:24000	DATE: 07/05/2011	FIGURE NO. Figure 1
APPROVED BY: CBM	DRAWN BY: NDA	PROJECT NO. 1303.PHI.00

According to the USGS 7.5-Minute Topographic Map, Tulsa Quadrangle, the subject property is located in a relatively flat area, gently sloping northwest. The Site elevation is approximately 730 feet above Mean Sea Level (MSL). Figure 1 is a topographic map of the Site and surrounding area.

Figure 1 presents a topographic map of the Site. Figure 2-A is a general layout of the Site and adjoining properties.

The Topographic Map (Figure 1) shows the general Site location and topographic relief. Figures 2-B and 2-C indicate the approximate locations of the features referenced in the following subsections for the Evans Building Complex and the Fintube Building Complex, respectively. The Site Inspection Form is provided in **Appendix C**. The Site Photographs are provided in **Appendix D**.

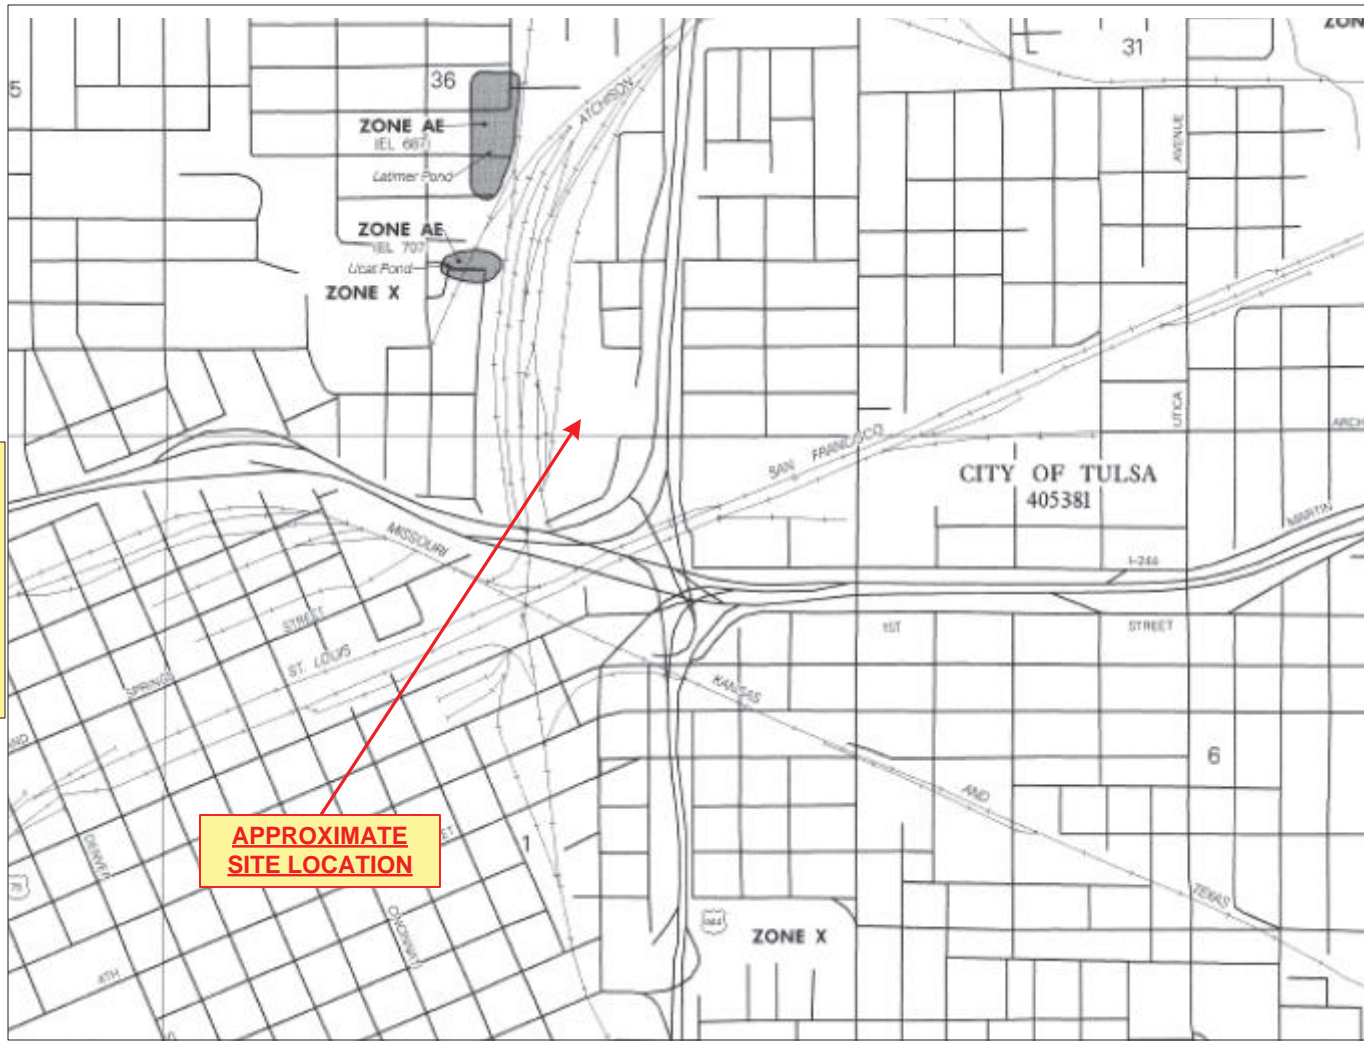
FLOOD MAP		
FINTUBE TBA TULSA, OKLAHOMA		
SCALE: AS SHOWN	DATE: 07/05/2011	FIGURE NO. Figure 3
APPROVED BY: CBM	DRAWN BY: NDA	PROJECT NO. 1303.PHI.00

According to the EDR overview map, the Site is not located within a 100-Year or 500-Year floodplain. No visual evidence of recent flooding or prolonged surface water retention was observed on-site during the inspection. Figure 3 is a Flood Map for the area.

LEGEND	
ZONE	EXPLANATION
AE	AN AREA INUNDATED BY 100-YEAR FLOODING FOR WHICH BASE FLOOD ELEVATIONS HAVE BEEN DETERMINED
X	AREAS LOCATED OUTSIDE THE 100-YEAR OR 500-YEAR FLOOD ZONES

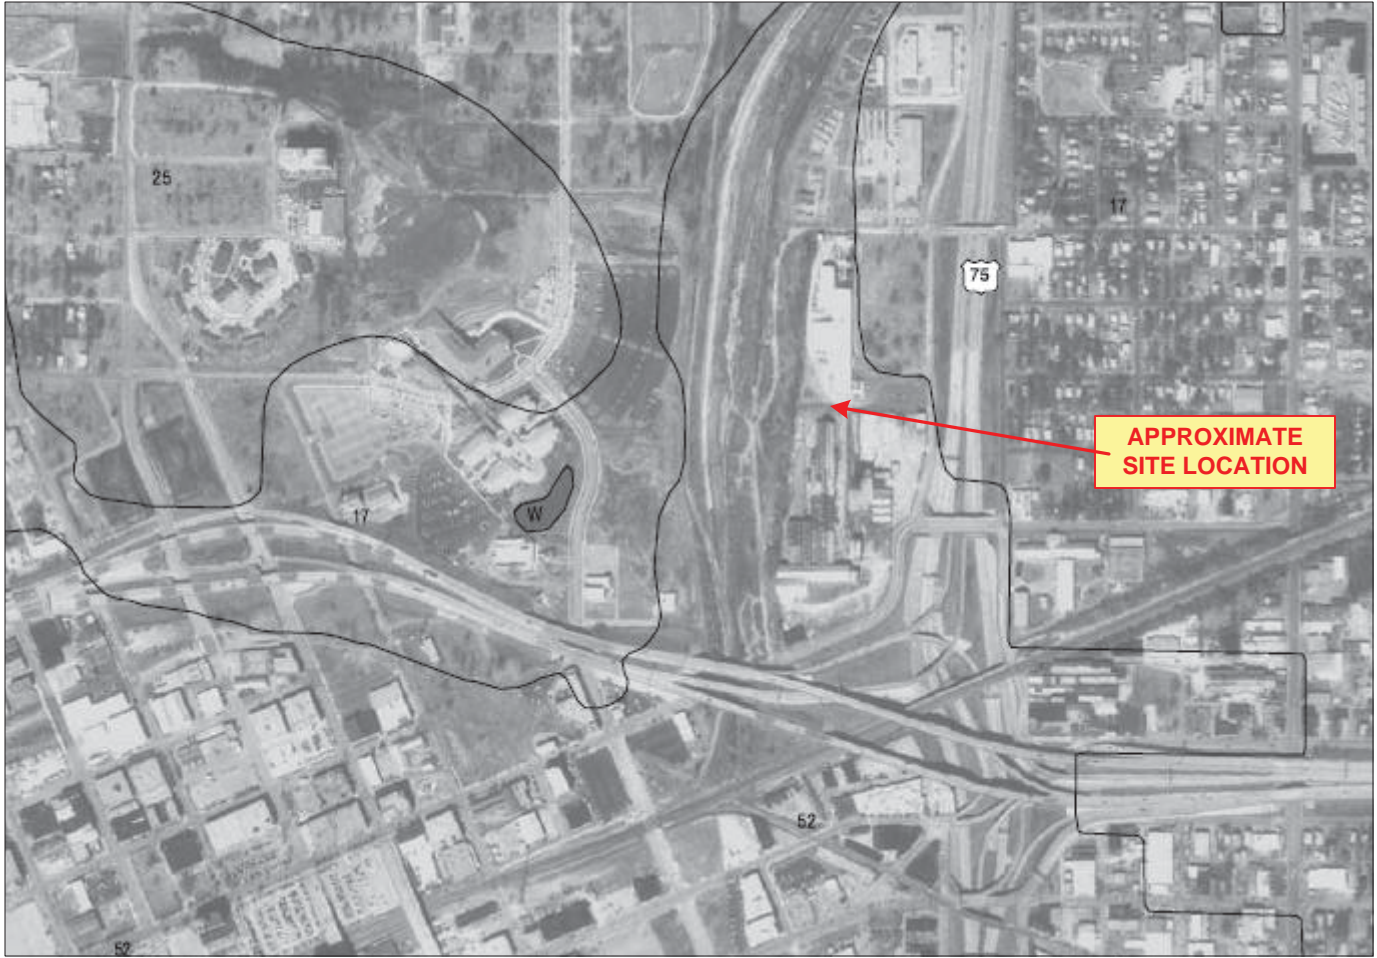
SCALE: 1:24000	DATE: 07/05/2011	FIGURE NO. Figure 4
APPROVED BY: CBM	DRAWN BY: NDA	PROJECT NO. 1303.PHI.00

According to the United States Department of Agriculture - Natural Resources Conservation Service Soil Map the soil at the Site consists mostly of Urban Land. Urban Land typically has 0 to 8% slopes, a very high runoff rate, and is not typically subject to flooding or ponding. Urban Land's land capability classification is 8s, and is not assigned as an ecological site. The Urban Land at the Site is the result of intermingling native soil with fill material introduced during the prior development of Site and surrounding properties, which makes it impractical to distinguish the native soil types. Often, the development of a site involves the stripping of the top soil horizon and placement of fill material on top. Figure 4 is a Soils Map of the area.

- 17 - URBAN LAND - DENNIS COMPLEX, 0 TO 5 PERCENT SLOPES
- 25 - KAMIE URBAN LAND COMPLEX, 1 TO 8 PERCENT SLOPES
- 52 - URBAN LAND
- W - WATER

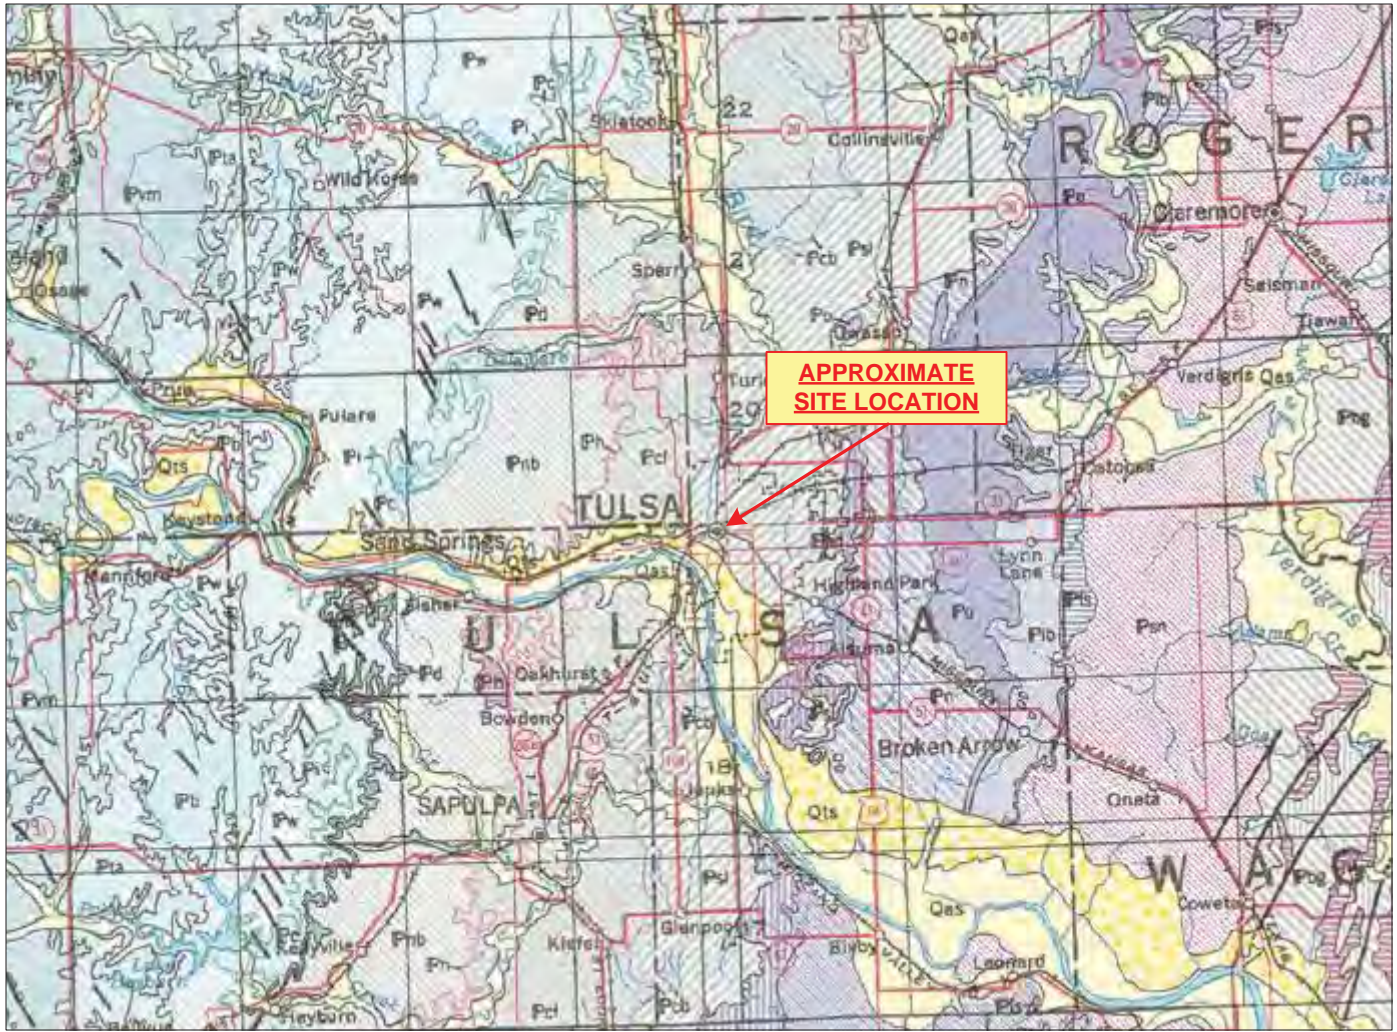
GEOLOGY MAP		
FINTUBE TBA TULSA, OKLAHOMA		
SCALE: 1:500 000	DATE: 07/05/2011	FIGURE NO. Figure 5
APPROVED BY: CBM	DRAWN BY: NDA	PROJECT NO. 1303.PHI.00

The Geologic Map of Oklahoma shows the geologic units underlying subject area to consist of the Upper Pennsylvanian age Seminole Formation, comprised mainly of shale with interbedded siltstone and sandstone. Figure 5 is a Geology Map of the area.

LEGEND	
Pnb- NELLY BLY FORMATION	Pcf- COLLINGS RANCH FORMATION
Pe- ELGIN SANDSTONE	Psi- SEMINOLE FORMATION
Pvm- VAMOOSA FORMATION	Pb- BARNSDALL FORMATION
Pi- IOLA LIMESTONE	Pw- WANN FORMATION
Pcb- CHECKERBOARD LIMESTONE	Phd- HOLDENVILLE SHALE
Qas- ALLUVIUM	Ph- HOSHOOTER LIMESTONE
