BORE/OPEN CUT CONDUIT DETAIL	
CITY OF TULSA, OKLAHOMA ENGINEERING SERVICES DEPARTMENT	
DRAWN BY: S.R.W.	APPROVED
CHECKED BY:	
DATE: OCTOBER 2013	
NOT TO SCALE	STANDARD NO. 307

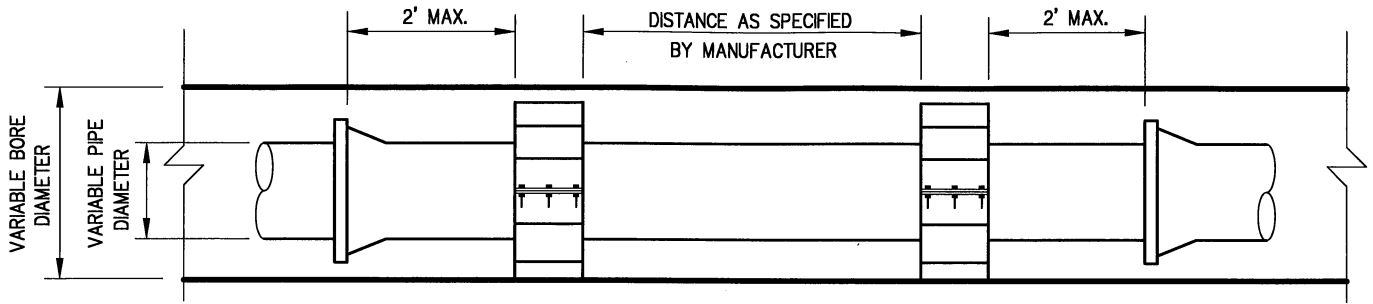
TYPICAL BORE WITH PIPE INSTALLED

LONGITUDINAL VIEW
NOT TO SCALE

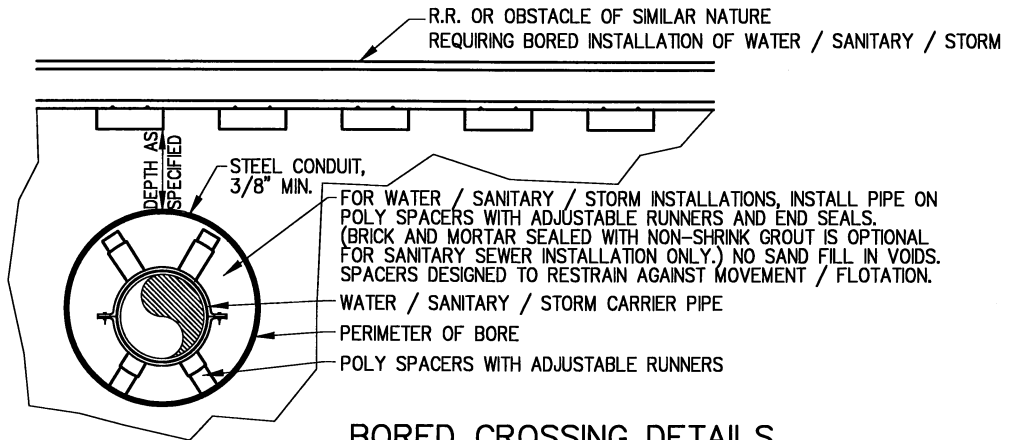
BORED CROSSING DETAILS

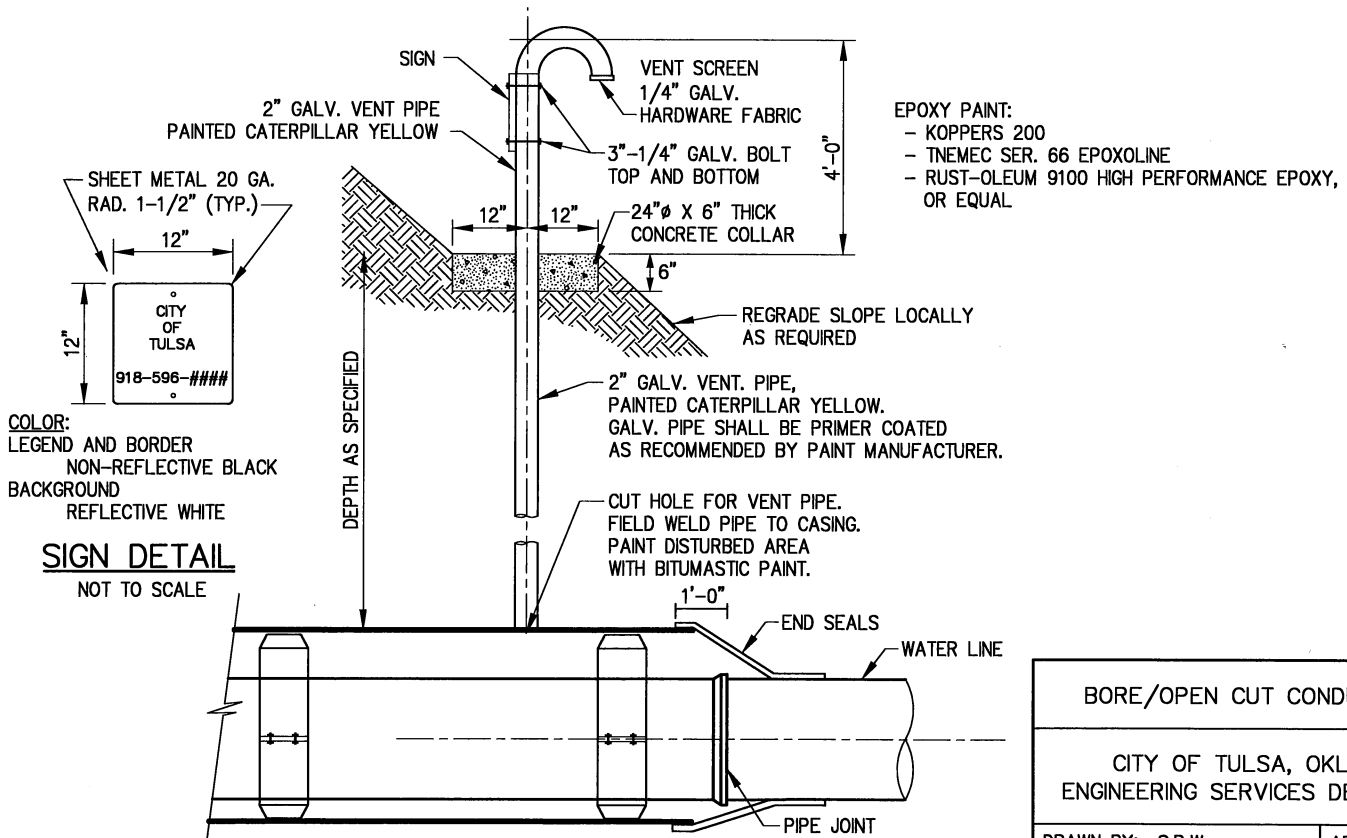
ALTERNATE VENT PIPES AT CONDUIT ENDS
